Eli Bridge Company

Bulletin No.: 20190501-2

SAFETY ALERT

Ride Manufacturer: Eli Bridge Company **Affected Production Dates:** All Scrambler® Seats 35 years and older
Ride Names: Seats for Scrambler®, TMS® (Trailer Mounted Scrambler®) and 28' RS® Trailer Mounted Scrambler

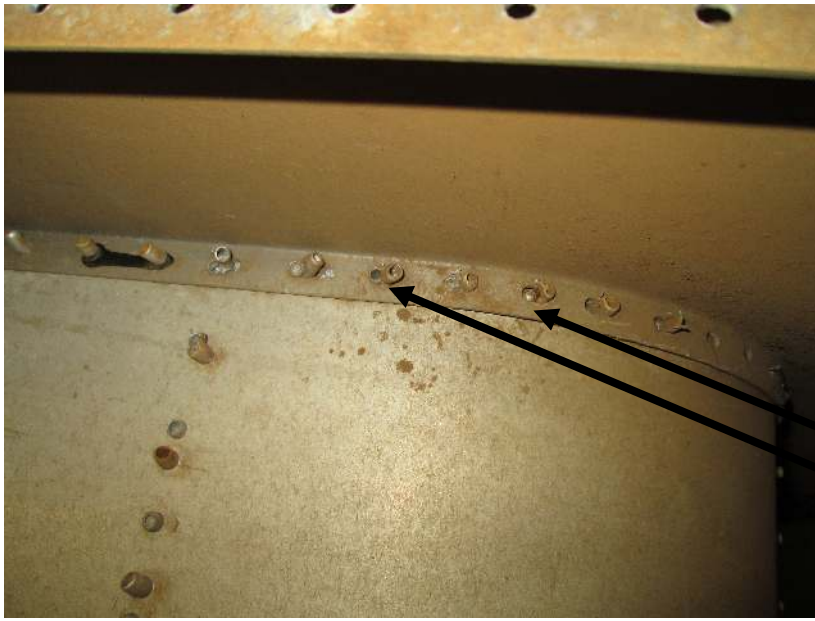
#1 It is obvious in the photo that new holes were drilled in the rib instead of properly aligning the holes in the skin with the holes in the rib. This causes the two holes to become a slot. New holes should NOT be drilled when replacing the skin. Call the factory if you have difficulties with this. The skin has misaligned holes as well from side to side. Both the skin and the flange must be replaced.

The misaligned holes caused slots to form which do not keep the rivets tight and take too much Material out of the flange.

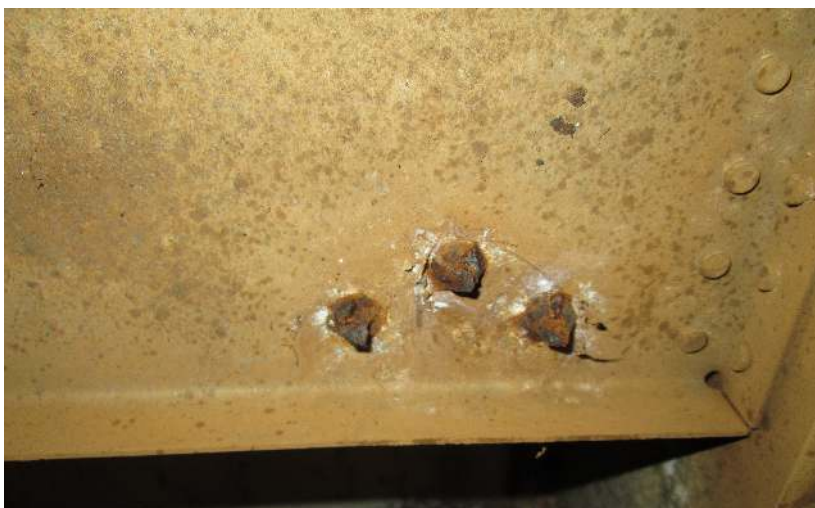
#2 shows advanced corrosion on both the skin and the fasteners causing cracking around the fasteners. Notice too, the delaminating just to the right and below the fasteners on the right. This seat must be replaced.

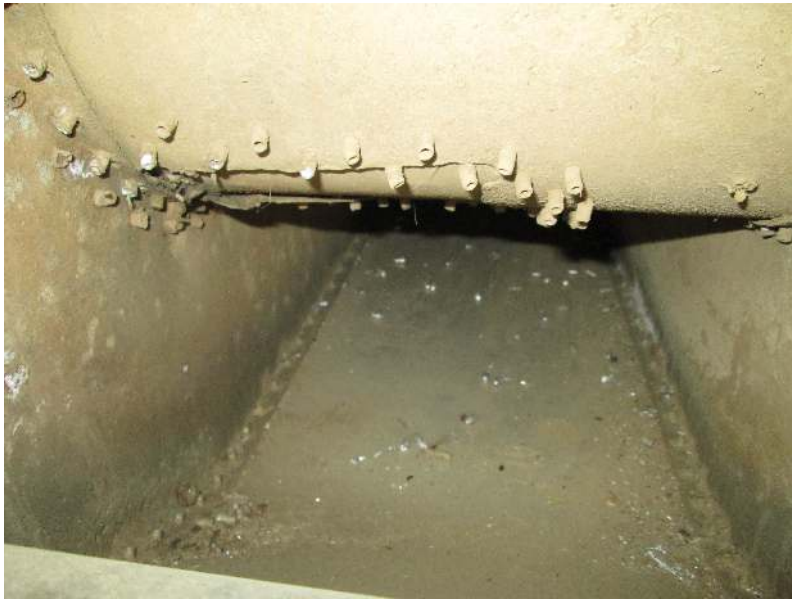
#3) shows multiple problems with corrosion and misaligned rivets. There should only be one line of rivets on the left side attached to the above skin. There should be no rivets on the side of the rib as are shown in this picture. There is also significant corrosion on the bottom of the skin. This seat must be replaced.

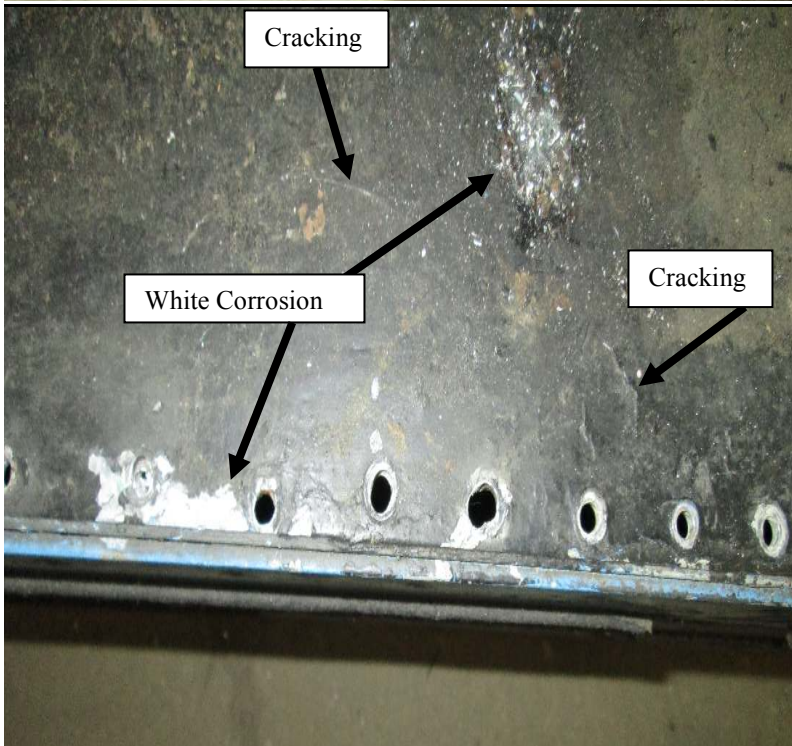
#4) shows several areas of white corrosion and misaligned holes such that some have become slots, which are unacceptable. The arrows show cracking on the skin, most likely from embrittlement. This seat skin must be removed and replaced. When the skin is removed, if the rib to which it was attached has holes like the ones shown and or corrosion, it must also be removed and replaced.
