ACTION NOTE

ROLLER COASTER BRAKING SYSTEM

A recent accident in South Shields involving a 1986 Pinfari Zyklon Roller Coaster occurred when a moving car ran into a stationary car in the station causing a number of minor injuries. An HSE investigation of the accident is under way.

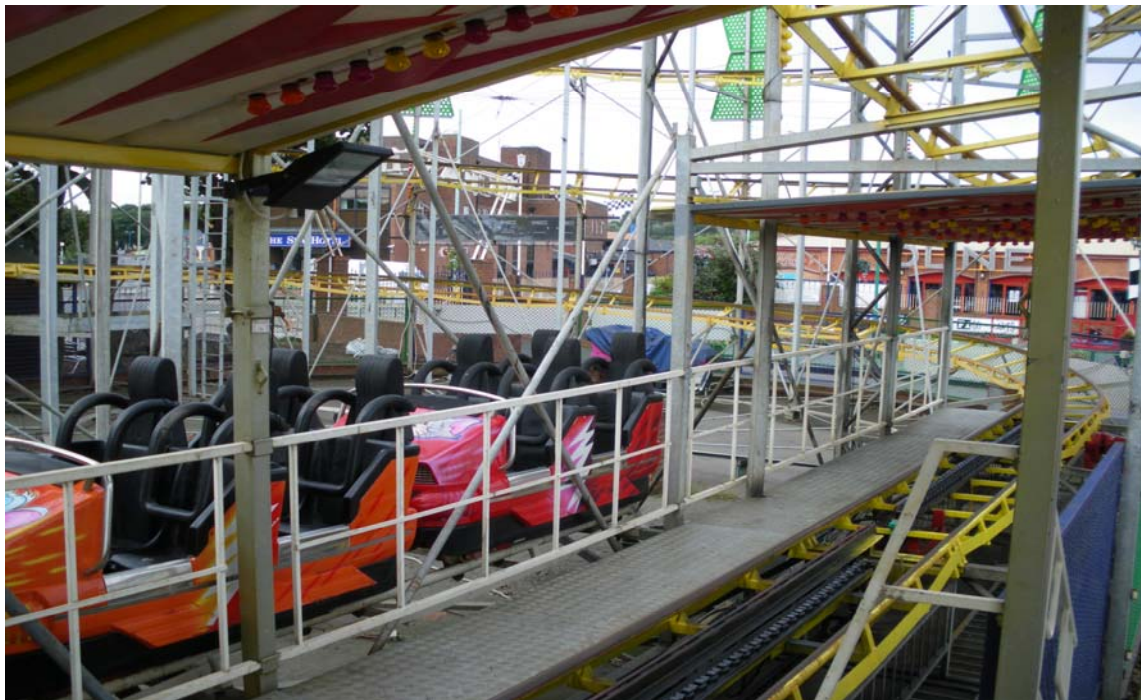
Fig 1:

The ride involved in the accident is a Pinfari Zyklon Roller Coaster **but it is possible that similar brake control systems may have been fitted to other coasters.** A general view of the station area is at Fig 1.

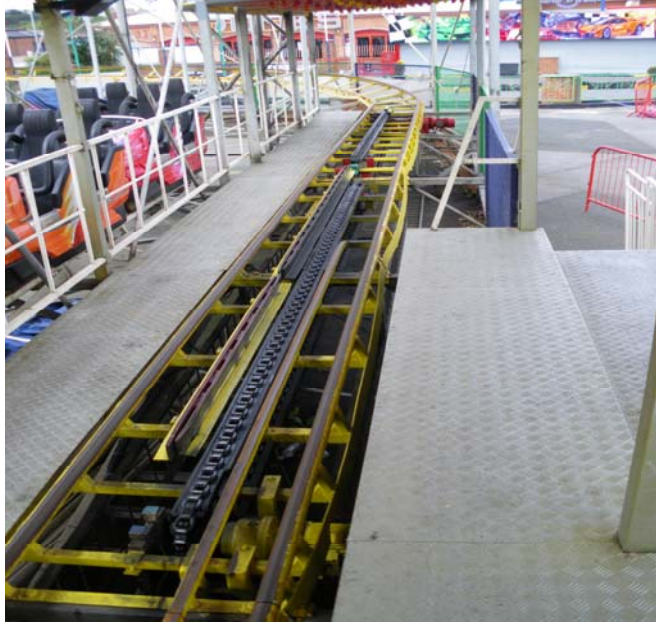
Cars arriving back in the station are, under normal conditions, slowed and stopped by a chain brake system. In certain circumstances however ie when the car is carrying more than average weight or running in wet conditions this chain brake may not be sufficient to bring the car to a complete stop and a secondary air brake is used. This may be operated either manually or automatically. A general view of the braking area is shown at Fig 2.

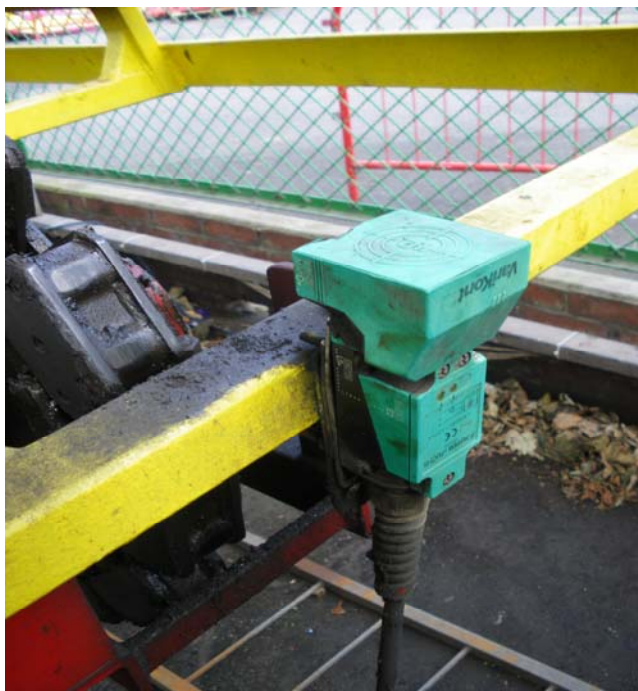
The coaster involved in the accident had a retro fitted automated secondary air brake, operated by proximity sensors fitted to the track in the braking area. An example of such a sensor is at Fig 3 and Fig 4 shows one of the pair of sensors fitted to the track.

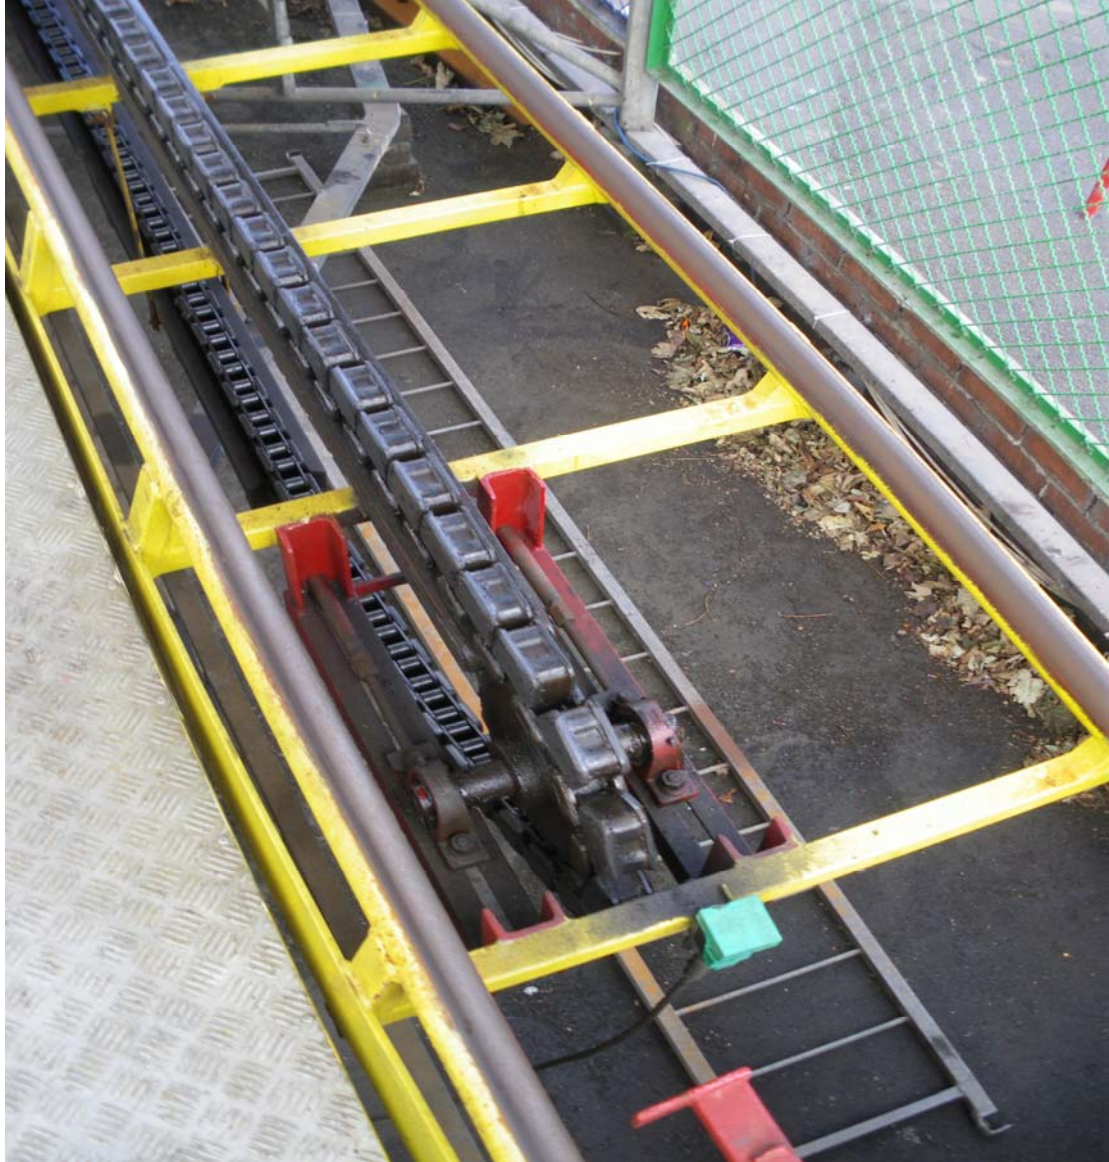
Fig 4.

The sensor was set to operate the secondary air brake when the car passed it and functioned when a piece of metal plate attached to the car passed within 40mm of it.

Early indications from the investigation suggest that the secondary air brake did not come on because the sensors were not functioning correctly and did not recognise the car passing them. The sensor was fixed at a suitable distance from the plate on the passing car.

1. Controllers using roller coasters with such sensor controlled systems should ensure that this secondary braking system is working correctly.
2. Testing of this system should form part of the daily checks on the ride and the tests should be conducted with realistic load weights in the cars.

3. Controllers should discuss with their ride inspectors the feasibility of changing this single sensor system to a parallel wired reserve sensor system or to a system able to detect state changes across pairs of sensors.

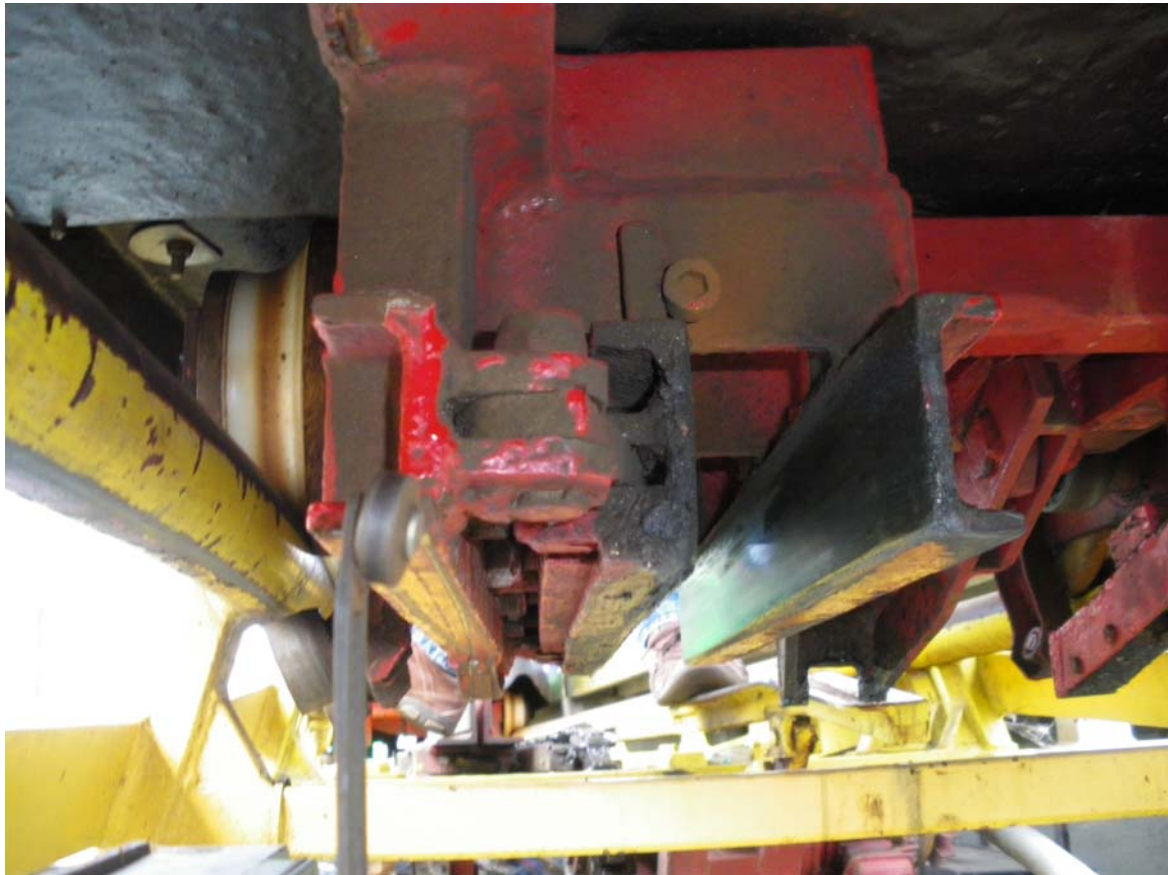
Fig 4.

Fig 4 is a photo taken underneath a car showing the metal plates which engage the chain brake system and it is also these plates that operate the sensors when necessary
