SERVICE BULLETIN QUA/03/001

(QUASAR AMUSEMENT RIDE)

SEPTEMBER 1988

MFG: A.R.M. (UK) LTD.
NAME: QUASAR
TYPE: NON-KIDNIE

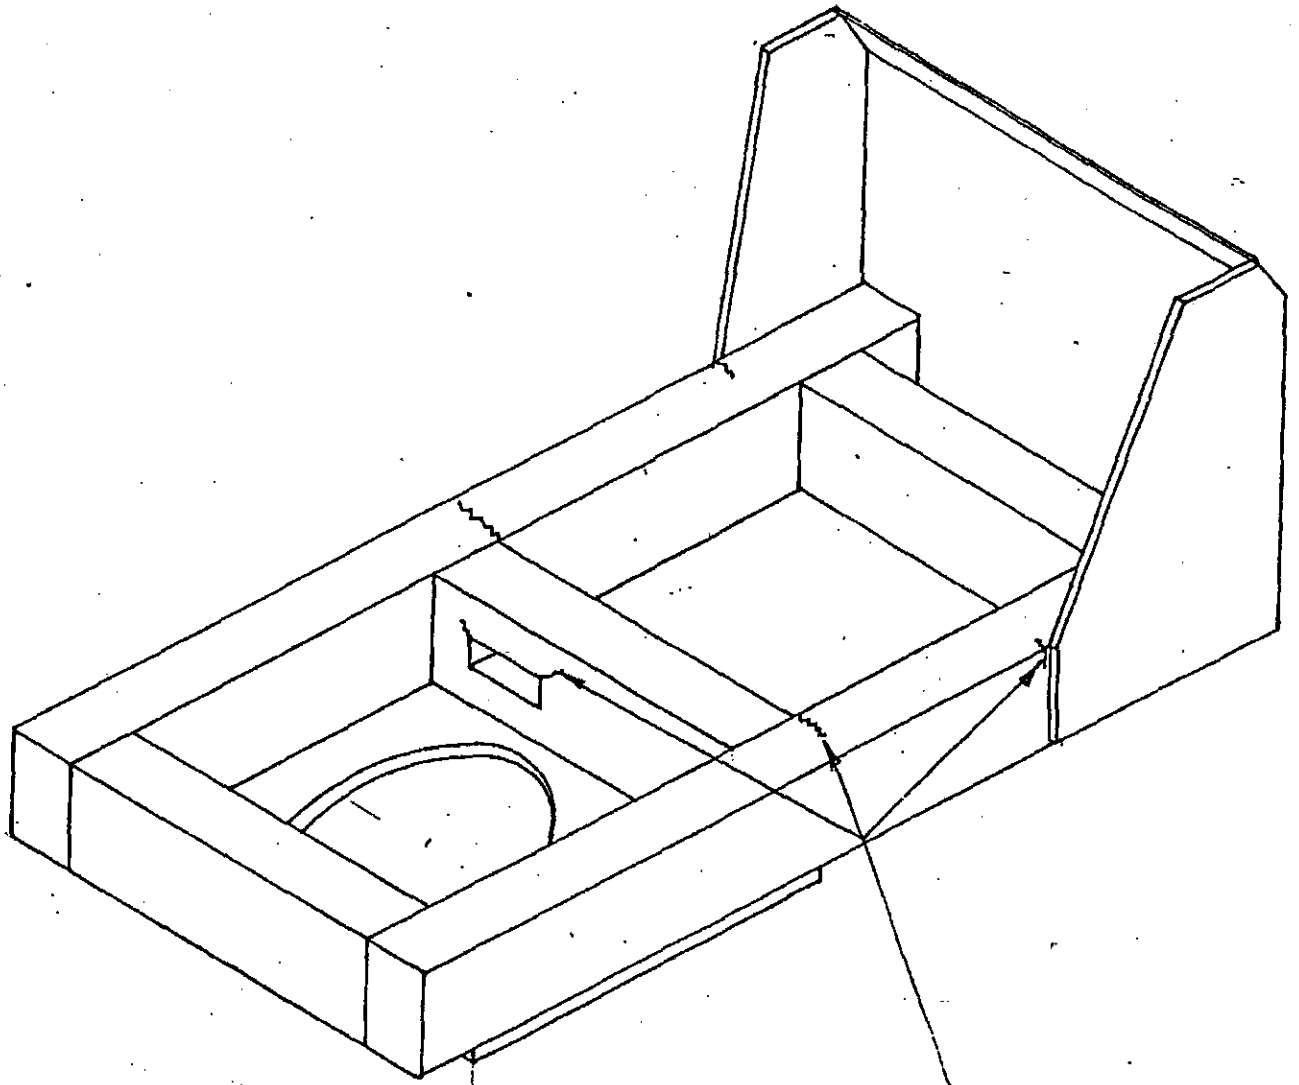
ORIGINAL CONSTRUCTION

After examination and assessment it has been concluded that the cracking is fatigue initiated due to the presence of geometrical discontinuities in the vicinity of the tensile fibres of the main side members and forward crossmember.

These discontinuities in the form of weldments and square profiled pipe slot produce local stress concentrations and initiate cracks in the tensile fibres.

POTENTIAL CRACK LOCATION

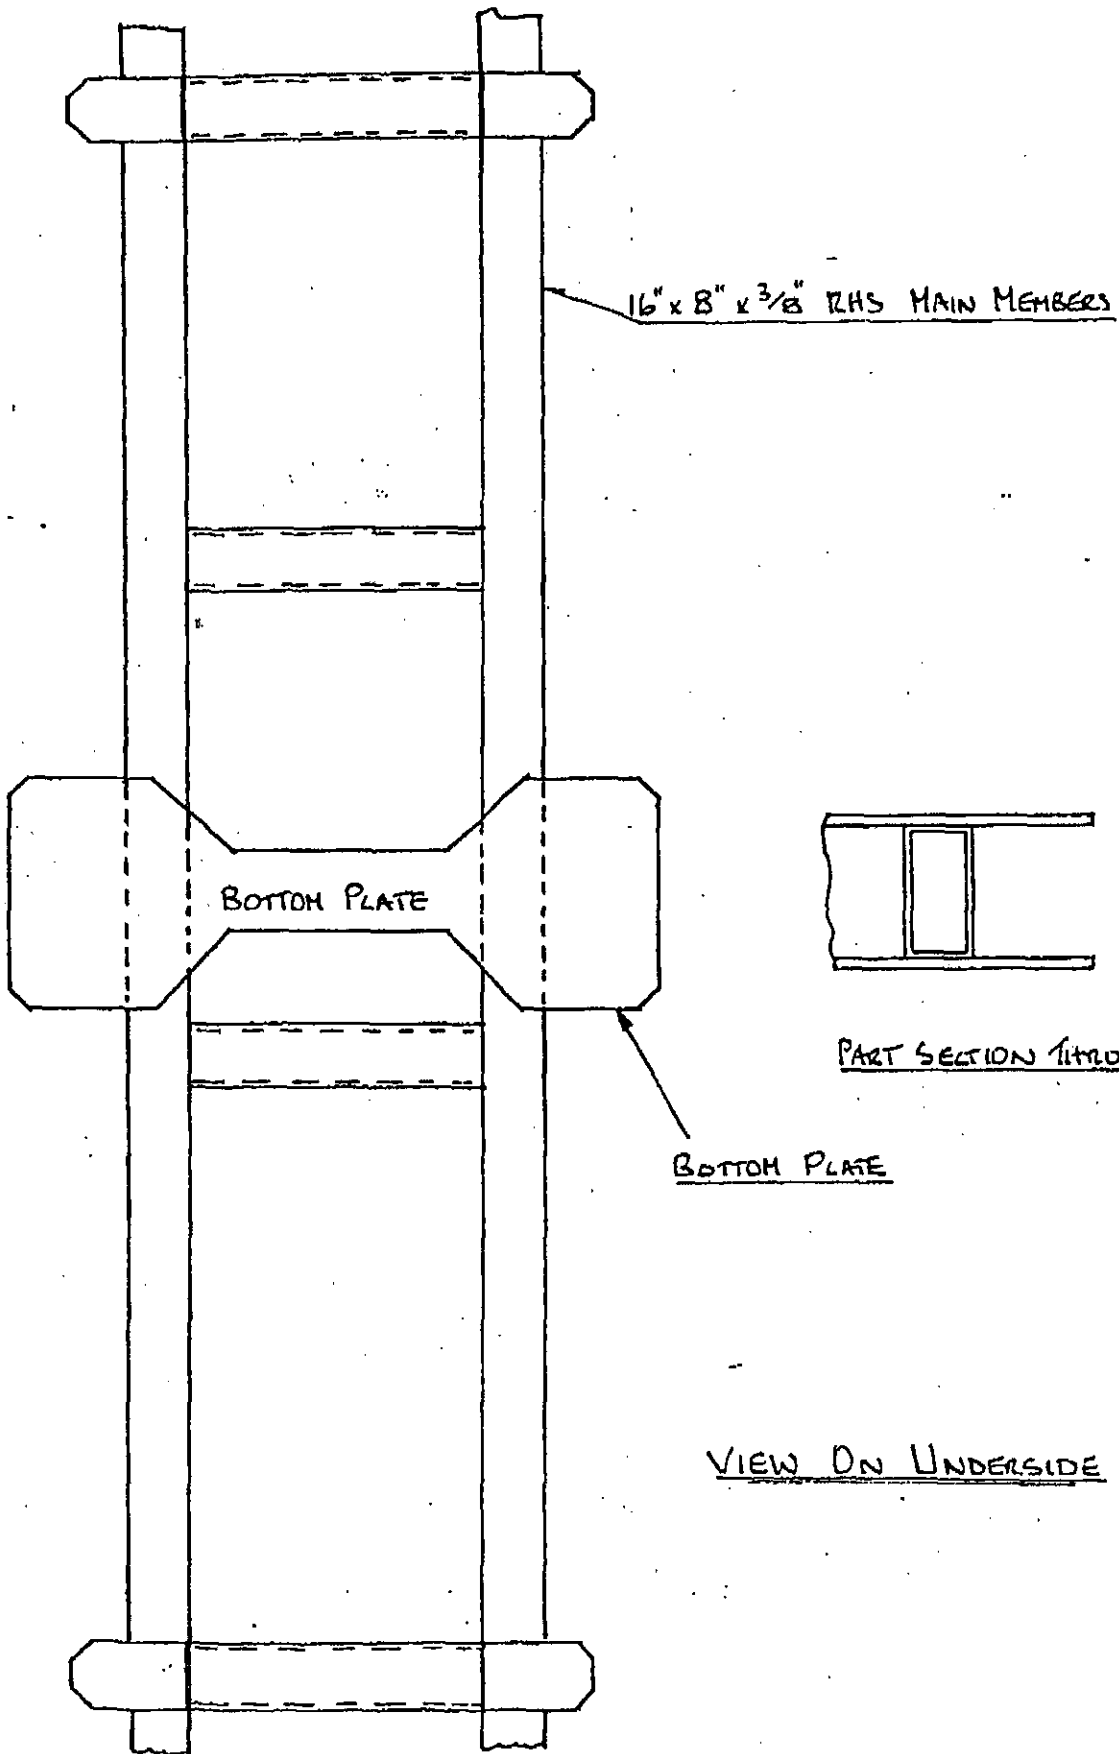
ORIGINAL CONSTRUCTION (STRAIGHT TYPE)

After examination and assessment it has been concluded that the cracking is fatigue initiated. The loading spectrum on the trailer is very complex because when in travelling mode the trailer will be subject to stress ranges of varying magnitude and quantity. This will depend on the road surface quality and the number of miles travelled per annum. The former is impossible to evaluate without resorting to strain gauge analysis.

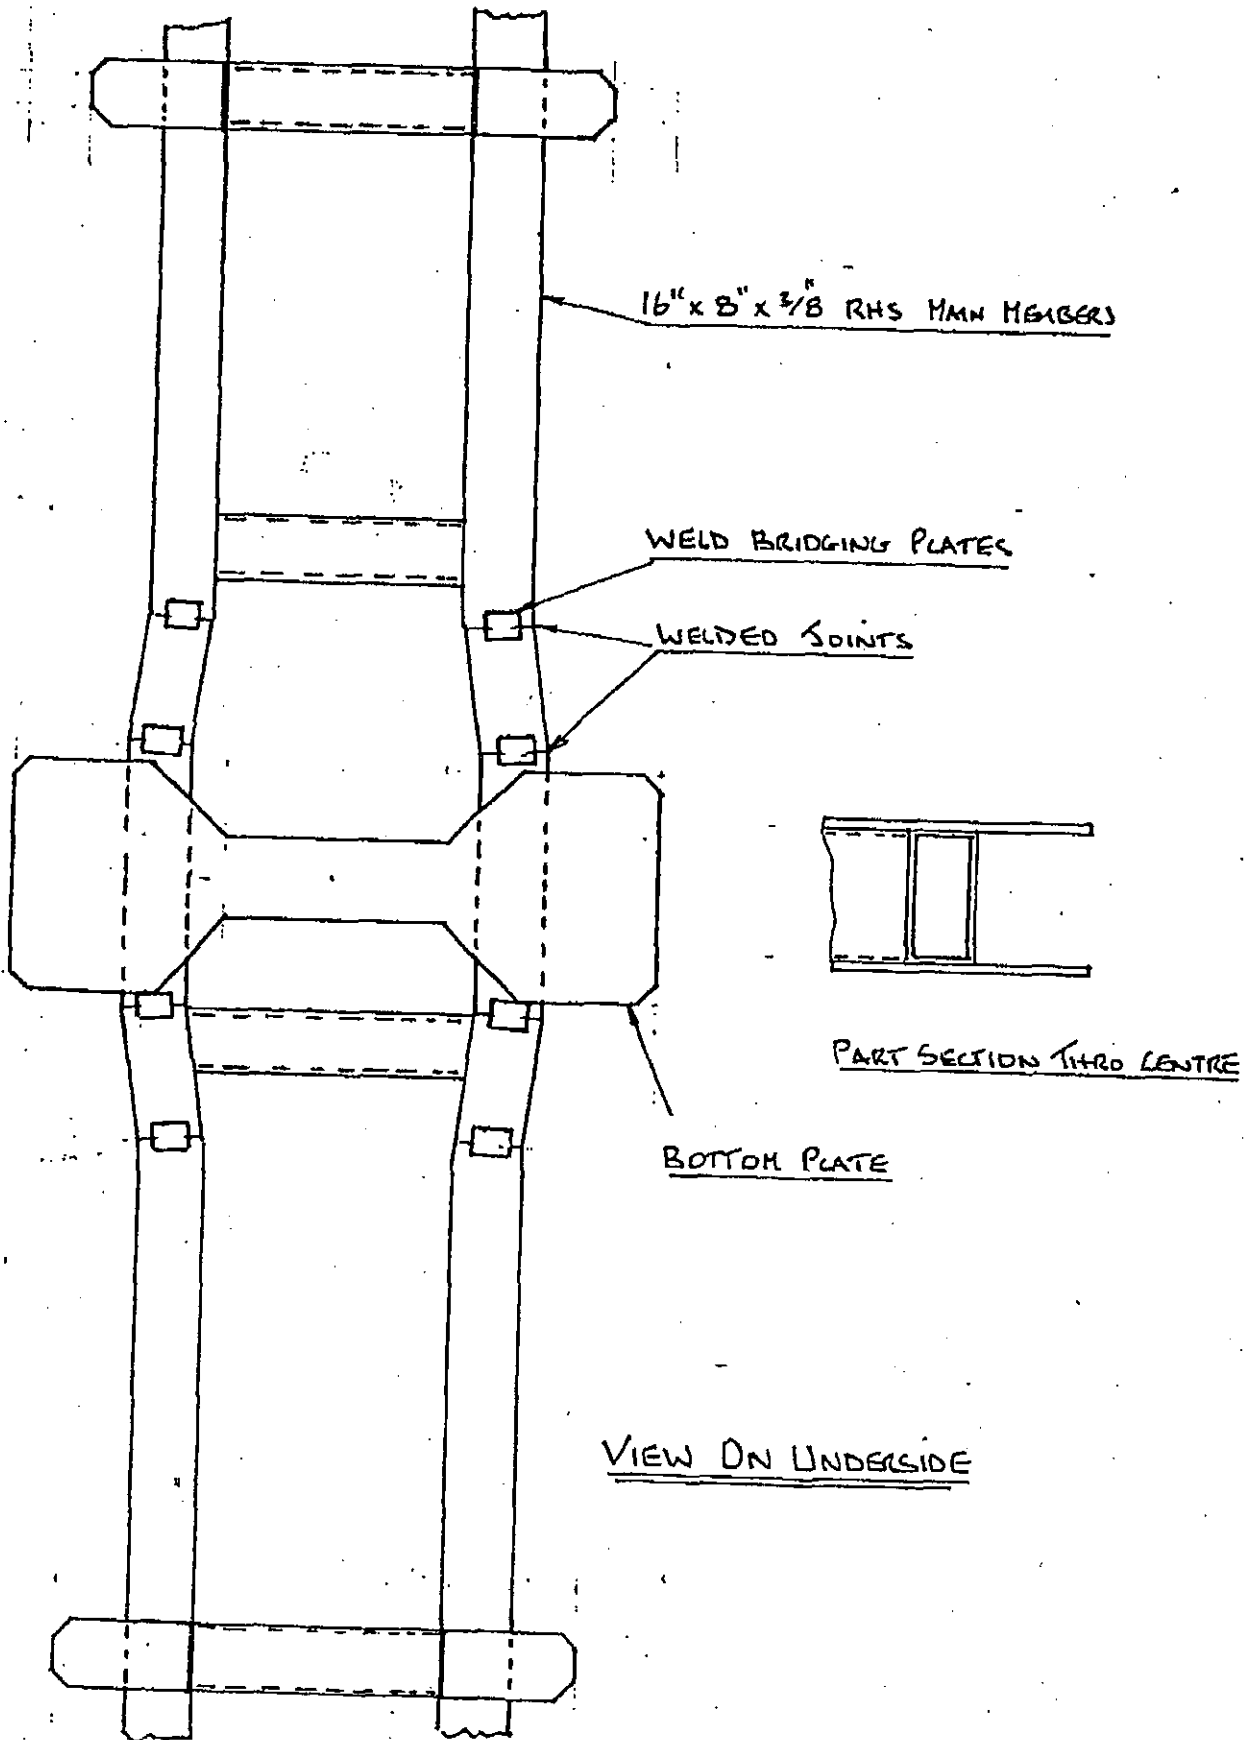
ORIGINAL CONSTRUCTION (CRANKED TYPE)

The picture is further complicated by their being two types of trailer construction, viz Type 1 with cranked main longitudinal members and Type 2, with straight members. The cranked version gives most cause for concern because the members are cut, bent and then welded which places a weldment at right angles to the stress lines in the tensile zone. This weldment then initiates cracks on the underside of the main members which propagate outwards and upwards.

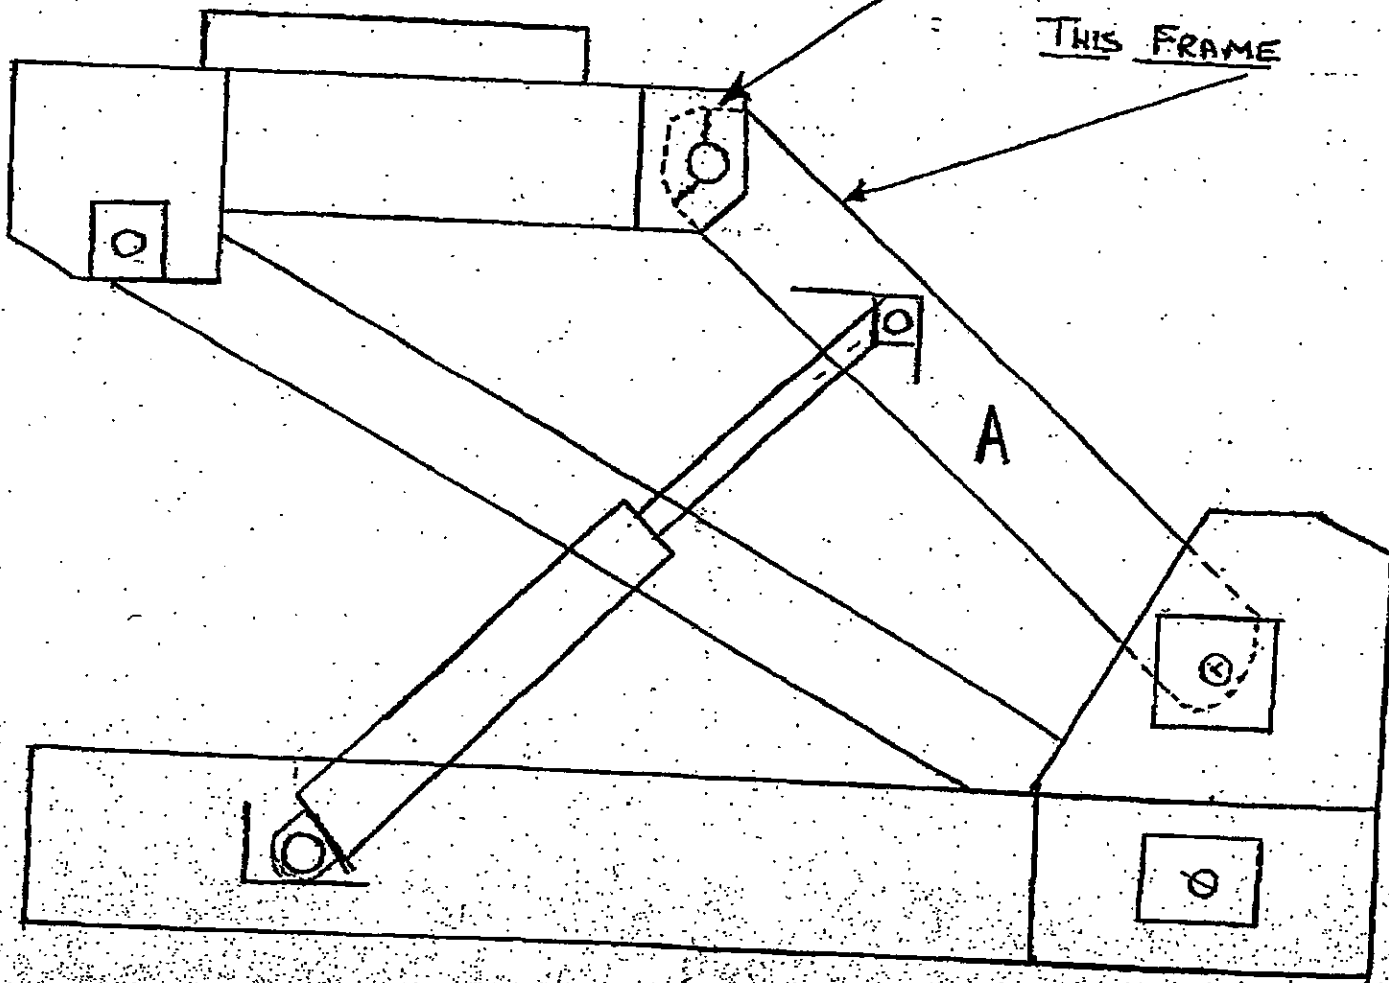
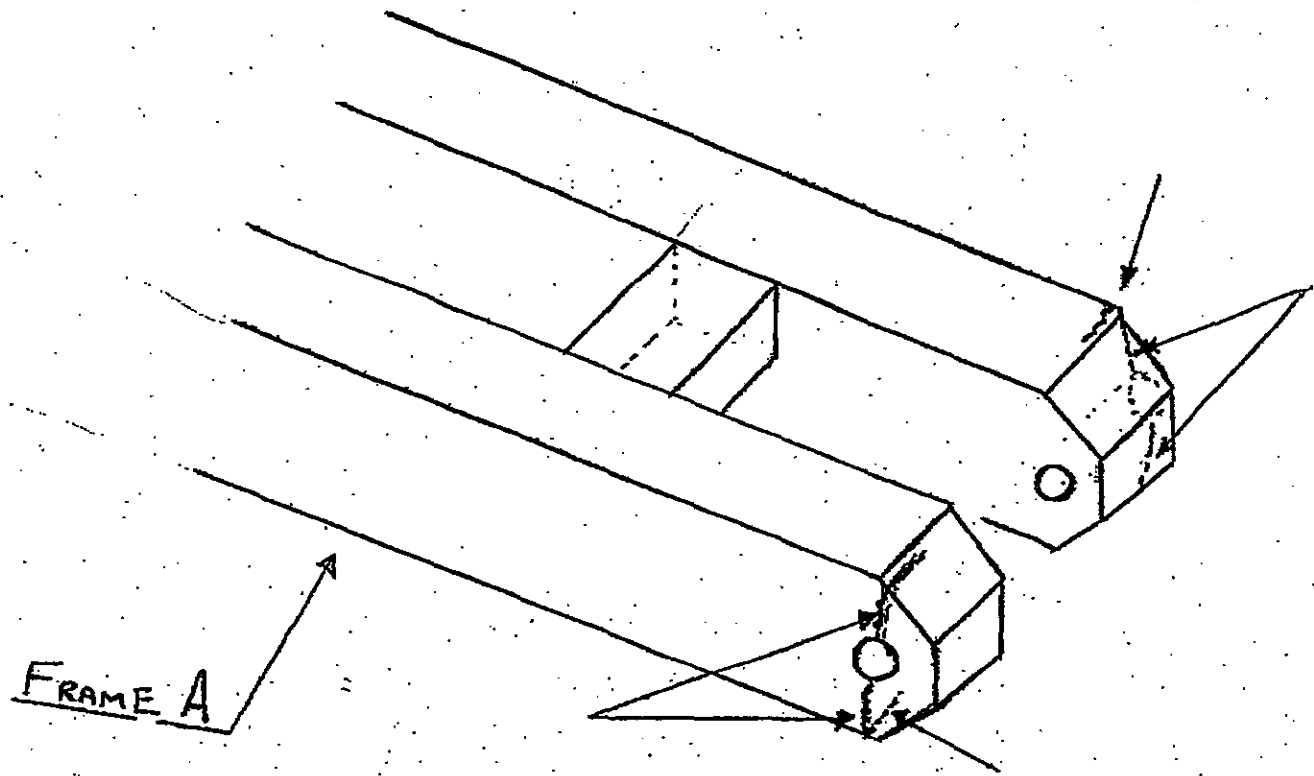
FRAME A

It has been noted that one Quasar has developed cracks on the 'H' frame upper pivot points, radiating from the hinge pin holes (see attached sketch).

CRACKS FOUND ON 'H' FRAME AT THIS POINT

BOTH SIDES

CRACKS RADIATING FROM HINGE PIN HOLES BOTH SIDES.
AND RUNNING ACROSS BOX SECTION

All operators must inspect for cracks in this area. If any cracks are found, please inform the manufacturer and ensure that the ride is not used until repairs have been carried out.

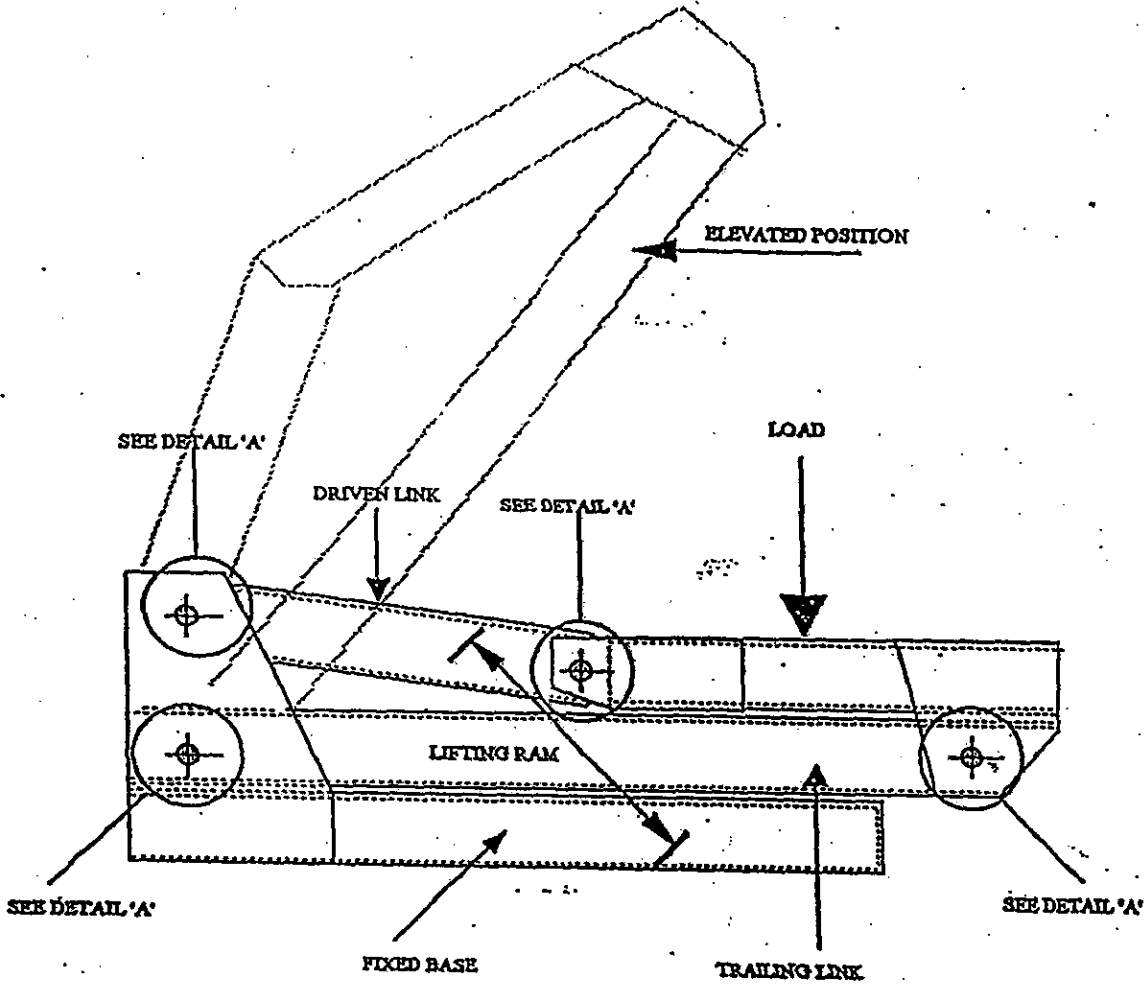
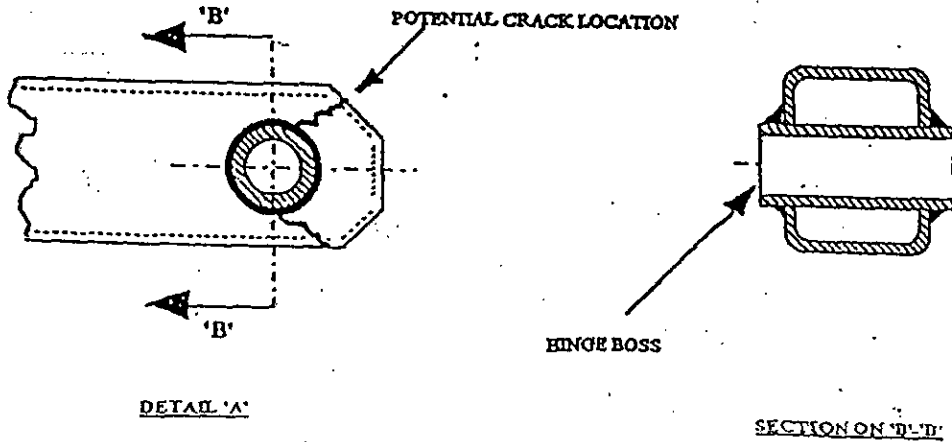
Quasar Lifting Frame

On investigation it would appear that some hinge bosses may have inadequate weld preparation and may suffer fatigue induced cracking emanating from the area of the hinge boss and propagating outward at 45° into the parent metal of the links.

- 1) Visual inspection of the area immediately in the vicinity of the hinge bosses situated at either of the two main travelling links, one link being ram driven and one being a trailing link

Check for any indication of a crack both in the weldment of the boss to the link and also in the link parent metal. If cracks are visible then these areas are to be subjected to non destructive testing as in 2) and 3) below to determine the extent of any possible damage.

- 2) The area as described in 1) above to be checked by non destructive testing for cracks in the weldment or surrounding parent metal, and to be certified sound in writing by a suitably qualified inspector.
