*Sky Master*

## SERVICE BULLETIN

## NOTICE OF RECOMMENDED ACTION

To: Amusement Owners  
From: Mark F. Mooney, Chief of Inspections - Mechanical  
RE: SKYMASTER Over the Shoulder Restraint

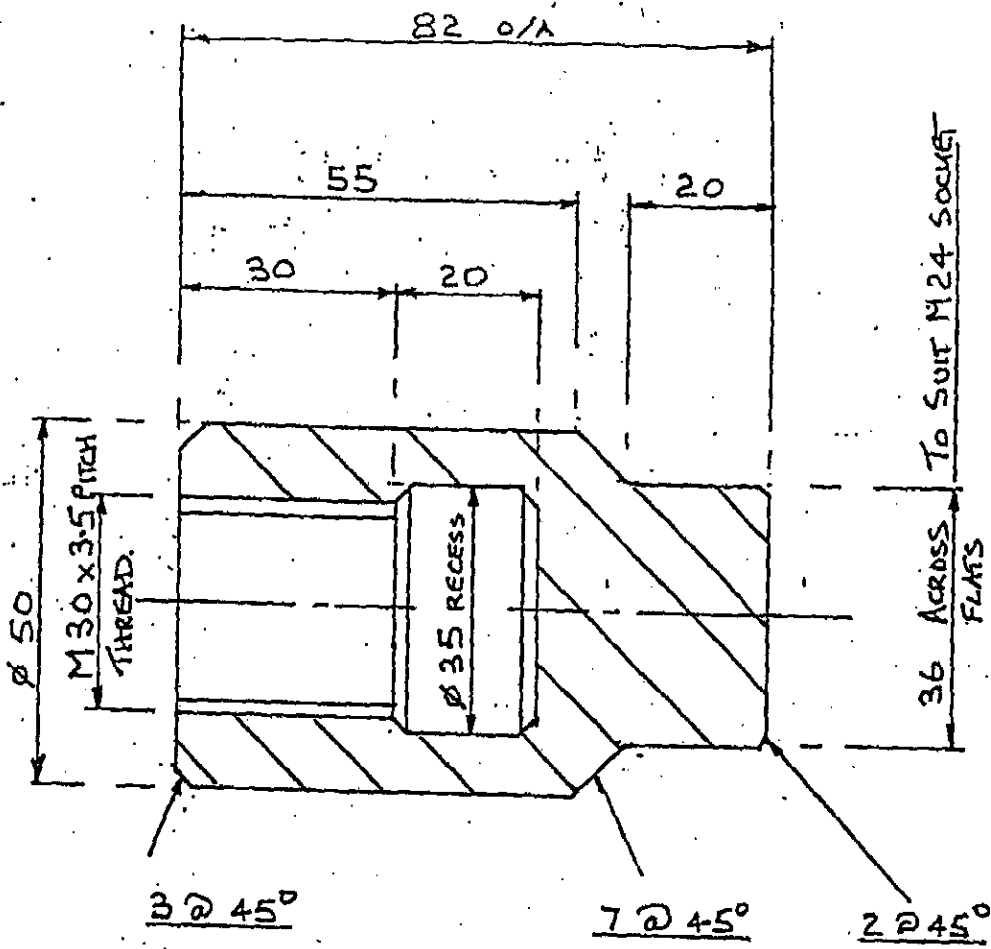
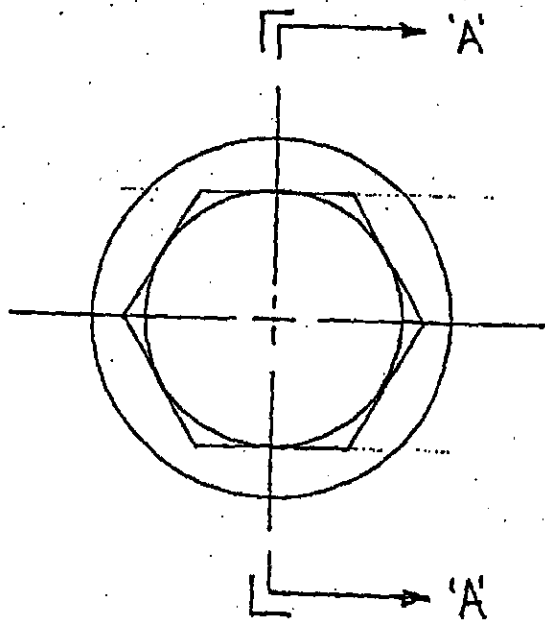
SECTION 'A-A'

COUNTERWEIGHT ARM HINGE FIXING BOLTS

- 1) In view of the prevalence of counterfeit bolts purporting to be bona-fida grade 8.8 or better, the following course of action has now been implemented.
- 2) Special purpose nuts with reduced hexagons (M30 x M24 hexagon) that enable torque to be accurately established are to be retro-fitted on serial numbers SKY 1 to 8.
- 3) Rides with serial numbers SKY 9 onwards are now modified to allow a standard socket and nut to be utilised.
- 4) To further guard against the possibility of counterfeit bolts, a back up shear pin with bracketry is to be retro-fitted to serial numbers SKY 1 to 6. All rides from SKY 7 will have this as factory fitted.

SPECIAL NUT FOR "SKYMASTER" 4-DEE PER PIPE

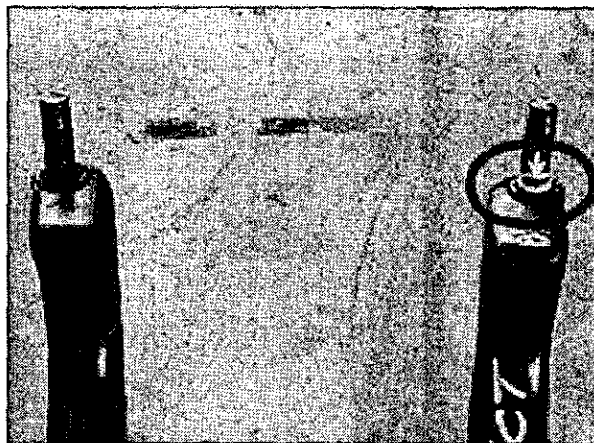
Location of cracking

Recently, an owner found hairline cracking occurring on the shoulder restraints on their Skymaster amusement device manufactured in 1994 by A.R.M. The owner performed additional magnetic particle examination on the remaining restraints and found additional restraints with similar cracking.

The cracks were found at the point where the foam padding ends. This is the area where the restraint passes through a block to secure the restraint to the device (see photos attached).

If you have this device, you are strongly urged to immediately remove all the shoulder restraints and have them non-destructively tested to ensure the integrity of the restraints.
