SERVICE BULLETIN

Affected Park:
Affected Ride: INVERTED COASTER
Ride Name:

Item: Vehicles bumpers SP # IC FB7 4505

Abstract of Issue:
Inspection of the vehicles front and back bumpers condition.

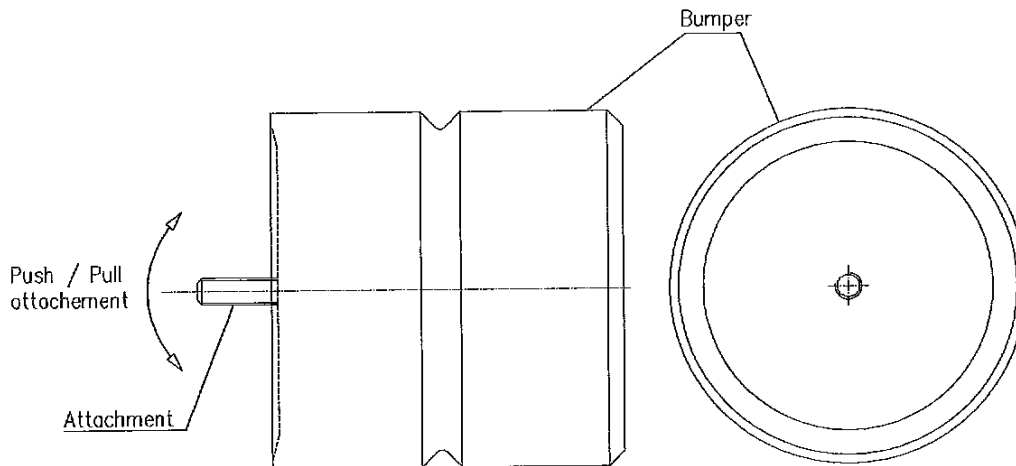
Reason for Release:
Risk of loss of a train bumper due to hydrolyze of material (crumbling of the polyurethane).

- 1) Manually push and pull the attachment to check for movement of the inserted threaded stem or sign of hydrolyze of the bumper material.

- 1) Visual inspection of the attachment, as shown in the detail of issue.
- 2) Replacement of bumpers presenting signs of material hydrolyze.

- 2) To complete the control and determine if the material is affected, mark the bumper surface on the fastener side with a sharp object (i.e. screw driver). The sharp object should not leave a groove in the polyurethane.
