SERVICE BULLETIN

Affected Park:
Affected Ride: INVERTED COASTER
Ride Name:

Item: Steel brake pad
Retaining bolts of the steel brake pad

LIST OF MANUFACTURER'S NOTICES

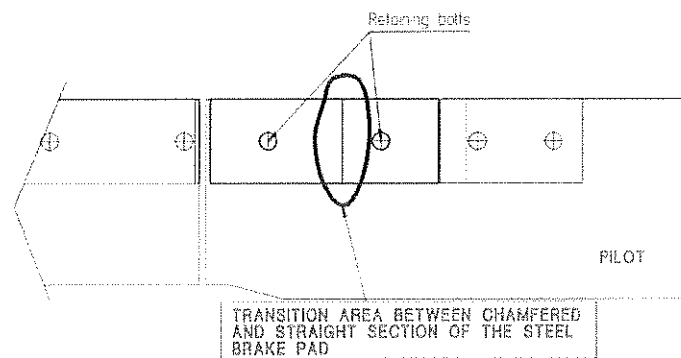
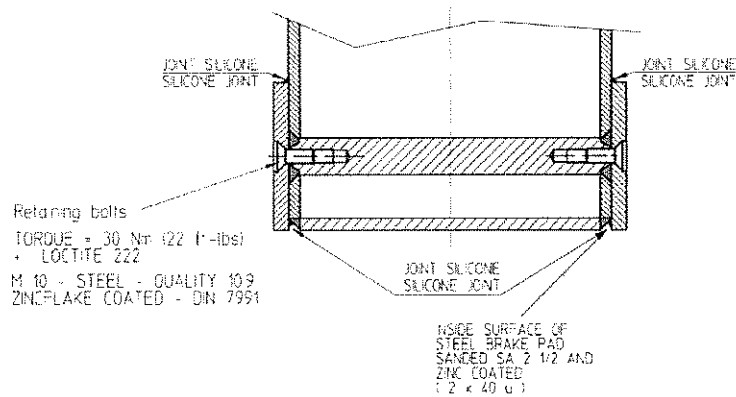
Inverted Coaster (pilot car)

Cracks were discovered on the second steel brake pads of the pilot coach in the transition area between chamfered and straight section.

- visual and magnetic particle inspection of the steel brake pads in the area shown in the drawing on page 2. The Steel brakes pads presenting indications must be replaced.
- visual inspection and torque inspection of the retaining bolts.

- Note:**
- the retaining bolts for steel brake pads are M10 hexagon socket countersunk head screws according to DIN 7991:
 - fully threaded
 - material: steel – quality 10.9
 - surface treatment: 3 zincflake coated (Dacromet)
 - recommended torque: 30 Nm (22 ft-lbs)
 - the contact surfaces between the steel brake pad and the beam must be clean and free of grease / oil
 - silicon joint must be applied after assembly.

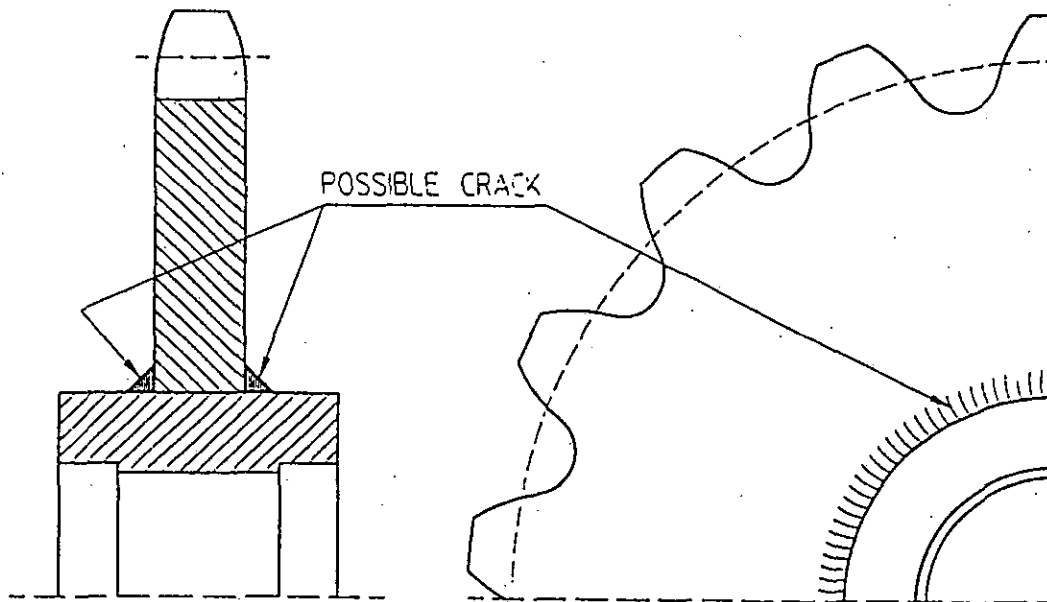
We draw your attention to the fact that cracks were found on one of our coasters on the center hub weld of the lift chain sprockets:

A total failure of such weld would cause severe damage at the lift chain.

Accordingly, we ask you to carefully visually check, every three months, the center hub welds of all lift chain sprockets, namely:

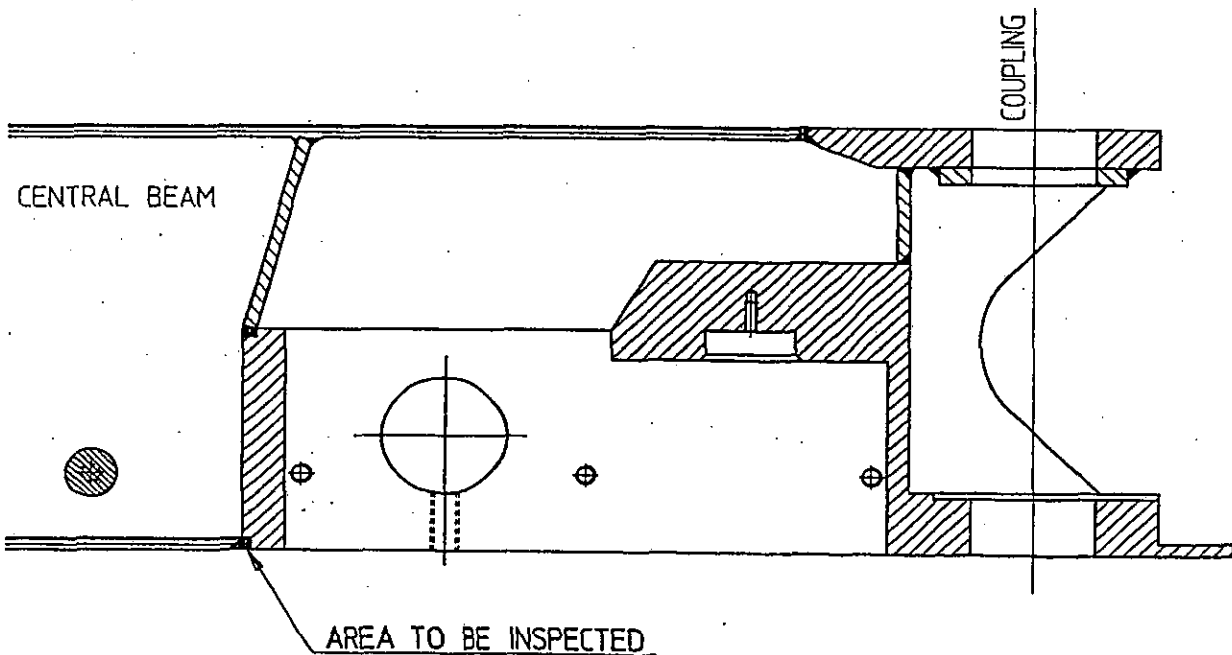
- 1) We draw your attention to the fact that cracks were found at the connection ratchet box / plate on the central beam of the coaches on one B&M ride.

- 2) We accordingly ask you to inspect these connections as follows:
 - a) immediate visual inspection, then
 - b) weekly visual inspection.

- 3) If any crack is found, the crack needs to be repaired before being further operated.

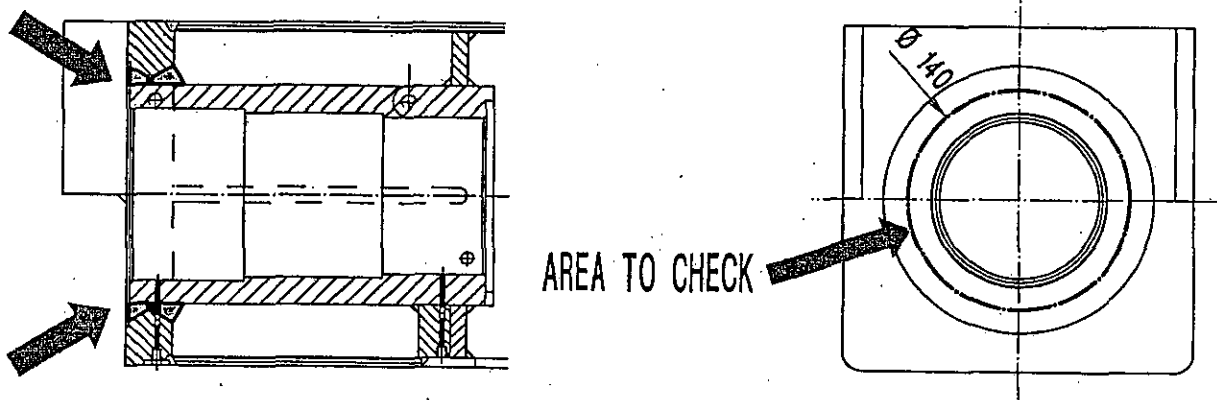
1. We draw your attention to the fact that one crack was found in the weld between the front plate of the central beam and the pipe of the coupling receiver on a B&M coaster.

THE AREA SHOWN ABOVE SHALL BE INSPECTED AT LEAST ONCE A YEAR AS FOLLOWS:

- a) dismantle the fork and the front thrust washer on each vehicle.
- b) magnetic particle inspection of the area shown above.

Bolliger & Mabillard shall be informed of any crack found. Vehicles presenting cracks shall not be operated.
