SAFETYALERT

Drawing No: SC-033-101
Item No:

Abstract of Issue:
Inspection of the safety harnesses weldments as per Detail of Issue.

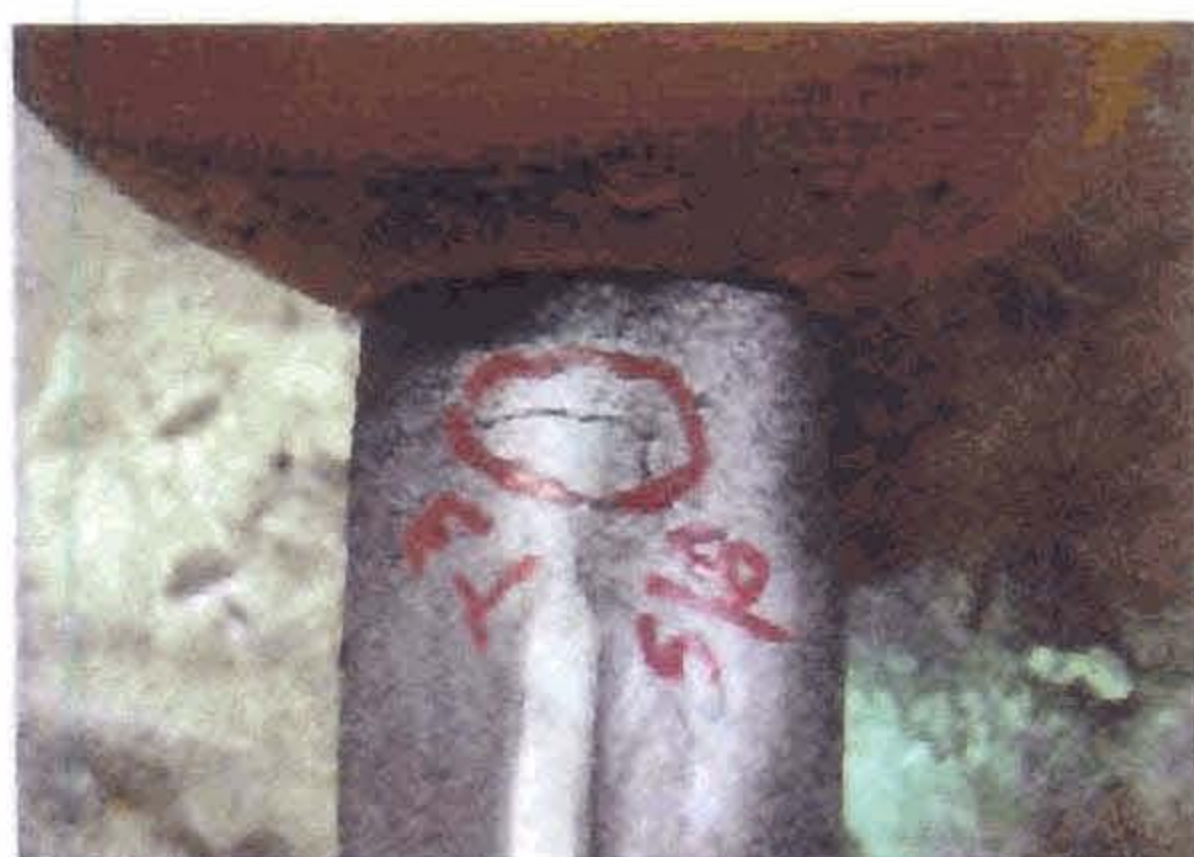
Reason for Release:
Cracks were discovered on several harnesses.

Indication found

⇒ harness can be repaired if the indication is smaller than 25 mm (1 inch) in length. Harness presenting larger indication must be rejected and replaced.
