Report on the Enchanted Forest Accident of Carousel Serial # 77-2845
(RI # 96), on Saturday July 19, 2003

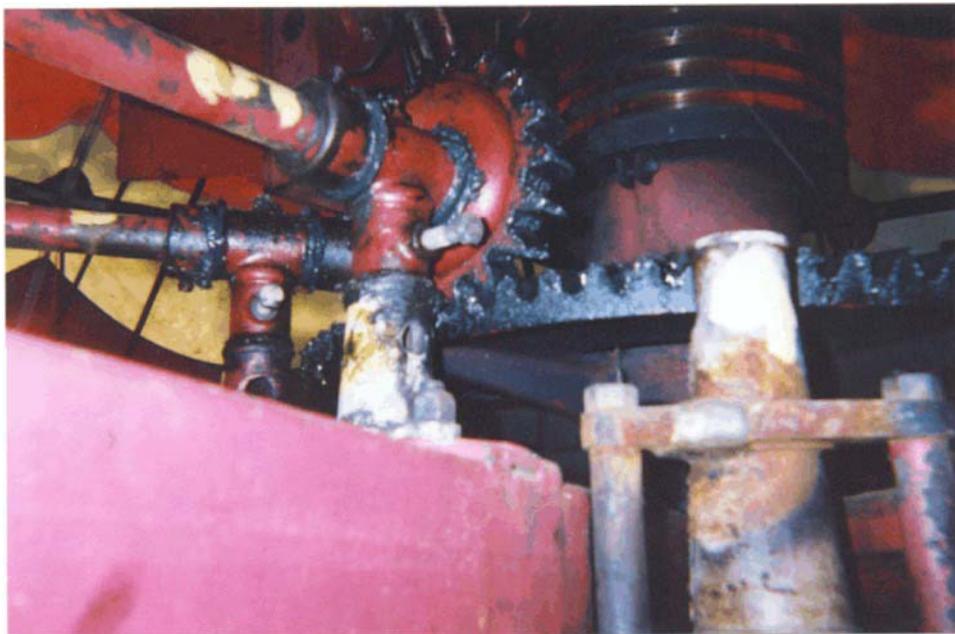
1. One of the Cam-Shafts that cause the horses to go up and down broke out of its seat right next to the gear at its end (see Figure 1A, B, C & D and Figure 2). The core the connects the shaft's seat to the pedestal # "3", which is bolted to the driving gear "G" (see Figure 2), is made out of cast iron. The manufacturer (Bob Boyle of Chance) stated the cast iron connection ensures that, if stressed, the cam-shaft would be broken at that point where it could result in the least damage. Creating a point of stress release is a valid design approach because it safeguards against failure at a random point, which could result in worse conditions than when the failure is controlled (at a known point). The snapped cast iron section can be clearly seen at the bottom of the shaft's seat in picture Figure 1-B. Picture Figure 1-C shows a close up on the snapped section.

1. Photo Figure 1-A shows a healthy camshaft seated properly. Please notice the plane that snapped is the horizontal plane that lies about half an inch below the side screw.

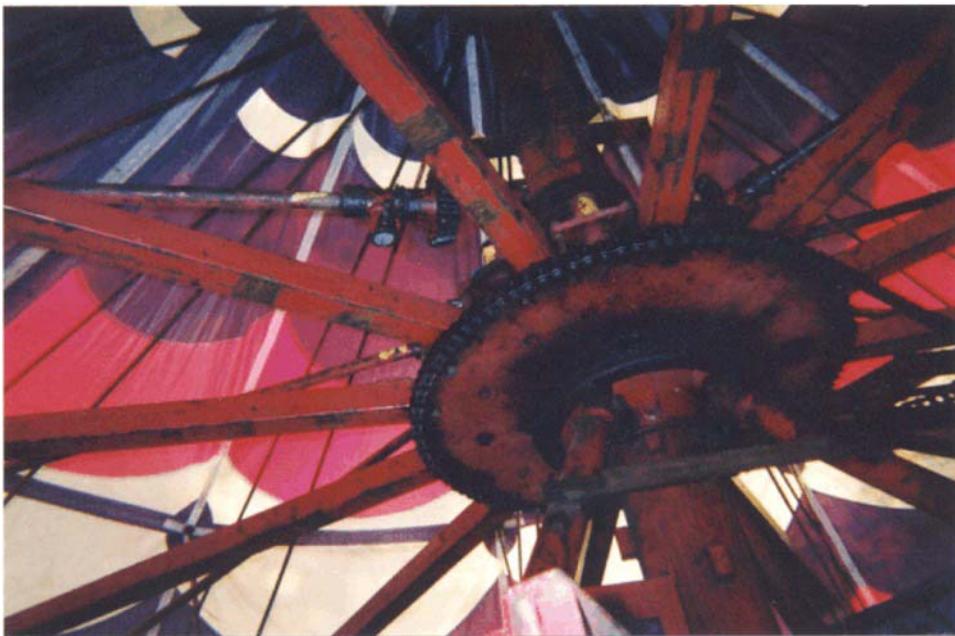
1. The most likely reason for the breaking of the camshaft, according to the manufacturer (Bob Boyle of Chance), is wear in the telescope pipe system. Excessive wear beyond a certain

tolerance, may cause the pipe attached to the horse, which slides between the outer pipe and the inner pipe (both attached to the platform) to jam. When the cam cannot push the jammed horse down, the jammed horse pushes the cam up, pulling the cam-shaft out of its seats and snapping it at the (controlled) failure point. The same ride has three seats with the same snapped cast iron section. The missing horses make the ride less balanced.

2. Photo Figure 1-B shows the snapped cast iron section.

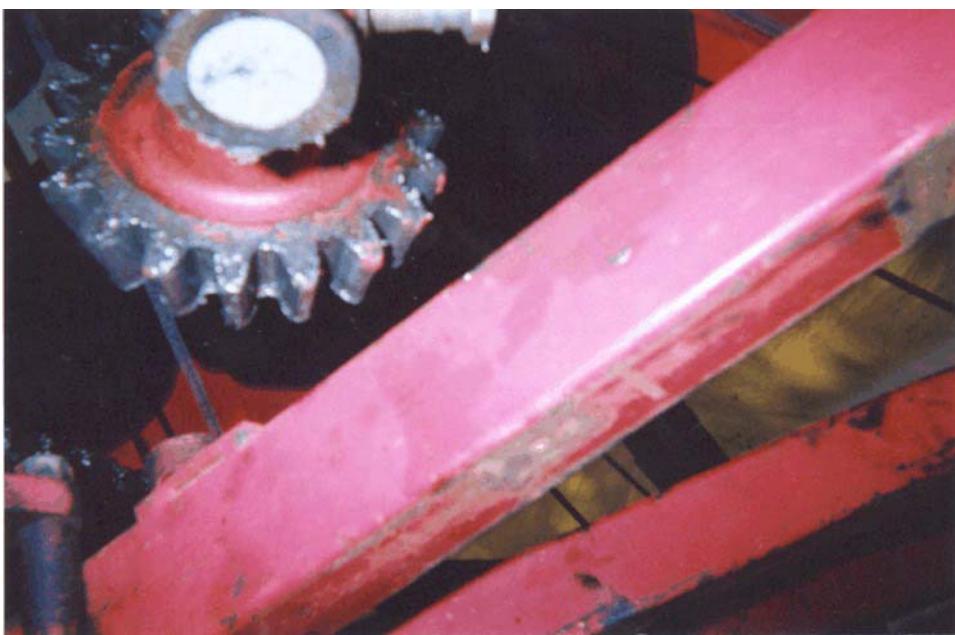
3. Photo Figure 1-C shows a close-up on the failure plane shown in the previous picture.

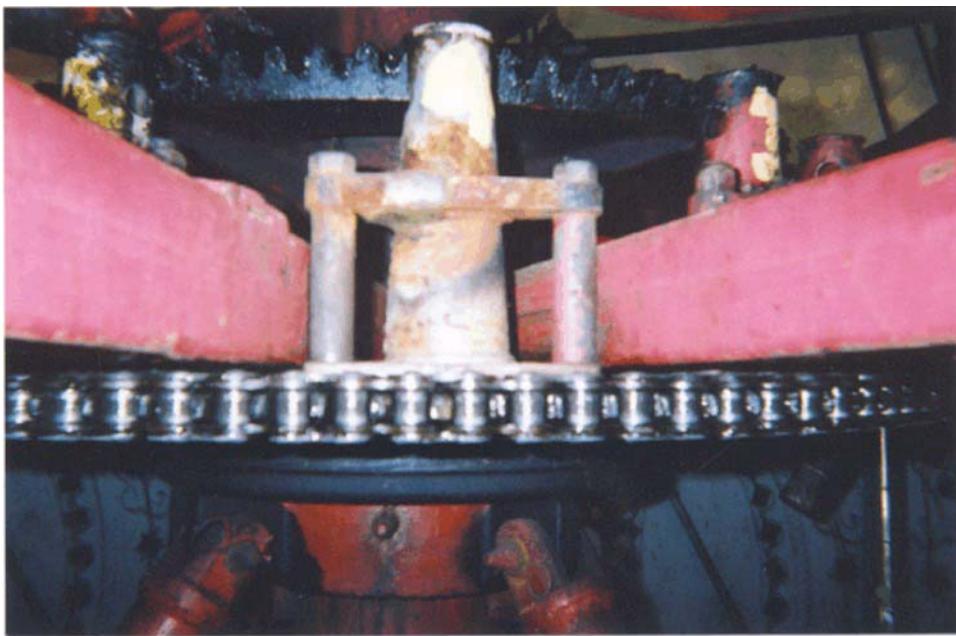
4. Photo Figure 1-D shows the camshaft seat, bolted to the driving gear.

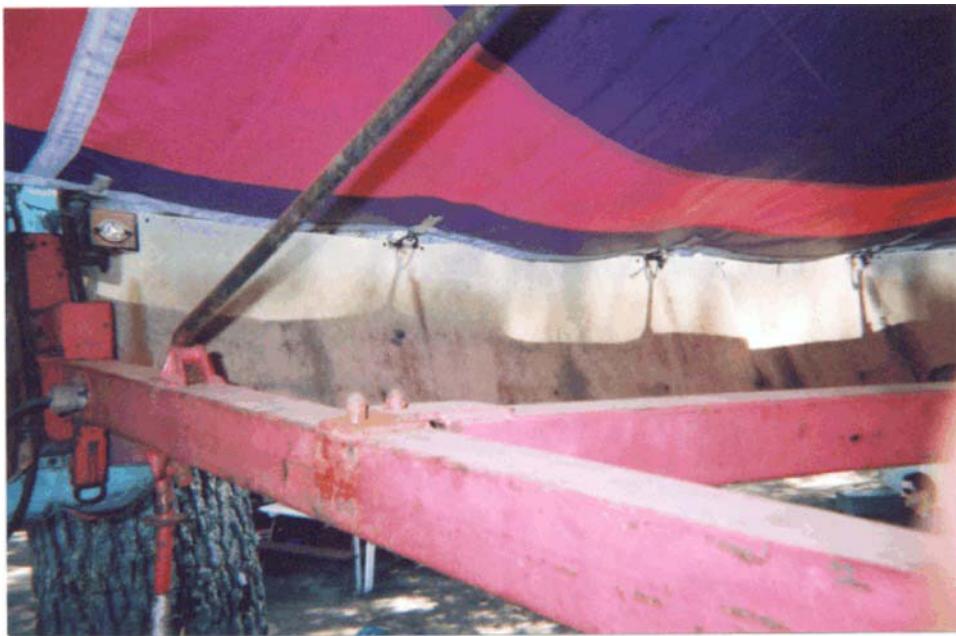
2. When the cam-shaft was freed from the circular motion, and the horses proceeded to travel on a tangential path, the two outer horses, along with their telescoping pipe, separated from the telescope pipe assembly, which remained fixed on the platform. The innermost telescope pipe assembly broke away from the platform and left with the horse telescoping pipe inside of it.
3. When the outer horses separated from the telescope pipe assembly, the landed hard on the platform, and the outermost horse actually fell off the edge of the platform. The impact caused the platform to move down. When it bounced back up, it caused the spreader beam to jump up off the sweep it was sitting on, and out of the bolt that kept it in place. This worst aspect of the accident would have never happened, had the R-keys were in place.

5. Photo Figure 1-E shows the spreader beam sitting on the sweep. Please note the missing R-Key. Please also note the missing spreader beam (which you see on the floor in the last picture), and the bolt designated to keep it in place.

1. All park rides must have cotter pins in all the holes located in the bolts on which spreader beams sit. In general, operators are not to exercise judgement. If a bolt has a hole, it means that the manufacturer wants a safety pin there, and it must be installed.
2. Owners of carousels must obtain maintenance requirements from manufacturers. The owner must know the tolerances of wear, beyond which he must replace the telescope pipe assembly and the horse pipe, or the recommended frequency of changing the telescope pipe assembly, as well as the horse pipe.

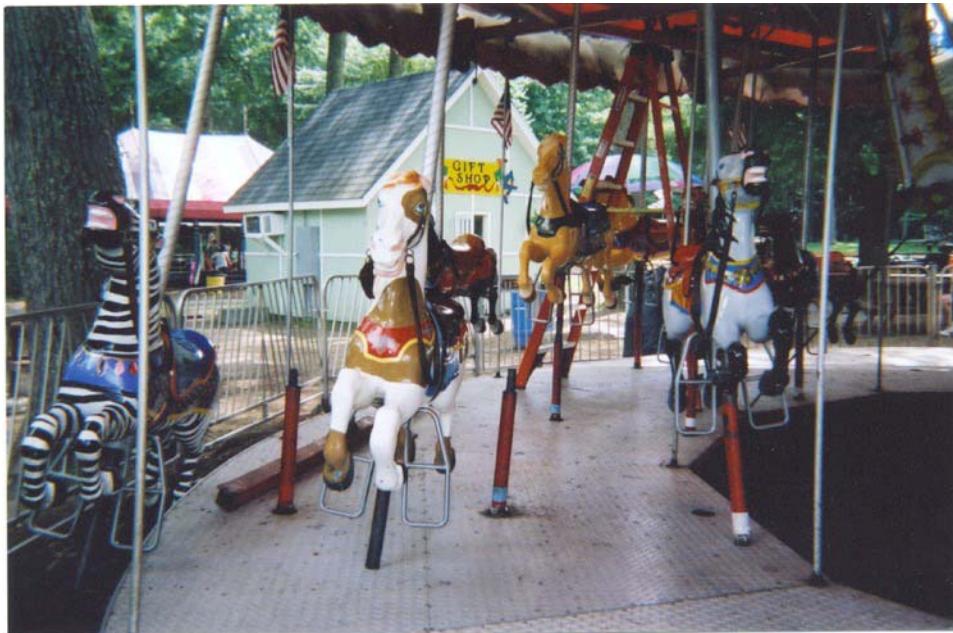
3. The cam-shaft also jumped out of its seats, and the two outer horses separated from their telescope pipe assembly and the outer horse landed just off the platform (see picture Figure 1-F). The two inner horses landed on the platform, keeping the cam-shaft in a (more or less) horizontal position. Had the two inner horses been missing, the outer horse, which was off the edge of platform, would have caused the cam-shaft to pivot over the shaft seat and slide completely out of the platform. Since the two horses effected a balance and prevented pivoting, the camshaft stayed horizontal as it slipped out and was stopped from further sliding when the innermost cam hit the innermost spreader beam as stated above. Please notice in picture Figure 1-F that the innermost horse did not separate from the telescope pipe assembly, but the entire assembly snapped and moved with the horse out of its base in the platform. Please note the footprint of the snapped telescope pipe assembly, in line with the two outer assemblies, which remained fixed in the platform, as the outer horses separated from them.

6. Photo Figure 1-F shows how the horses fared. Notice that the outermost bottom pipe is off the platform. Notice that the two telescope assemblies of the outermost horses are still in place, while the third has been carried away with the innermost horse. Notice the footprint of the innermost horse telescope pipe assembly. Finally, notice the spreader beam on the platform.

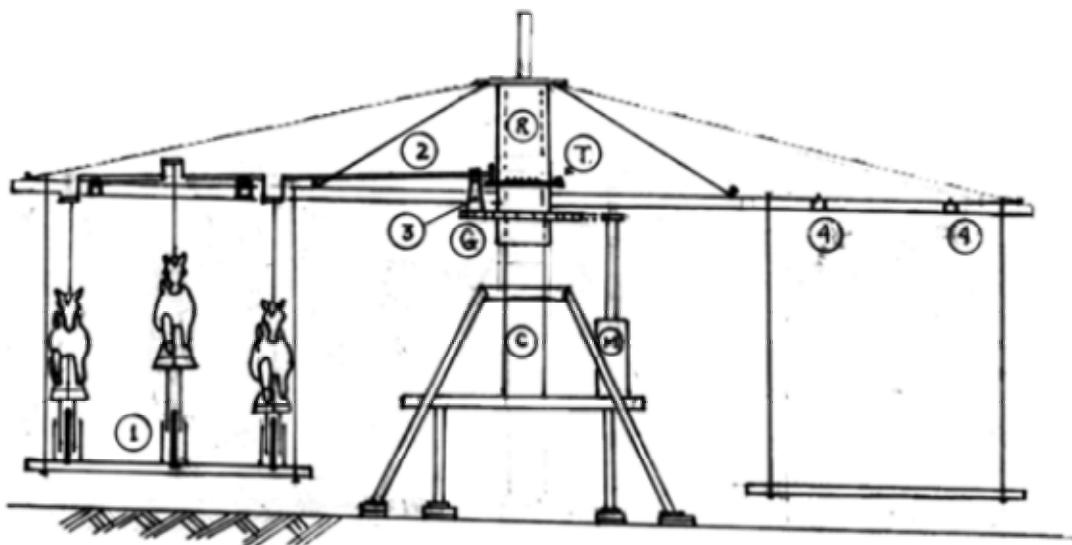
Figure 2

7. Figure 2. Item 1 is the telescope pipe assembly. Item 2 is the camshaft. Item 3 is the camshaft seat. Item 4 is the spreader beam sitting on the sweep. "C" is the stationary central shaft. "R" is the rotating top shaft. "G" is the main driving gear. "M" is the motor, and "T" is the camshaft gear tray.

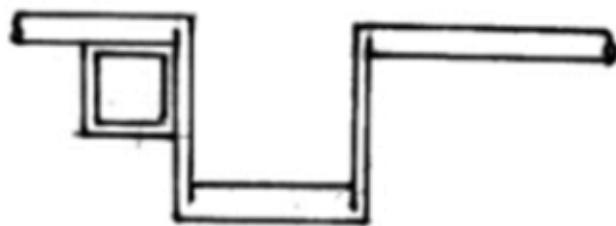
2. Once the cam-shaft broke loose, the horses were freed from the circular motion and proceeded to travel on a tangential path, causing the cam-shaft to slide away from the center of the ride. The cam-shaft was stopped from further sliding when the inner cam hit the inner spreader beam (see Figures 2 & 3).

8. Figure 3 shows the innermost cam as it hit the innermost spreader beam and stopped the camshaft from further sliding outward.

**Final resting point of cam shaft,
stopped from further sliding outward
by inner-most cam shaft support beam.**
