NUMBER: B106R1095-0

SERVICE BULLETIN

Ride: Zipper

Subject: Seat Support Assembly Bushing

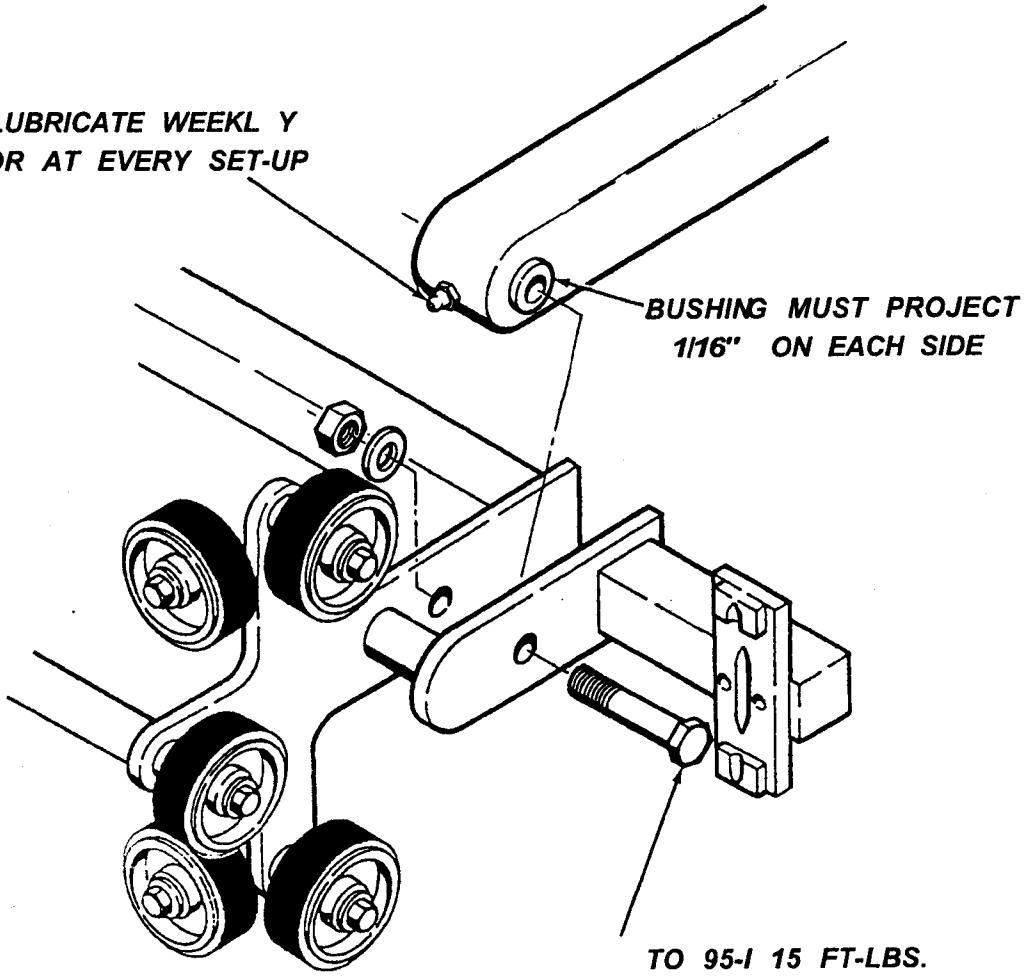
Recent field inspections have found seat support assembly bushings on ZIPPER amusement rides either badly worn or not clamped correctly. Chance Rides, Inc. requires all owner/operators of ZIPPER rides to inspect these bushings to ensure that the manufacturer's specifications are being met.

The bushing used in the seat support assembly is a specially manufactured bushing with an overall length of 2-1/8 inches. This length allows for the trolley axle weldment to clamp to the bushing. This holds the bolt stationary in the bushing as the bushing turns inside the seat support assembly. The outside diameter of the bushing is the wear area. The bolt wearing into the bushings is an indication that the bolt was not adequately tightened. If this occurs the bushing must be replaced and the bolt tightened securely so as to adequately clamp the bushing.

Lubrication of the bushing is done once a week or at each set up, which ever occurs first. Use number 2 lithium base grease on the bushing, applied through the grease zerk at the end of the seat support assembly.

LUBRICATE WEEKLY
OR AT EVERY SET-UP
