**Bulletin #** SR-5K-810

## SERVICE BULLETIN

Ride Name: Cliff Hanger

**Abstract of Issue:** The following is a procedure for upgrading hardware on the pivot pins of the upper and lower hanger blocks.

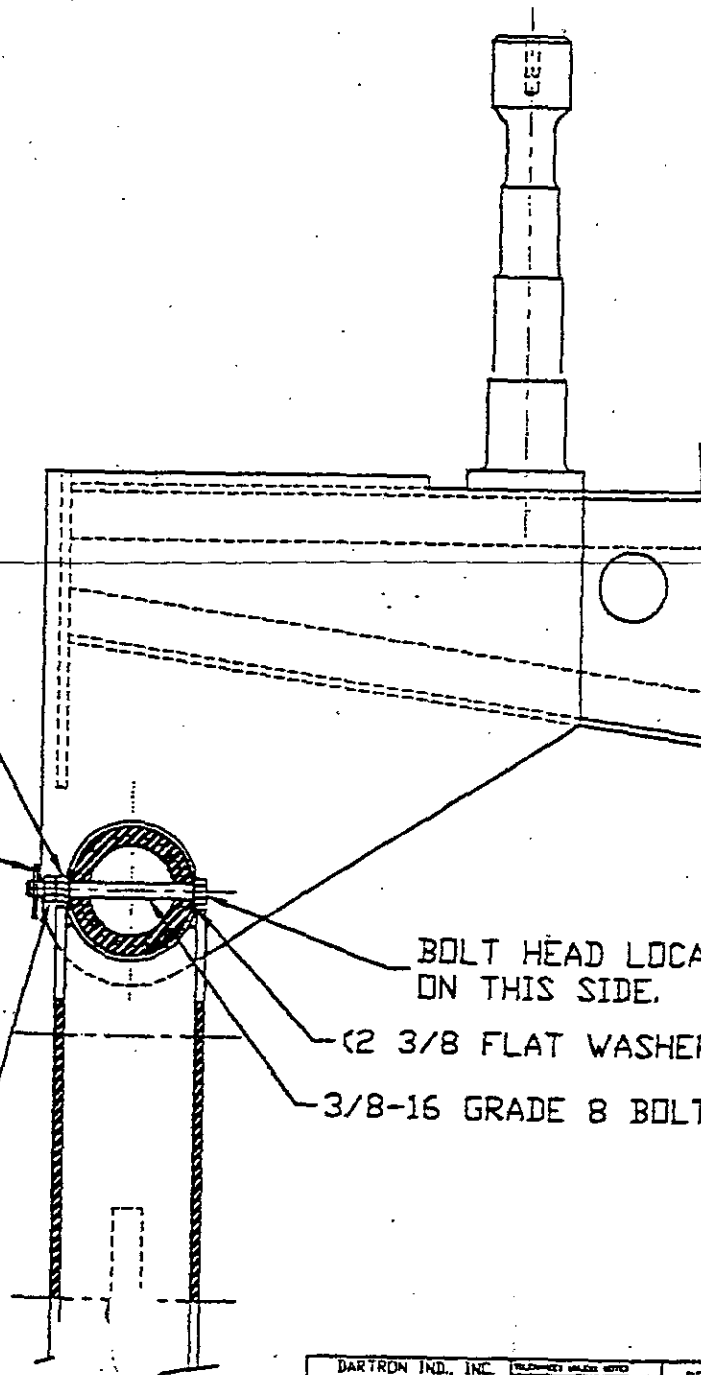
**Sweep and Shaft locating implemented:** Attachment I shows the proper location of the bolt and the proper hardware required to secure the bolt to the shaft. A daily visual inspection of the bolt by the ride operator and ride safety personnel is required. The purpose of the inspection is to insure that the bolt is in position and is fastening hardware is in place and tight.

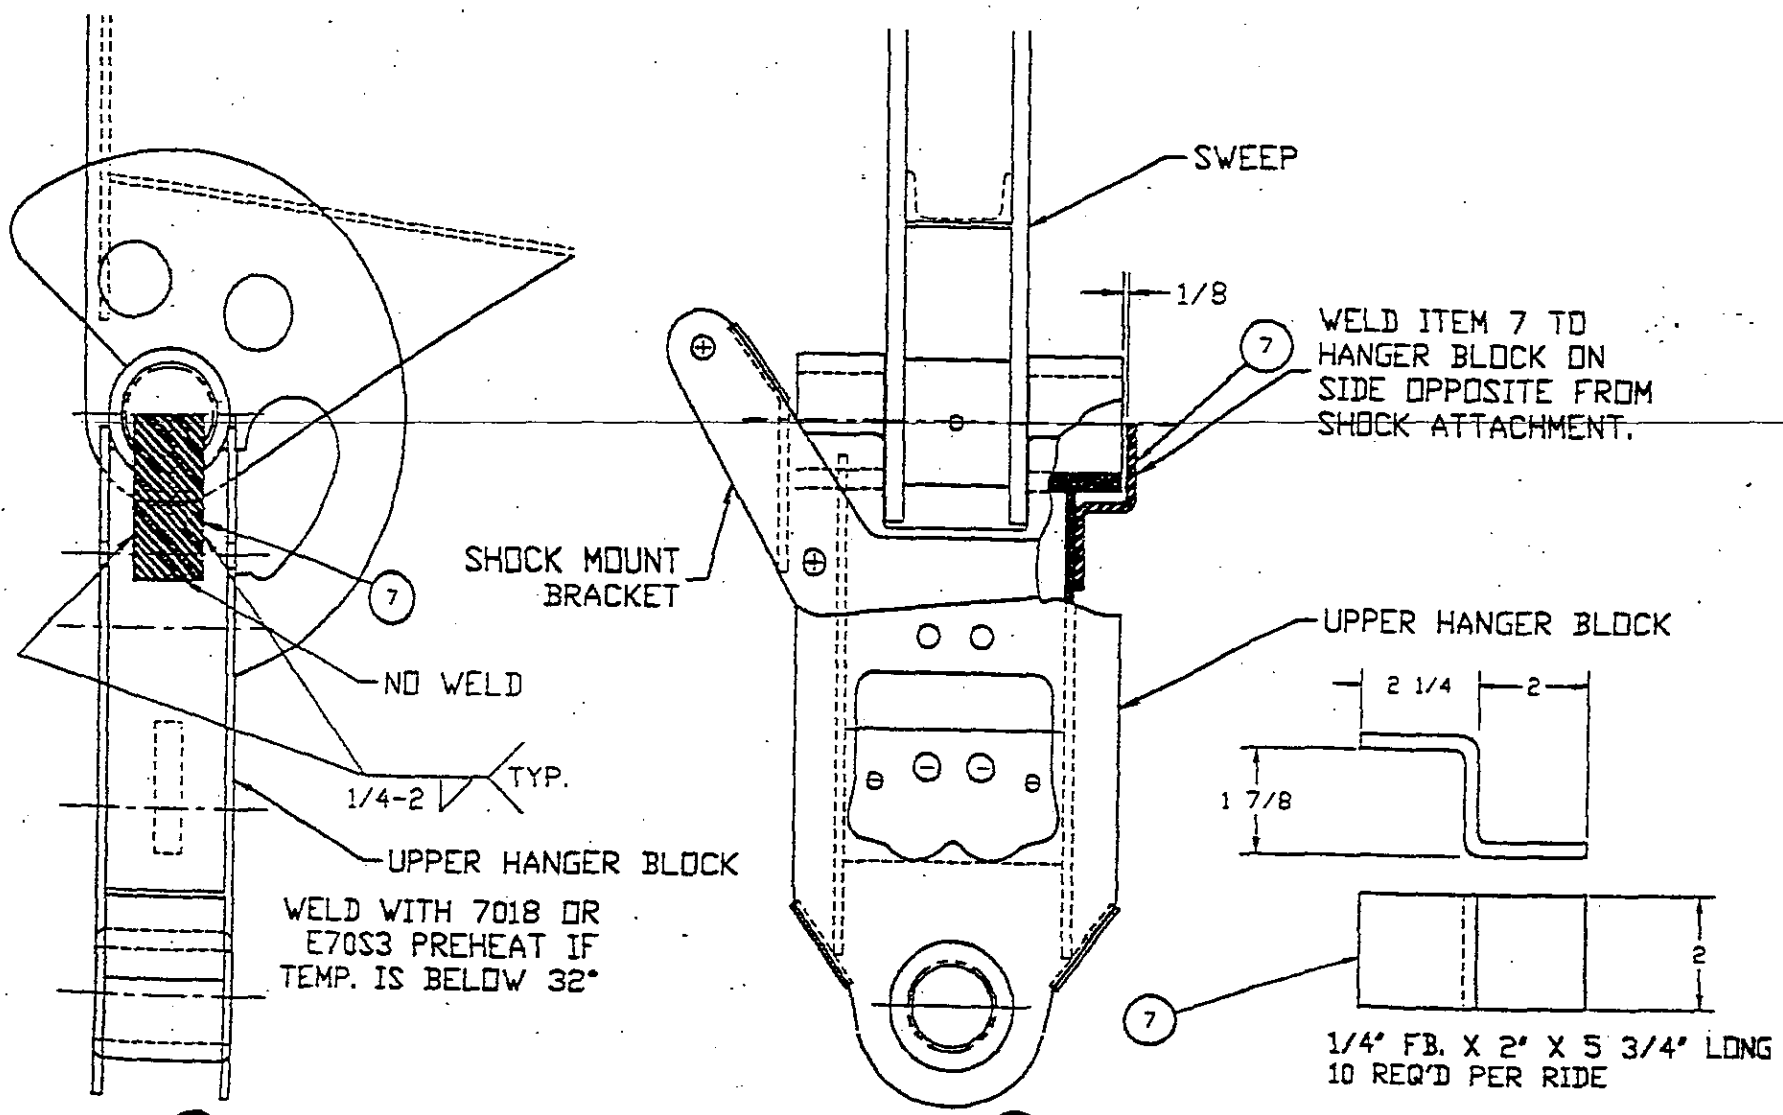
⑦ PIN STOP FOR UPPER HANGER BL IN

**Shaft Stops:** Attachment II shows the plate that must be welded to the side of the upper hanger block on all Cliff Hangers. With this plate in place the shaft will be retained in position in the upper hanger block even without the bolt properly located.

⑦ 1/4" FB. X 2" X 5 3/4" LONG  
10 REQ'D PER RIDE

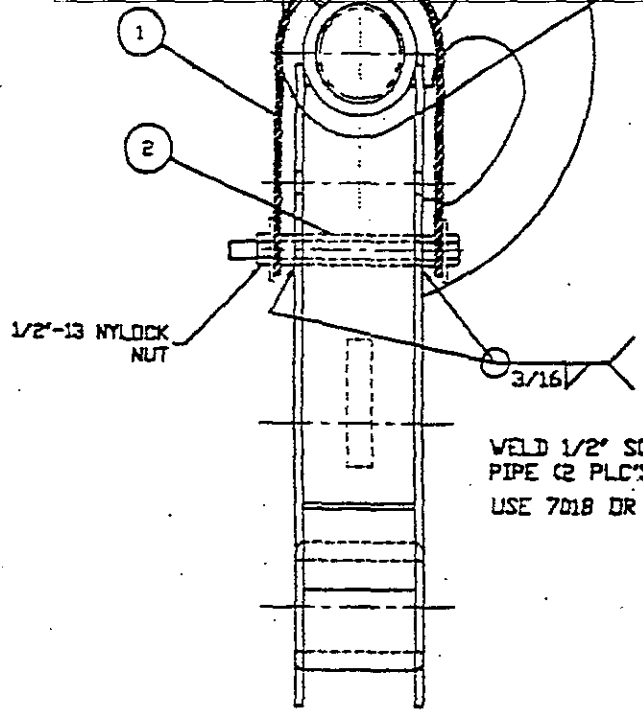
SAFETY LOOP FOR UPPER HANGER BLOCK

**Upper Restraining Strap:** Attachment III shows the addition of a retaining strap that will loop over the end of the sweep and be bolted to the upper hanger block. In the event of a failure of either the shaft, the upper hanger block bore or the sweep ears a connection will still be maintained between the sweep and the upper hanger block.

10 REQ'D PER RIDE

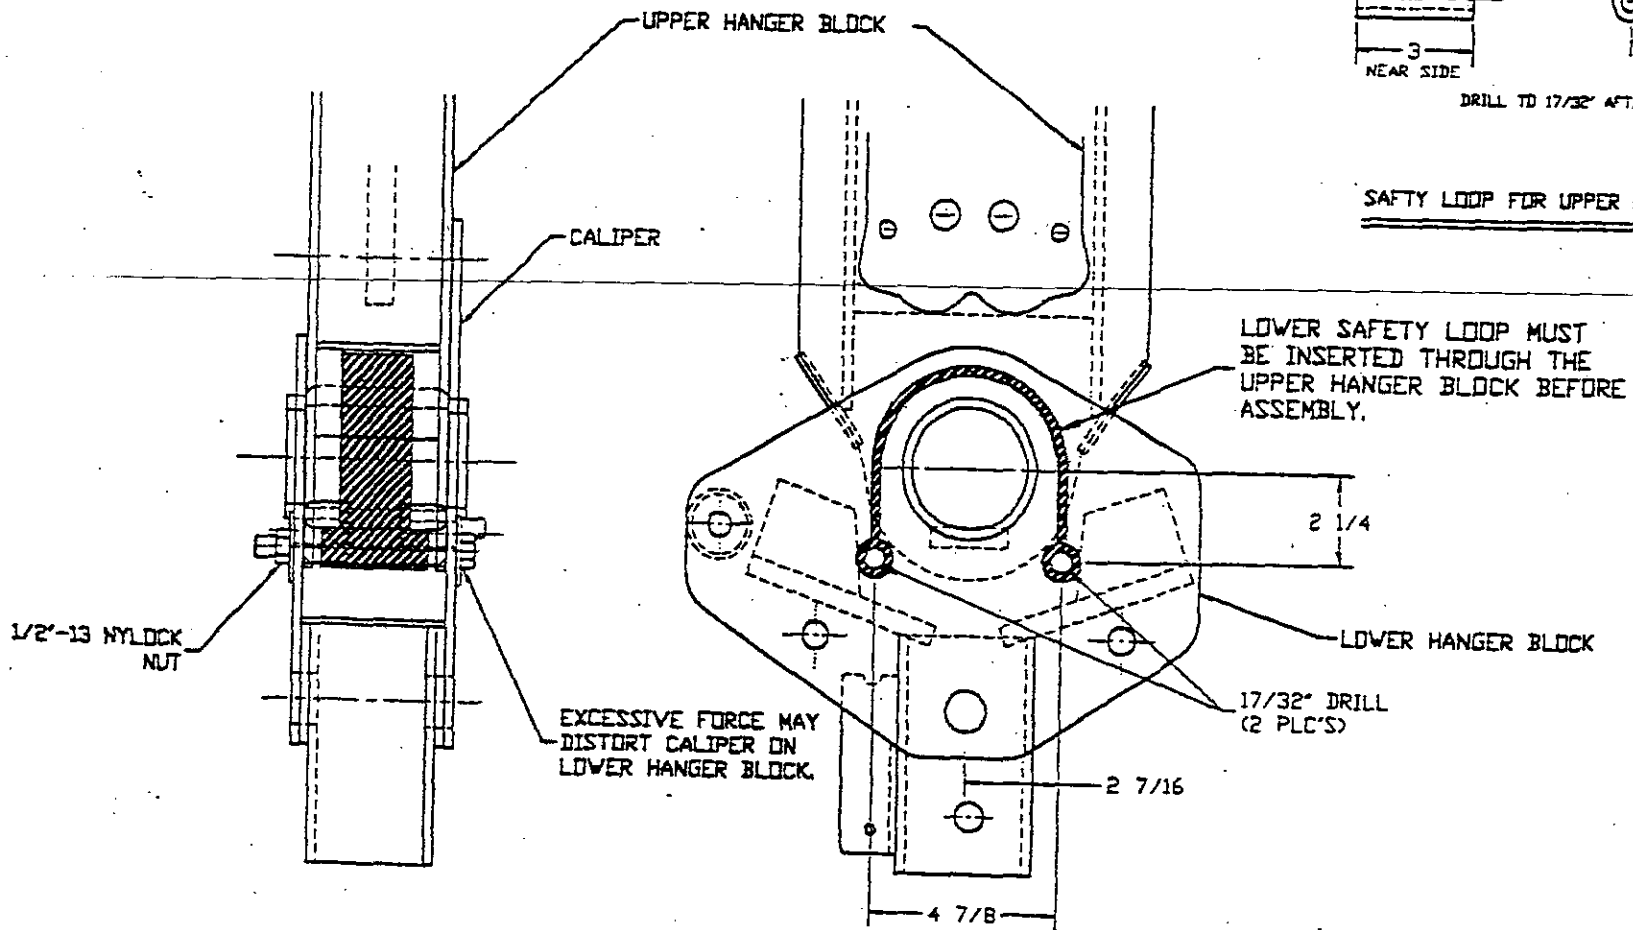
**Lower Hanger Block Retainer:** Attachment IV shows the installation of a retaining ring that will maintain a connection between the upper and the lower hanger blocks in the event of a failure or loss of the upper and lower hanger block retaining shaft.

LOWER SAFETY LOOP MUST BE INSERTED THROUGH THE UPPER HANGER BLOCK BEFORE ASSEMBLY.

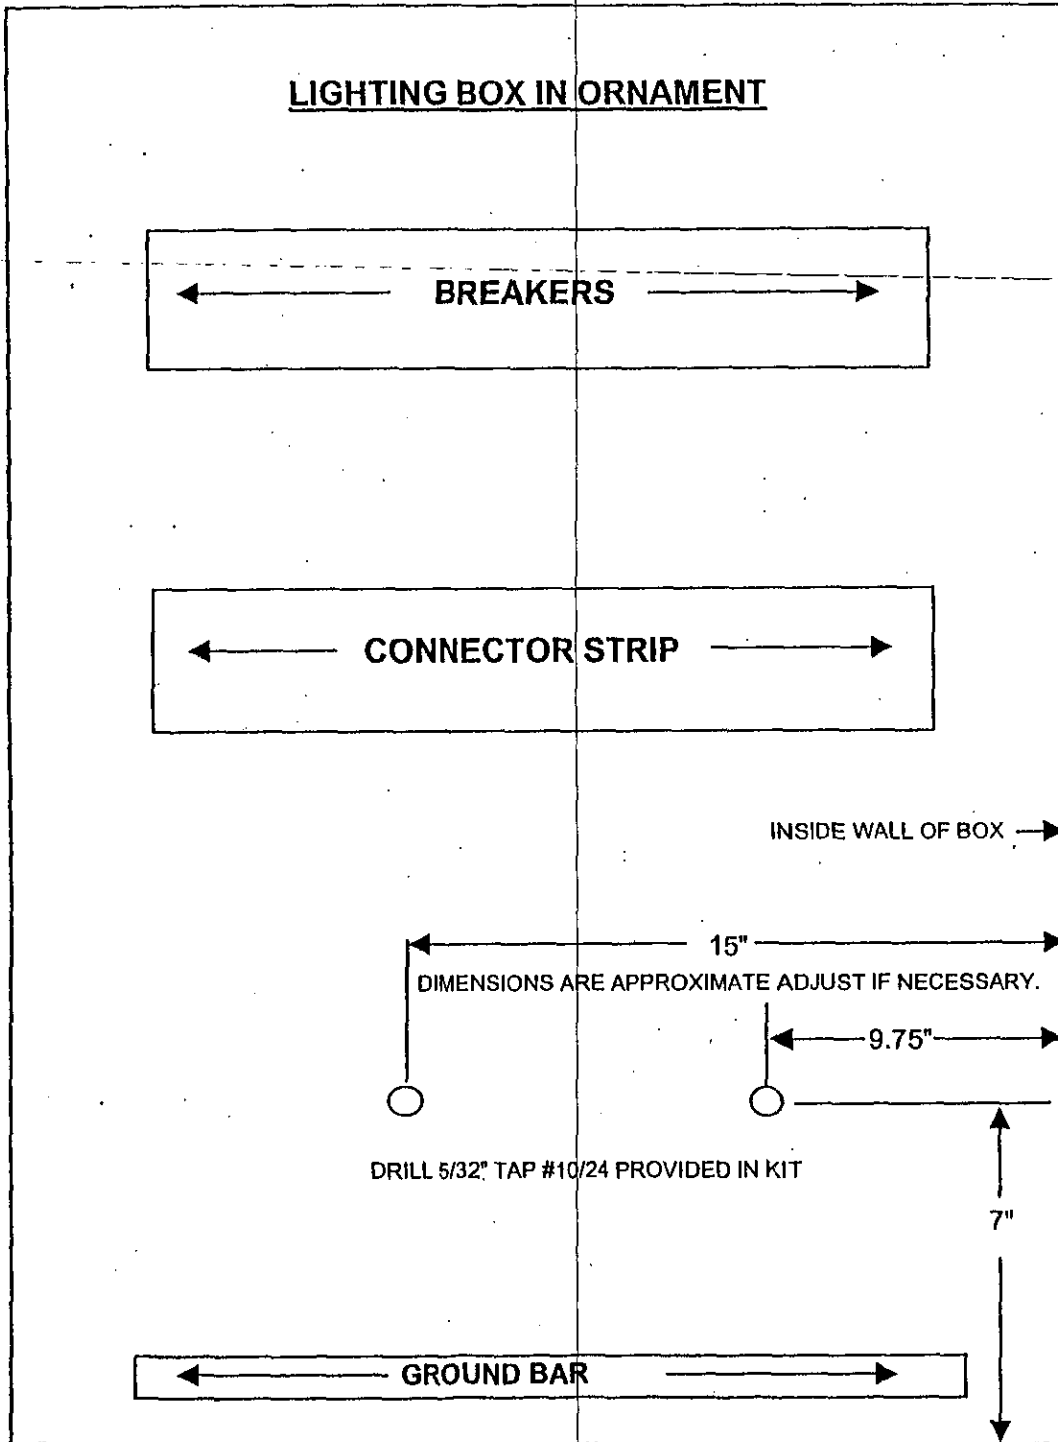
**CLIFFHANGER FUSE UPGRADE DIAGRAM.**

Ontario Hydro, Electrical Inspection Department, in the Province of Ontario, Canada has determined that the mini breakers used to protect relays in the Cliff Hanger light controller is not CSA approved therefore must be replaced with CSA approved fuses.

1. Remove the gray spacers-1 found on each side of the 24v power supply. They are unnecessary and their removal will provide room on the din-rail for the wider fuse holders.
2. Slide the 24v power supply all the way to the left.
3. Install the string of six fuse blocks labeled 1-6 in place of the circuit breakers, one at a time to avoid mixing up the wires.
4. Install the appropriate placard to the inside of the panel door.

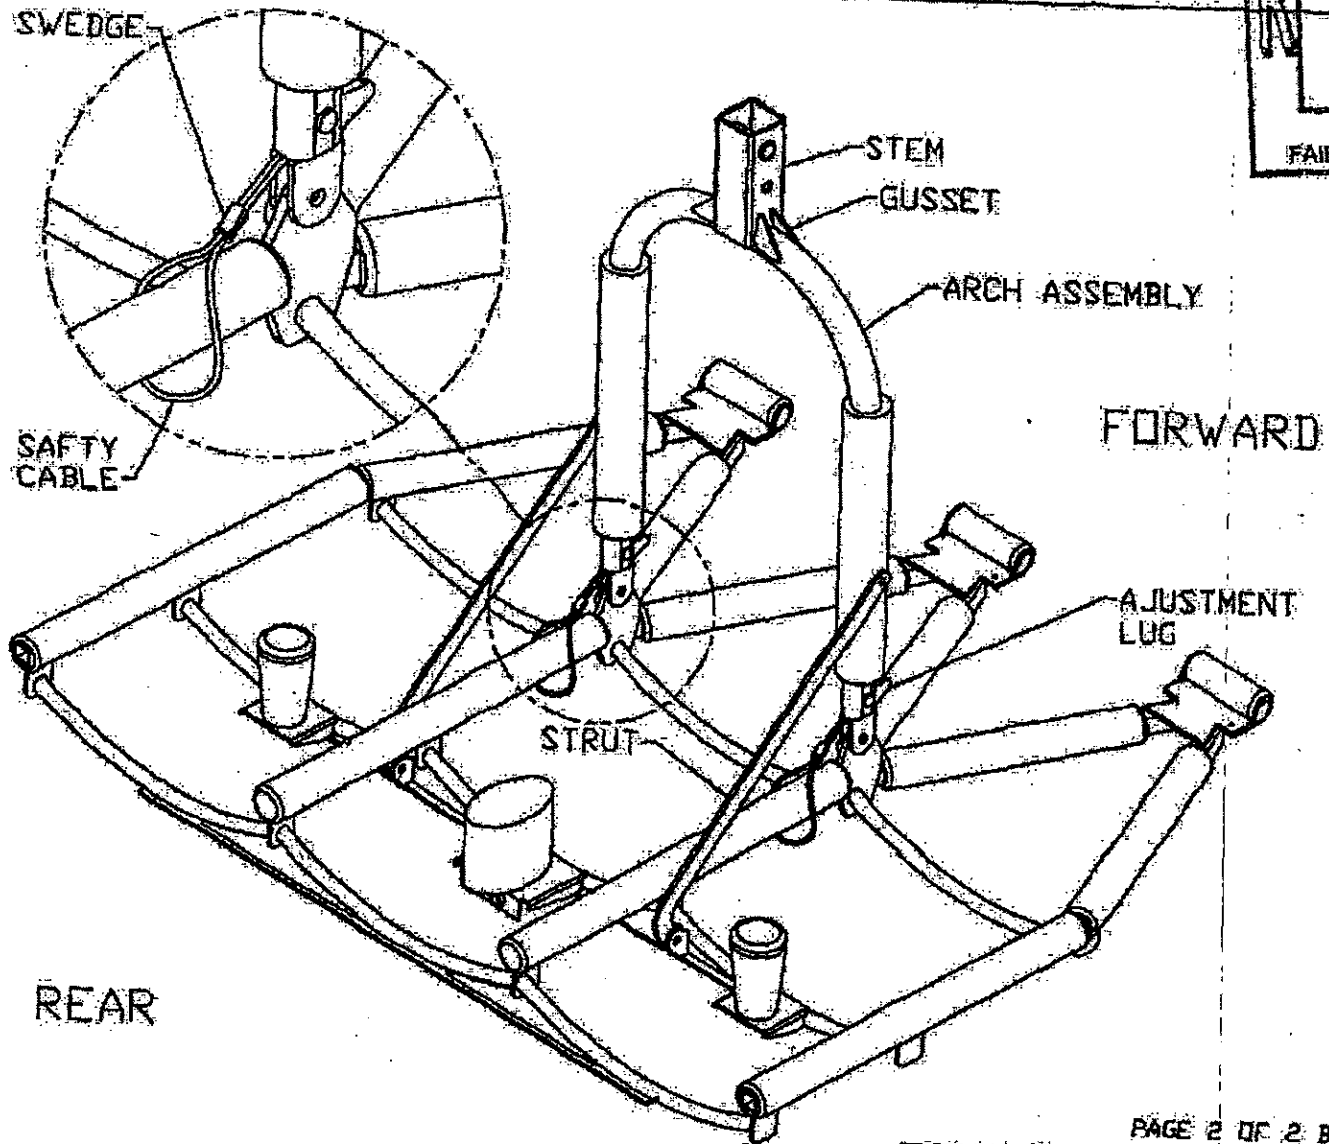
**Abstract of Issue:** As a result of an incident involving a Cliff Hanger ride in Florida Dartron is now aware that after a combination of events the Car Hanger Stem to Arch Assembly joint could fail. For this reason Dartron is requiring that all Cliff Hanger rides have a back up device that will support the car and its passengers in the event of a separation of the Arch Assembly from the Stem. Tests conducted by Dartron demonstrate that the factory-installed Arch Assembly to Car joint back up cable will safely suspend the car and its passengers in the event of a failure of the Stem to Arch Assembly joint. To identify the joint see Page 2 of this Bulletin and for more information on the factory installed cable see Page 3 of this Bulletin.

1. The retrofit back up device must be ordered from Dartron Industries.
2. The back up device consists of:
  - a) Arch Assembly to Stem strap.
  - b) Stem to Welded Pipe strap.
  - b) Cable that is inserted through the Arch Assembly and attached to the car. Cable does not enter the stem.
3. Install the Back Up device as shown on Page 2 of this Bulletin.

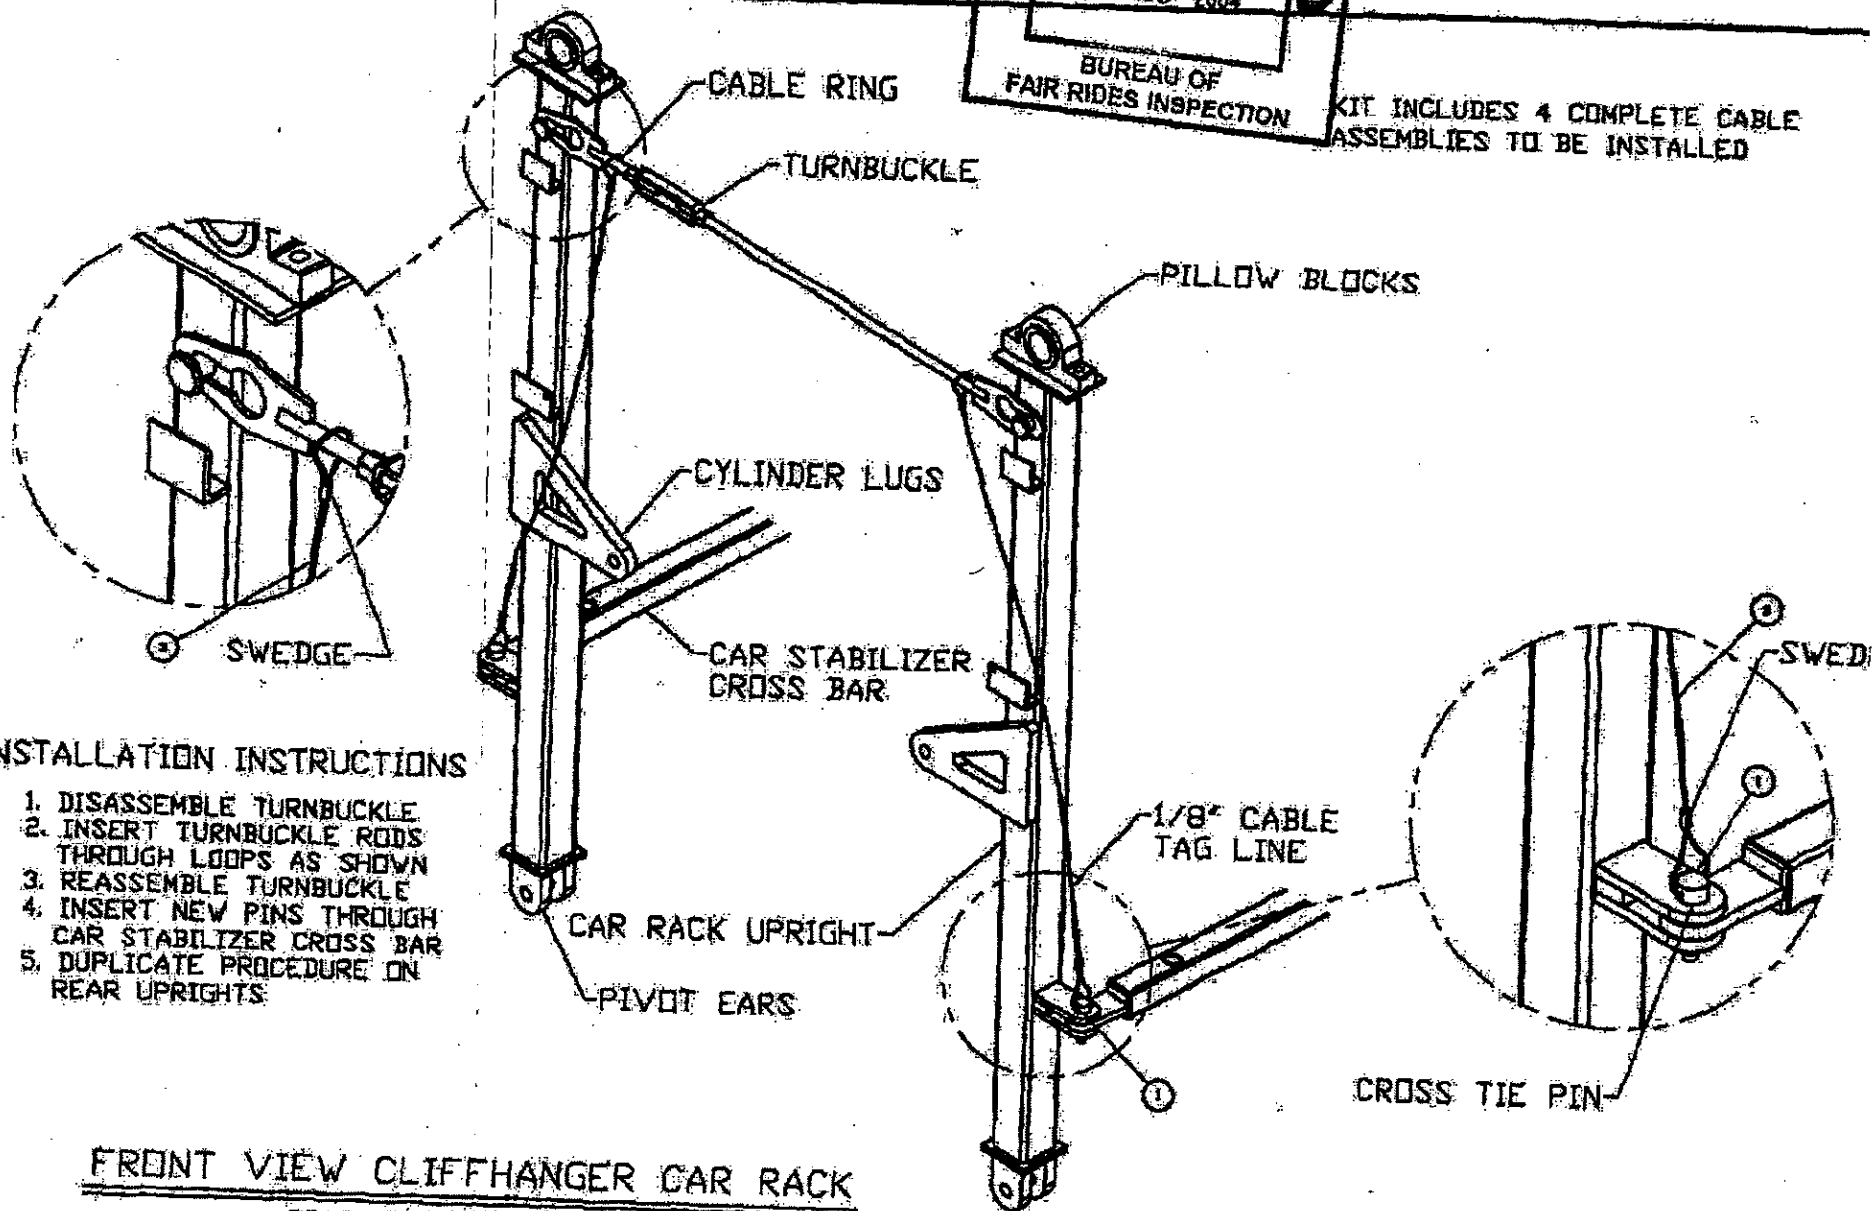
**Abstract of Issue:** Dartron is aware that some Cliff Hanger operators have experienced bent car Hanger Stems. Bent stems can result from lowering the car transport rack without removing pins that attach the Car Stabilizer Cross Tube to the car transport rack. See Page 2 of this Bulletin. Using the damaged stems can result in a failure of the stem and possibly injury to guests.

**Reason for release:** The chain of events that can result in a failure of the Car Hanger Stem starts with the failure to remove pins from the Car Stabilizer Cross Bar before lowering the car rack. This Bulletin requires the use of different Car Stabilizer Cross Bar pins that are difficult not to remove before lowering the Car Rack.

1. Four new Car Stabilizer Bar pins with cables attached must be purchased from Dartron.
2. The cables must be attached to the car rack turnbuckles as shown on Page 2 of this Bulletin.
3. After April 1, 2004 the Cliff Hanger car racks must not be operated unless the Car Stabilizer Cross Bar pins are attached to the turnbuckles as shown on Page 2.
4. Damaged Car Hanger Stems must not be used if two individuals manually lifting the car cannot insert them into the Lower Hanger Block.
5. Until the new pins/cables are installed inspection should be especially vigilant against the use of stems that do not fit correctly into the receiver tubes.

1. DISASSEMBLE TURNBUCKLE
2. INSERT TURNBUCKLE RODS THROUGH LOOPS AS SHOWN
3. REASSEMBLE TURNBUCKLE
4. INSERT NEW PINS THROUGH CAR STABILIZER CROSS BAR
5. DUPLICATE PROCEDURE ON REAR UPRIGHTS

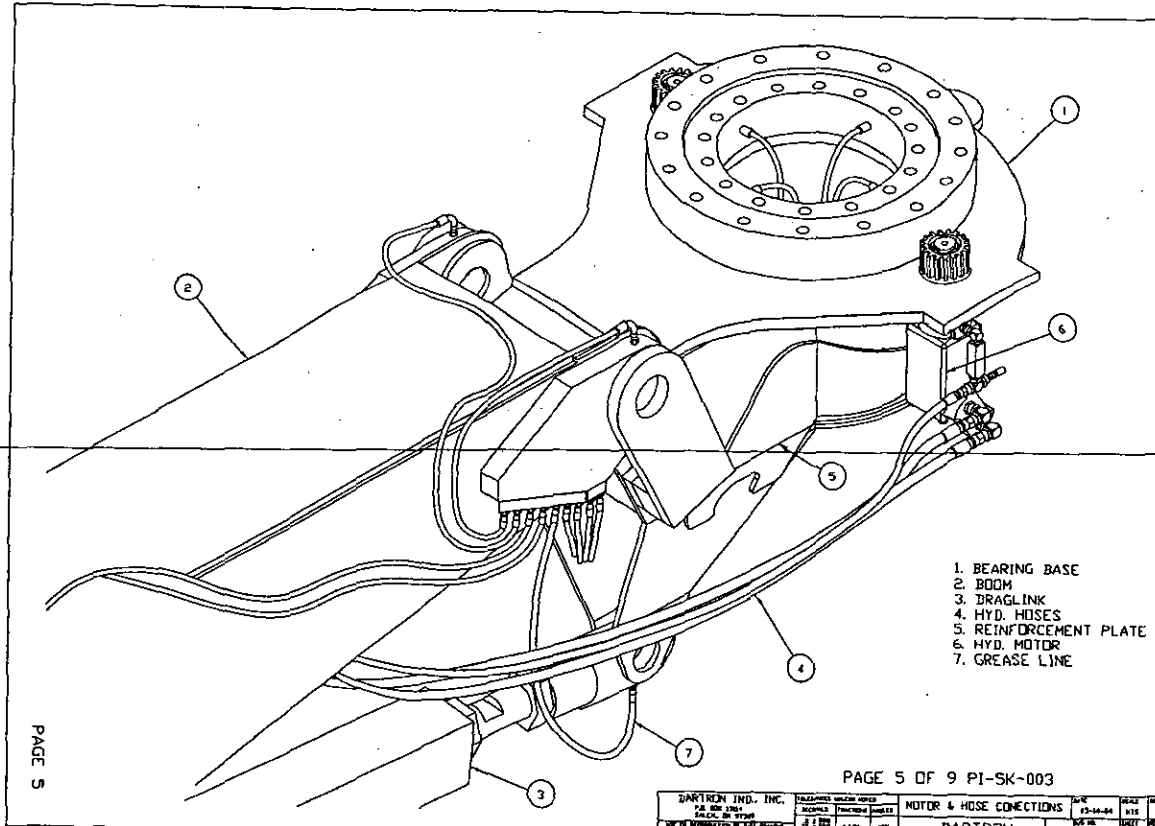
PAGE 5 OF 9 PI-SK-003

**Abstract of Issue:** Dartron is aware of Cliff Hanger rides that have developed cracks in the bearing base. Dartron Bulletin SB-5K-001 requires a visual inspection of the Bearing Base. If cracks are found the cracks must be repaired and reinforcing plates must be installed.

**Step 4:** Support must be provided under the Bearing Base to prevent the boom from dropping during the repair process. This support can be blocking or a similar material stacked on the ground under the Bearing Base. Remove the grease line and the fitting [Page 5, Item 7] from the bottom of the drag link pivot. The support should be provided directly under the pivot pin ears that attach the Drag Link to the Bearing Base. Do not support the 6" square drag-link tube, [See page 5, Item 3], as it will bend.

**Step 5:** Disconnect the hydraulic hoses to the two drive motors. [Page 5, Item 4] Caps and plugs must be installed on the hoses and motor ports to avoid leakage of hydraulic fluid. Mark the motor hoses so they will not get crossed during reassembly. Fold the hoses back out of the way. It is not necessary to remove the two hydraulic drive motors.

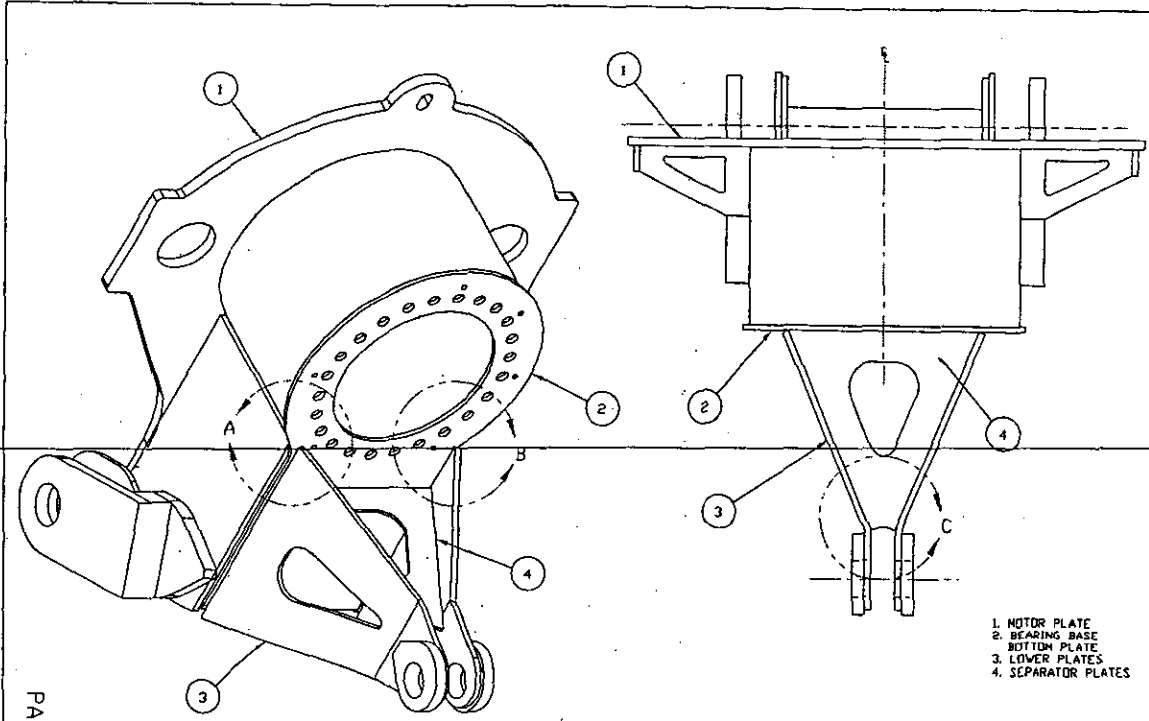
PAGE 3

Step 5: Visually inspect the three areas for cracks or broken paint.

Step 7: If a crack is discovered describe the crack on the form found on Page 6 & 7 of this Bulletin. Fax the form to Dartron at 503-362-2536. Dartron will coordinate a time to perform the repairs.
