BULLETIN: BU-136 MC

ROUND-UP/PARATROOPER HUB INSPECTION

BULLETIN: BU-135 MC

ANNUAL INSPECTION OF MAIN SPINDLE SHAFTS, ROCKER SHAFTS, CYLINDER ANCHOR SHAFTS

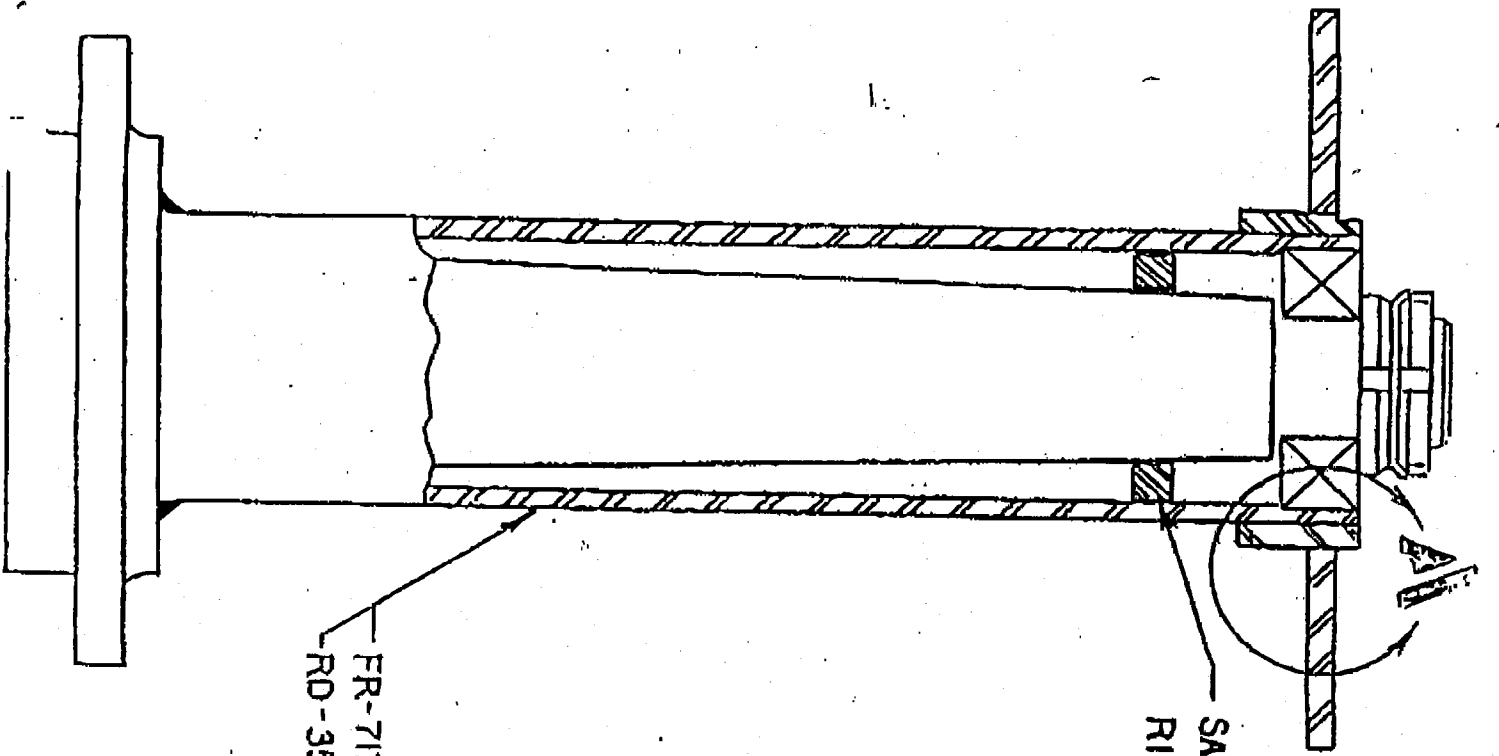
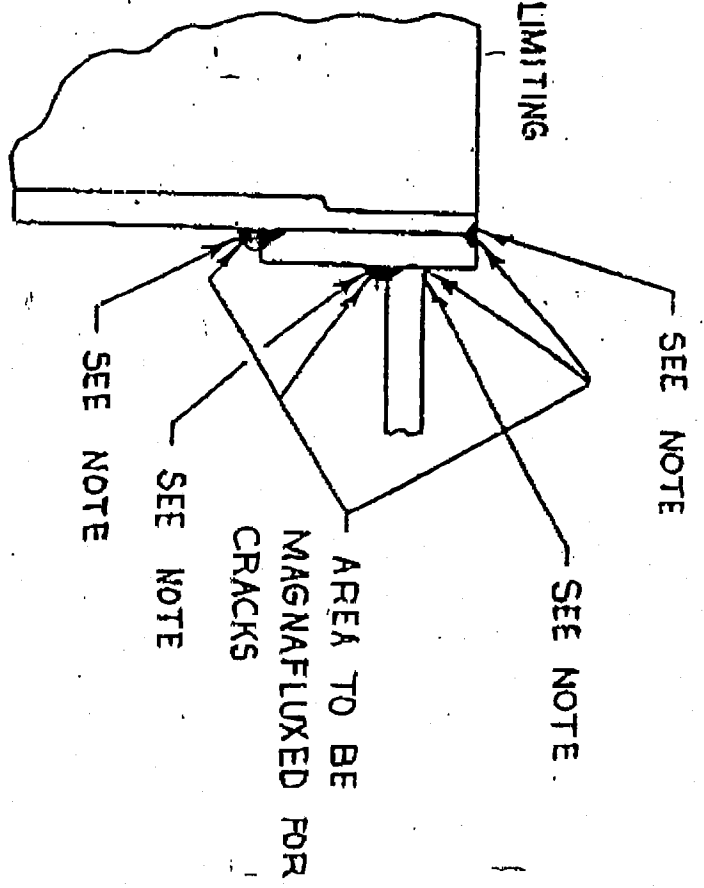
CENTER HUB - INSPECTION OF WELD
 ROUND-UP & PARATROOPER

The main spindle shaft hub housing on the Round-Up and Paratrooper amusement rides that were manufactured by Frank Hrubetz Co., and Kilinski Mfg. Co. (KMC) have shown some sign of fatigue cracks in the weld areas of the hub assemblies.

NOTE:
 IF CRACK IS
 NOTED IN THIS
 AREA, CENTER HUB
 SHOULD BE REPLACED

We at Man-Co feel that this is something that should be inspected on a more regular basis and so we are recommending that the welds shown in the attached drawing (BU-136-MC) be inspected annually. If any sign of stress or cracks are noted, then we recommend that the entire hub assembly be replaced for the safety of the ride owners and customers.

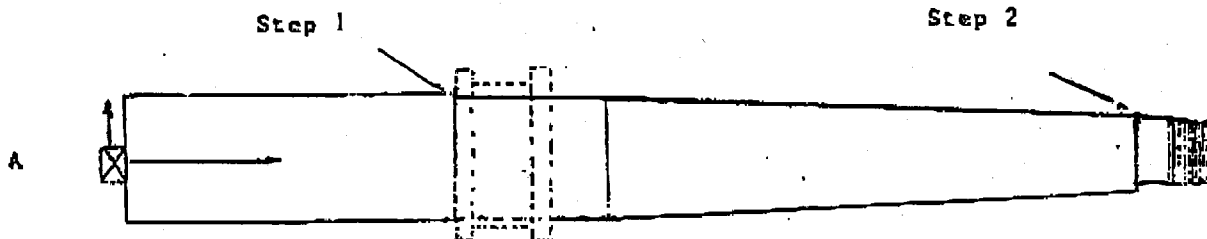
Figure 1

1. A 3/4" Diameter - 5 MHz Transducer is recommended.
2. The search unit shall be placed on center of shaft area (A) and adjust second back reflection to 100%.
3. Move transducer towards edge of shaft (A)
 - 3.1 Step 1 should appear to be approximately 25%.
 - 3.2 If not, scan the perimeter and adjust to the average.

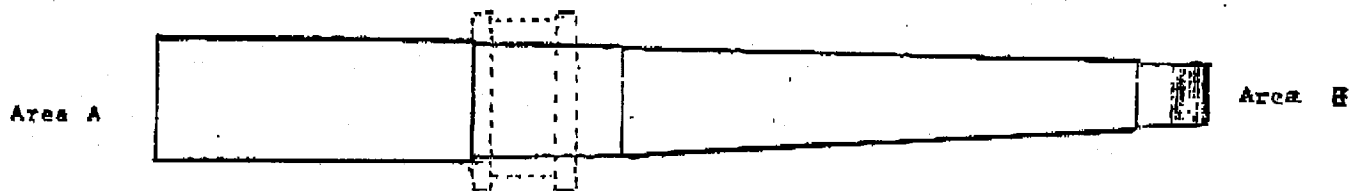
Figure 2

- A. After calibration per Figure 1, areas (A) and (B) shall be scanned 100%.
