Dokument-Nr./ <i>Doc. ID.:</i> KD15003	Ersteller/ <i>Author:</i> SJ/IG	Unternehmen / <i>Company</i> Doppelmayr Seilbahnen GmbH, Wolfurt	Datum/ <i>Date:</i> 17.03.2015	Seite/ <i>Page</i> 1 / 4	
Ersatz für/ <i>Supersedes:</i> KD11009	Ersetzt durch/ <i>Replaced by:</i> -	Type: CLD, MGD, CGD	Baugruppe/ <i>Assembly group:</i> Grips		
Abgeleitet von / <i>Based on:</i>					
Classification Code:	X	OS	O	IS	I

Revision of Bulletin KD11009:

Detachable Grips Type A – Spring Guide Slide Rods

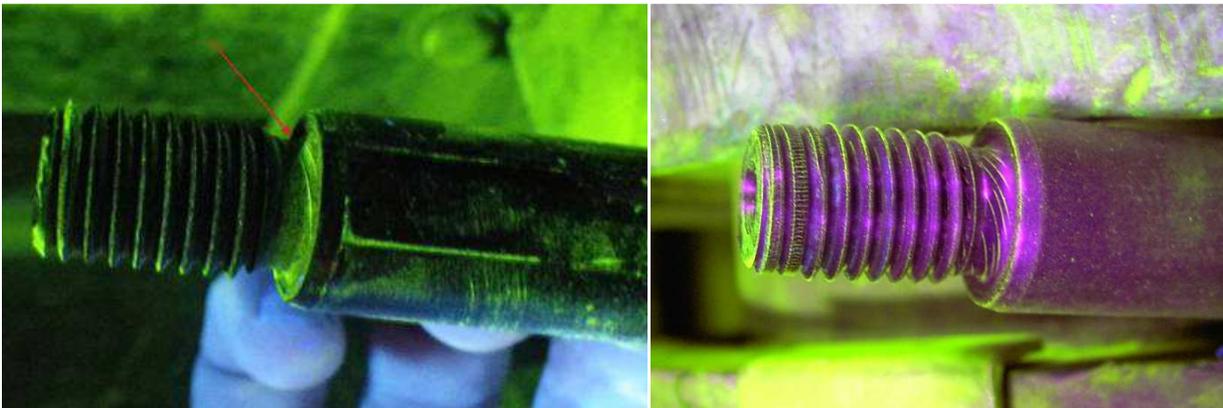
In the course of the recurrent non-destructive testing, there were indications found on the spring guide slide rods in the area of the undercut and the thread (see photos).

- So far examined indications showed different numbers and lengths.
- In most cases, several smaller indications were distributed along $\frac{1}{4}$ to $\frac{3}{4}$ of the circumference.
- The indications were ground in the area of the undercut until no indications remained. The maximum grinding depth to achieve this was 0.2 mm, which means that all indications were located in the nitrocarburized layer of the material.
- A spring guide slide rod with indications was then subject to rigid fatigue testing performed with double load and approximately 10 times the load cycles that occur on an average installation in 30 years. Upon completion of this extreme test, no indications of fatigue were found

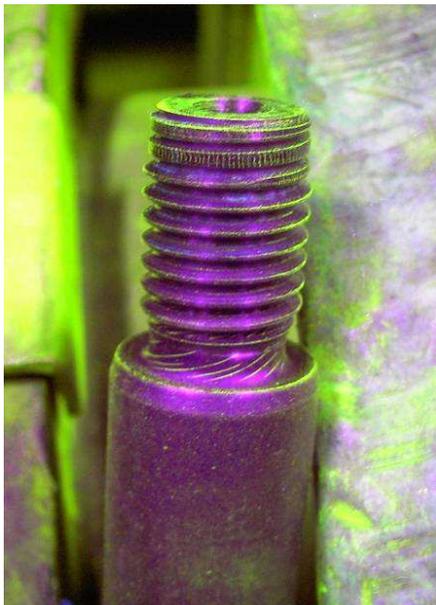
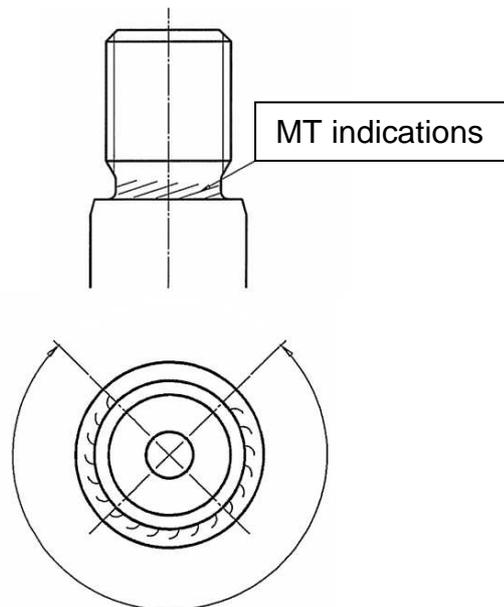
If rusty indications are found during the routine maintenance works or if indications are found in this area during the regular NDT/MT testing (see photo below), proceed as follows:

1. MT indications in the area of the undercut thread are permissible under the following conditions:
 - The indications are relatively short and are located at an angle of approx 30-45° to the axis of the component.
 - The indications are distributed along a maximum of ¾ of the circumference.
 - There is no continuous indication that is approximately perpendicular to the axis of the component.

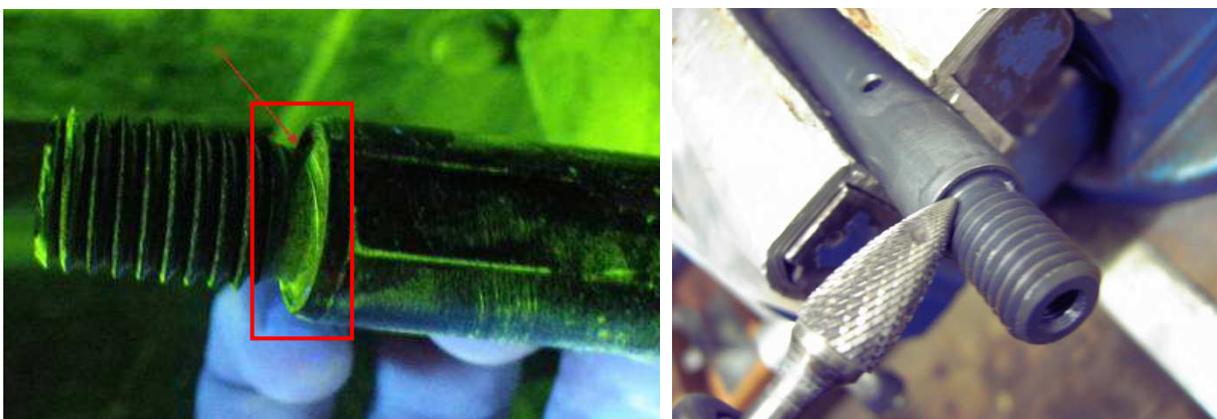
2. If the indications deviate from item 1, proceed as follows:
Using a round diamond hand file or a die grinder with a pointed metal burr remove the indications in the area of the undercut on the entire circumference on a sampling of at least 3 spring guide slide rods (see photos).

- The maximum grinding depth may be 0.3 mm.
- If the grinding removes the indications, the spring guide slide rods can be returned to service after applying an anti corrosion agent (paint).
- If the indications on the other spring guide slide rods of the inspection lot are of the same type, no further spring guide slide rods must be ground out and they also can be returned to service.
- Spring guide slide rods that have been ground to the maximum depth of 0.3 mm on the entire circumference must be permanently marked (by stamp or similar) to indicate that grinding to the maximum allowable depth has been completed and no additional grinding is allowed.
- If indications are found that are deeper than 0.3 mm, the component must be replaced and returned to Doppelmayr.

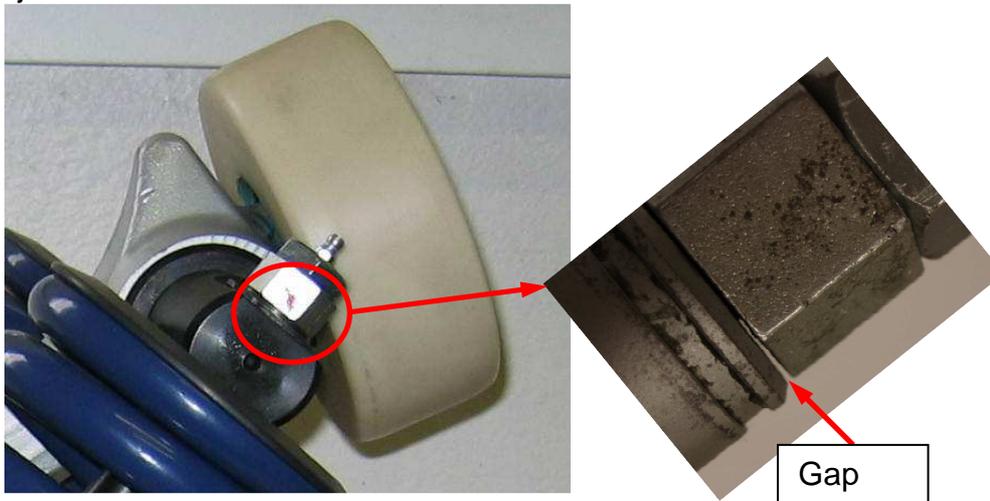
- Check along the entire circumference of the face turned nut for the presence of a gap (see photo above).
- If no gap is present, then no further measures are required.
- If the presence of a gap is detected, the nut must be replaced by a new one before returning the grip to service. For mounting instructions consult section 0.
- Furthermore, those spring guide slide rods whose hexagonal nuts were replaced must be tested for incipient cracks in the area of the undercut by means of NDT/MT testing in the course of the next inspection. If incipient cracks are found, proceed as described under section 2.

3. Important when remounting the nuts:
 - Treat the nut and counter nut with "medium strength" threadlock (e.g. Loctite 243 or 222).
 - Mount the face-turned nut first and tighten (**without torque wrench**) until the nut contacts the spring guide slide rod. Then fit the counter nut and tighten it opposite the face-turned nut with torque, however, without applying a torque to the face-turned nut. Tightening torque **M14 = 115 Nm, M18 = 200Nm**
4. Check the hexagonal nut (M14 for type A104, M18 for type A108) at the end of the spring guide slide rod for surface evenness (see service bulletin SB-08-022) on all grips:
 - Position of grip: The grip must be closed without a rope or without a test bar in the jaws.
