SAFETY ALERT BULLETIN

Title: Tower Failure Due to Water Intrusion

BULLETIN		Ersteller/ Author	Datum/ Date	Dok.- Nr./ Doc.-ID	Seite/ Page
				CH/HS/LAK	20.12.2008	KD08003E	1 / 5
Ersatz für/ Supersedes:	Ersetzt durch/ Replaced by:	Type:		Baugruppe/ Assembly group:			
-	-			Towers			
Abgeleitet von / Based on:	SA-06-022 Safety Alert Bulletin						
Classification Code:	x	OS	O	IS	I

Tower failure due to water intrusion

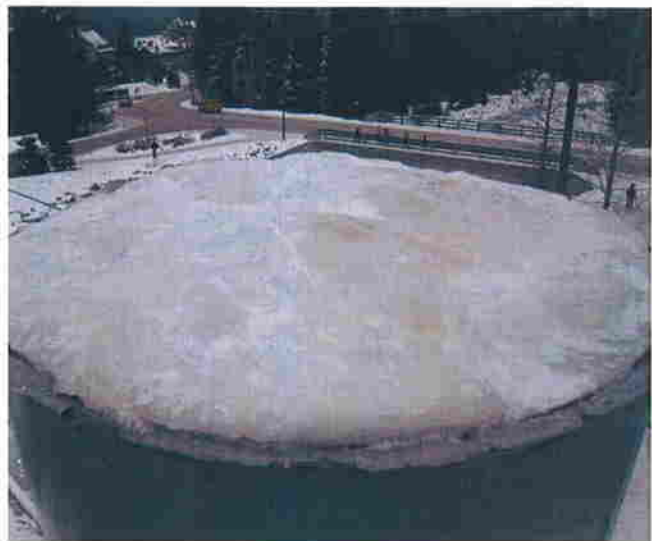
Tower with 2 x 6T/2FR assemblies;
16,7m tall; 9,7m of 30" tube spliced
to 7m of 24" tube.

Lower tower section filled approx.
5m with concrete, the remainder
with ice.

Temperature approx. -12°C/10°F.

Bottom tower section top flange
plate was pushed off the shaft by
ice and caused top tower section to
separate and fall.

The comm. line and the haul ropes
supported the tower head so the
upper section came to rest in a
more or less vertical position on the
ground.
