WOL	12/20/2008	SA-08-021 Wolfurt KD08003E

SAFETY ALERT BULLETIN

Title: Tower Failure Due to Water Intrusion

Tower failure due to water intrusion

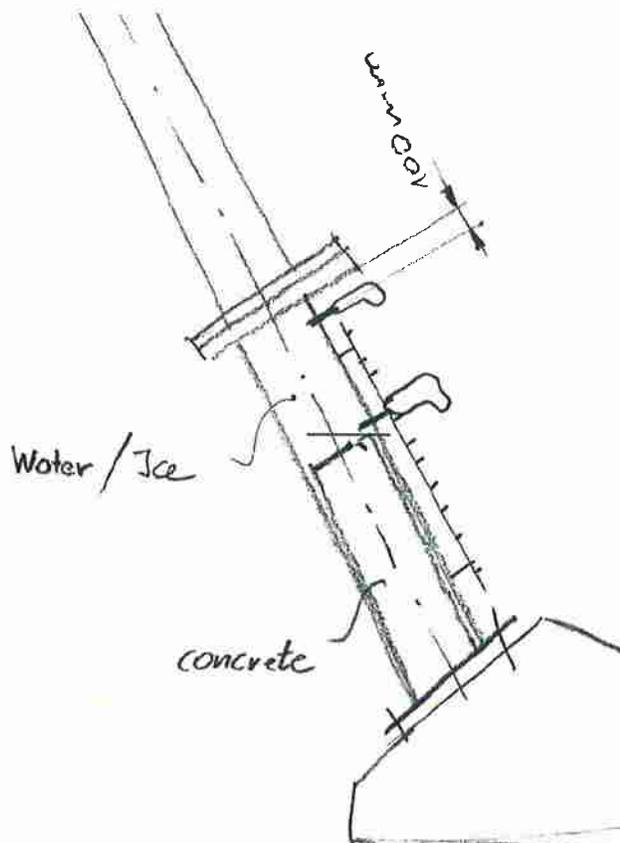
A small drain hole 3/8" - 1/2" (10 - 12 mm) is required to eliminate the water above the concrete level. See illustration below.

For tower shaft sections partially filled with concrete through the top plate, check the tower section with the hammer method as described previously. If water/ice is suspected, drill a small hole 3/8" - 1/2" (10 - 12 mm) approx. 2 inches (50 mm) below the top plate on the uphill side of the tower (behind the ladder). Tower shafts with a cover for concrete fill on the outside of the shaft already have a drain hole and the cover can be removed for inspection purposes. **If ice is found in this section, this shall be cause for immediate and continued closure of the lift to public transportation** and must be reported to the nearest Doppelmayr representation office for review and recommended repair procedures.

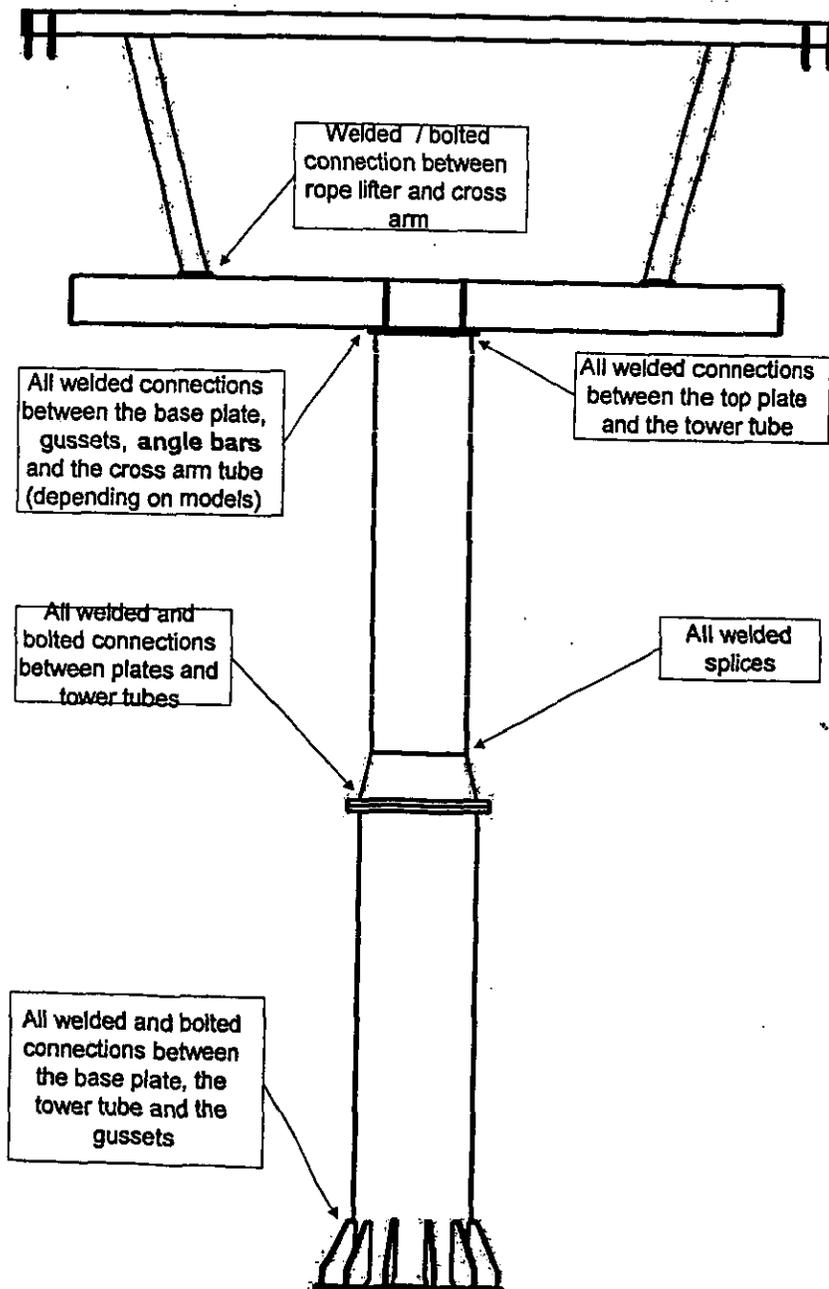
Fig. 1 Critical areas of towers and cross arms

Recently, cracking was observed in the cross arm of a negatively loaded tower. The crack started at the end of the angle gusset welded on the attachment plate and progressed into the cross arm tubing. It was also observed that the lift in question was (or had been) equipped with **urethane after-market sheave liners**.

Negative or combination loaded towers and adjacent towers are more susceptible to fatigue cracking due to unavoidable vibration and shock loading induced by grips passing under sheaves. Doppelmayr original equipment sheave liners are the product of many years of research and development, taking into account vibration damping, long life, electrical conductivity and other factors. **After-market sheave liners may not include these important features. DOPPELMAYR CTEC DOES NOT CONDONE THE USE OF AFTER-MARKET COMPONENTS, AND ACCEPTS NO RESPONSIBILITY FOR NEGATIVE CONSEQUENCES ARISING FROM THE USE OF SUCH PRODUCTS.**

- If you detect a crack during your inspection, contact your Doppelmayr CTEC representative for repair procedure or replacement. **Do not operate a lift with defective components.**

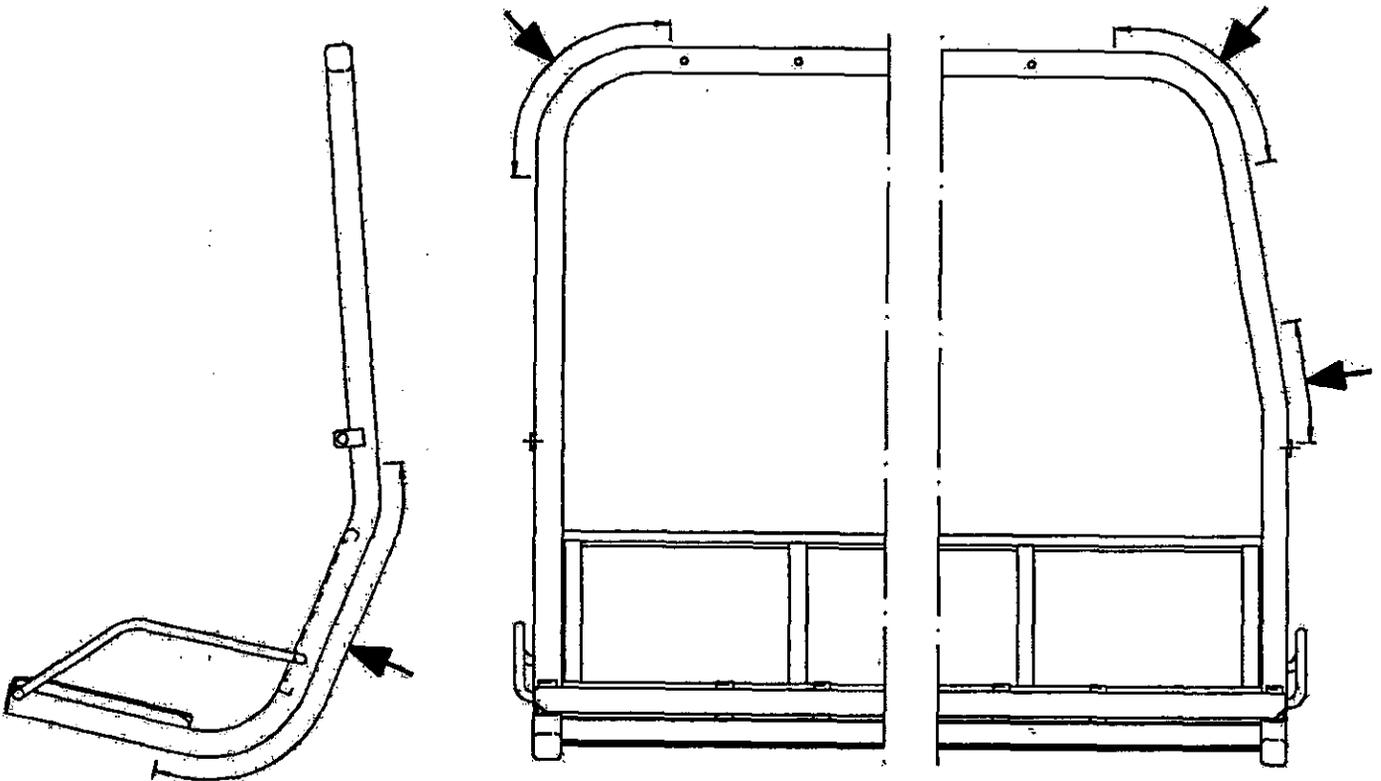
- Longitudinal cracks appear mainly in the bent area of the chair bail (see sketch below)
Pay particular attention to those areas when performing your periodic examinations.

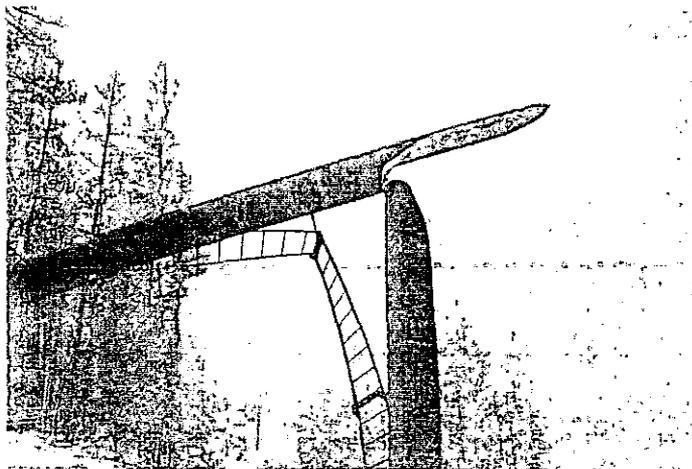
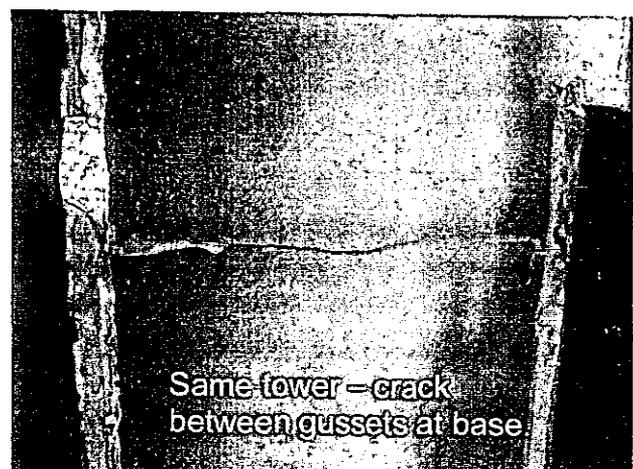
Bottom tower section top flange
plate was pushed off the shaft by
ice and caused top tower section to
separate and fall.

Tower: 6S/4S; 46' tall; 30' of 20" tube spliced to 16' of 16" tube. Ice filled to 30' position.

Weather conditions at failure:
Night; ~-5° F.; Wind ~ 57 mph.

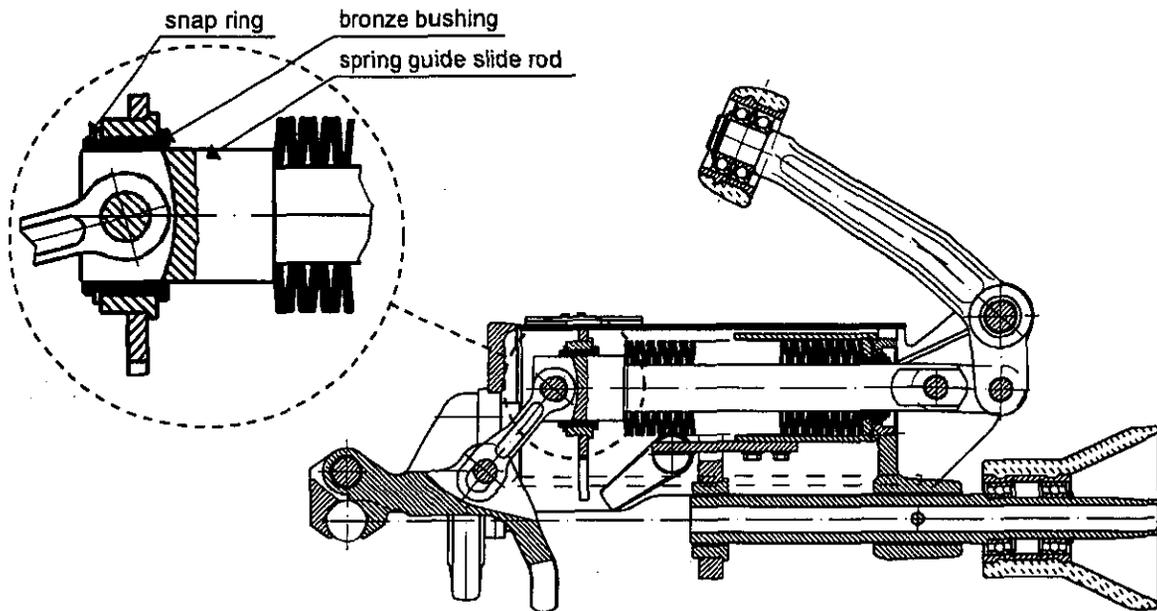
Because of current events we urgently recommend to pay special attention to the correct fastening of the bronze bushing of DS grips by means of the snap ring.

If the snap ring is not fitted correctly it can not be turned or only with difficulty. The space between the ends of the snap ring (dimension x) is significantly bigger than in the case of a correctly fitted snap ring.

Check if the snap ring sits properly, simply by turning it and checking the space between the ends of the snap ring.

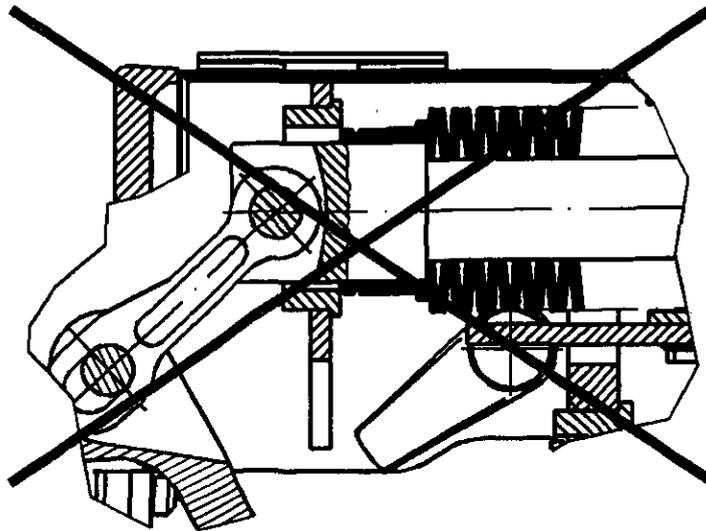
If the snap ring is not fitted correctly or missing, the bronze bushing may creep and as a result the grip may be blocked during the closing procedure!

This means that the grip leaves the station without being completely closed!

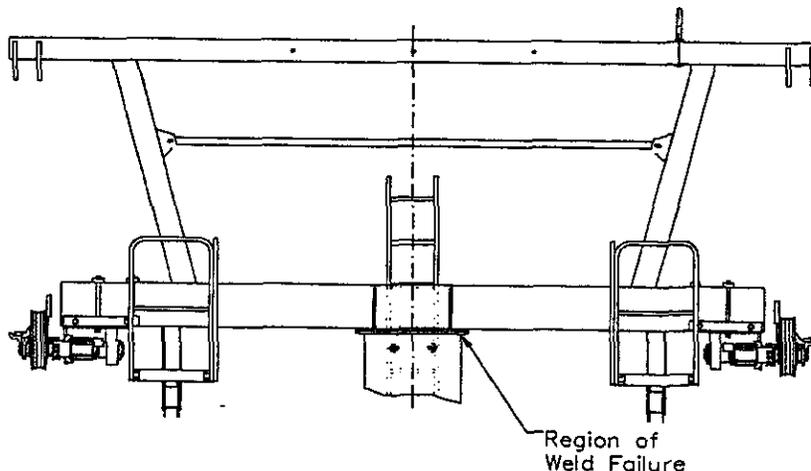
The following schematic depicts the location of the weld that failed.

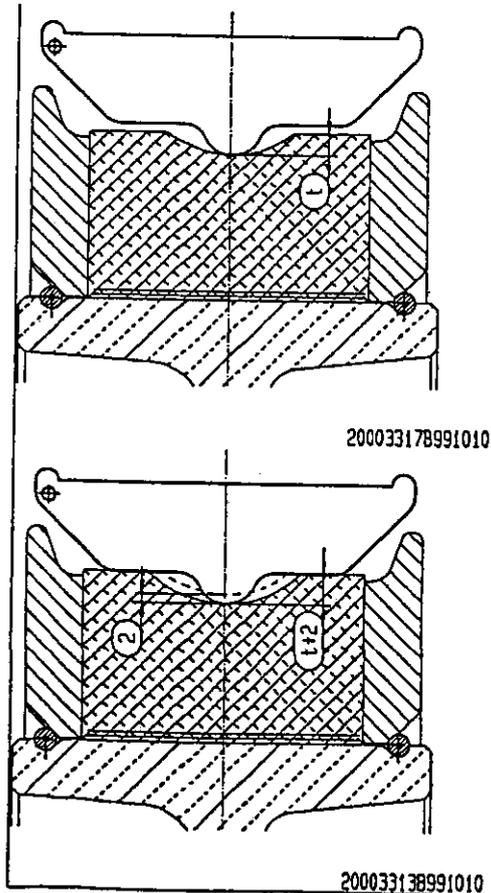
The template touches only the bottom of the groove.

If the rope groove is worn by 2 mm, the template will contact the sheave liner. The rubber liner must be replaced.

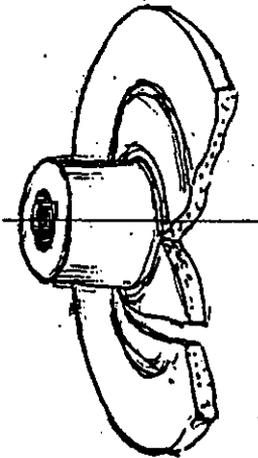
Upon cooling down and readjustment of the brake, operation was continued. Then, after approx. 30 minutes in operation, the brake disc suddenly broke.

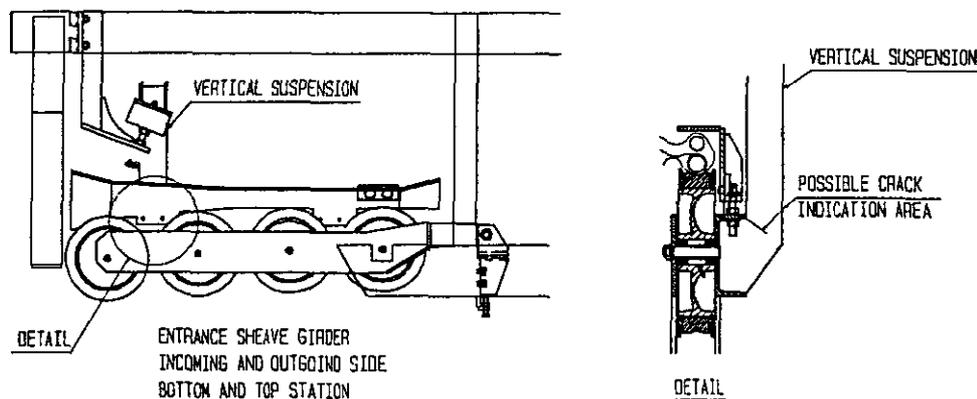
See sketch below:

According to our files, entrance sheave assemblies of this type are installed on your lift. We would kindly ask you to check the critical area (see sketch) for possible cracks.
