SUPPLEMENT TO THE BIG ELI® WHEEL MANUAL

Since this Manual was last revised there have been several bulletins sent out to owners/operators of record. This supplement will cover that material which was sent out, as well as new information, but which was not covered by this Manual.

Bulletin

For All Big Eli® No 16 Wheels
Before Serial No. 1080-59

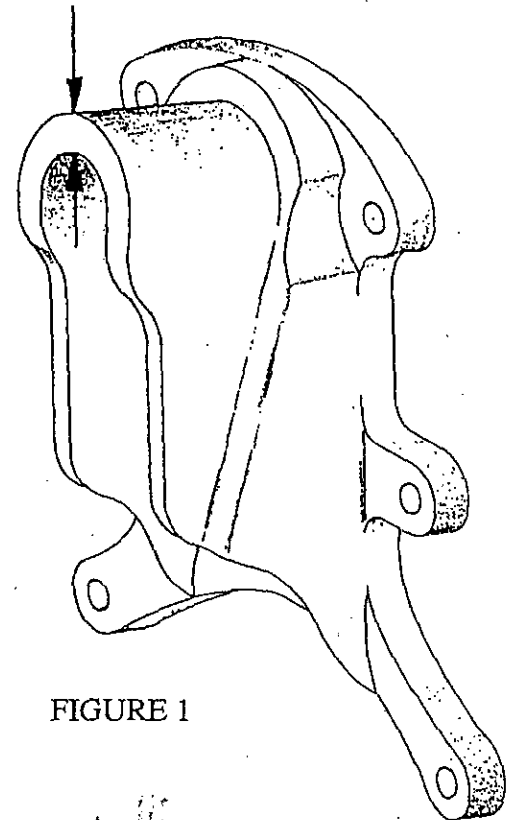
FIGURE 1

The most obvious place is at the top of the casting where the casting rests on the seat pin, as shown in Figure 1. THE THICKNESS ON THE END IS $3/8$ ". WHEN IT IS WORN DOWN TO A THICKNESS OF $5/16$ " THEN THE CASTING SHOULD BE REPLACED.

Since this is a casting with tapering surfaces for release from the molding sand, some "enterprising" operators have found that by grinding back on the outer end of the casting they get back to where the casting is thicker and where they can meet the thickness requirement of at least $5/16$ ". It is true that as you grind away the casting does become thicker, but this procedure introduces another problem, so DO NOT GRIND AWAY THE END OF THE CASTING.

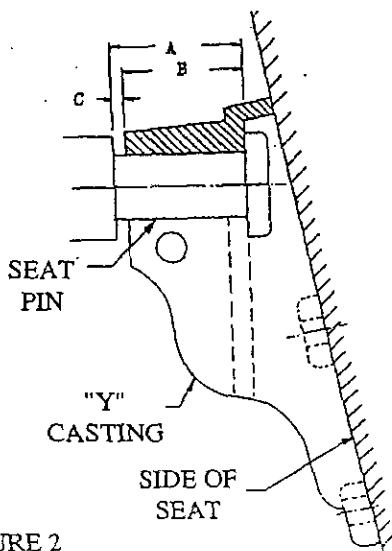
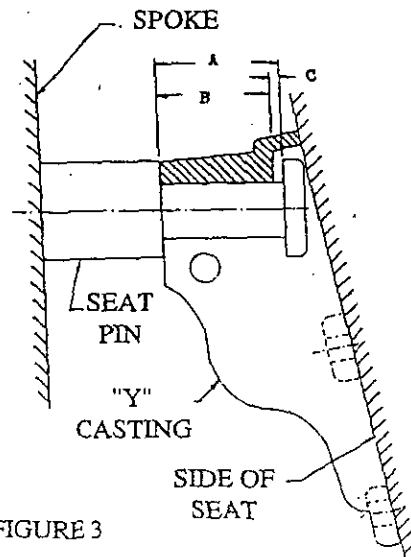
FIGURE 2

The seat pin has a reduced diameter where it fits up inside the "Y" casting. See Figures 2 and 3. When the pin is locked in place the head of the pin is held by the recess in the "Y" casting.

On a new pin the length "A" of the reduced diameter is $2\text{-}\frac{1}{8}$ ", and the portion of the "Y" casting where it rests, "B", is just $1\text{-}\frac{7}{8}$ " long. Therefore, there is a built-in clearance "C" of $\frac{1}{4}$ " for the seat pin to move in or out while still locked in position. Figures 2 and 3 show the extreme positions, Figure 2 with the seat pin all the way out, and Figure 3 with it all the way in. Notice that when the seat pin is all the way in, as in Figure 3, the head of the pin is nearly touching the side of the seat. When the outer end of the "Y" casting is worn or ground away the seat pin will actually dig into the side of the seat. There have been cases where the side of the seat has had a circle cut out of it because of the rubbing of the seat pin.

WHEN THE INSIDE LENGTH "B" OF THE CASTING HAS BEEN REDUCED $\frac{1}{16}$ " IN LENGTH (from $1\text{-}\frac{7}{8}$ " to $1\text{-}\frac{13}{16}$ ") THEN THE CASTING SHOULD BE REPLACED.

In recent years all seat pins have had a $\frac{1}{8}$ " radius machined on the edge of the head of the seat pin, as can be seen in Figures 2 and 3. If your seat pins do not have a radius at this point, grind a $\frac{1}{8}$ " radius on each one, and this will minimize wear on the side of the seat.

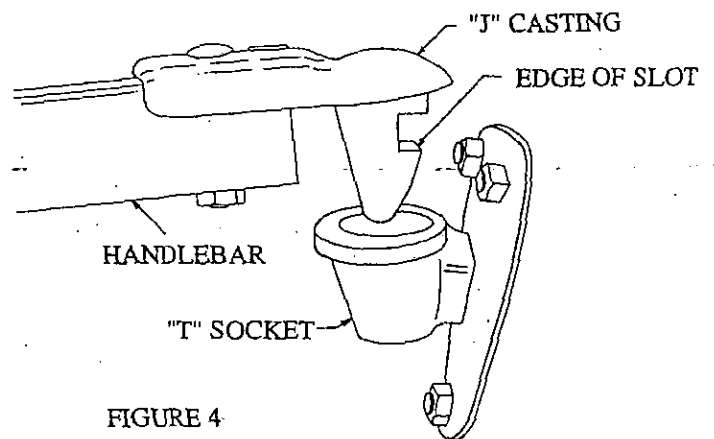
FIGURE 4

The bottom edge of the slot in the "J" casting, as shown in Figure 4, is the surface which engages the "AB" plunger to secure the handlebar in the locked position. THE "J" CASTING SHOULD BE REPLACED IF THIS BOTTOM EDGE IS ROUNDED OR BROKEN AWAY. You may find an indentation where the plunger has pressed against the bottom of the slot, but this will not impair the functioning of the latching mechanism, and is no reason to replace the "J" casting.

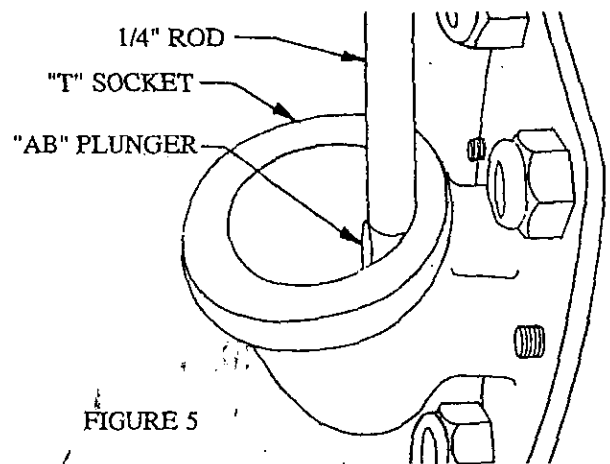
FIGURE 5

The "AB" plunger must extend into the "T" socket a minimum of 1/4" for secure latching of the handlebar. The easiest way to check this is to place a 1/4" diameter rod on top of the plunger when it is all the way extended. The plunger should be at least long enough to extend the width of that 1/4" rod. See Figure 5,

IF THE "AB" PLUNGER DOES NOT EXTEND 1/4" INSIDE THE "T" SOCKET, OR IF THE END OF THE "AB" PLUNGER IS BROKEN OR ROUNDED FROM WEAR, THE PLUNGER SHOULD BE REPLACED.

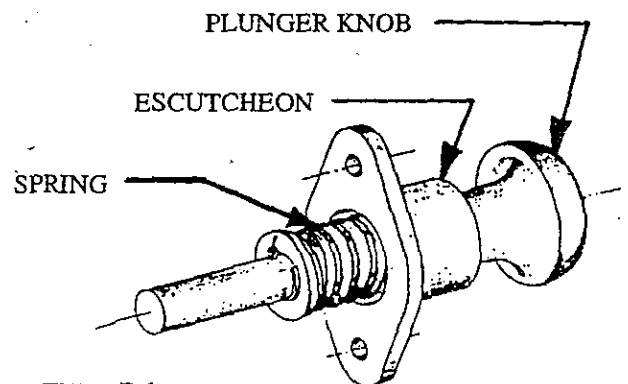
FIGURE 6

The spring on the "AB" plunger, shown in Figure 6, must always be maintained in good condition. When you release the plunger knob, the plunger should be forced firmly and completely all the way in until the knob is against the escutcheon. IF THE SPRING IS WEAK OR BROKEN REPLACE IT. DO NOT CARRY PASSENGERS IN A SEAT WHERE THE PLUNGER DOES NOT FIRMLY ENGAGE THE "J" CASTING ON THE HANDLEBAR.

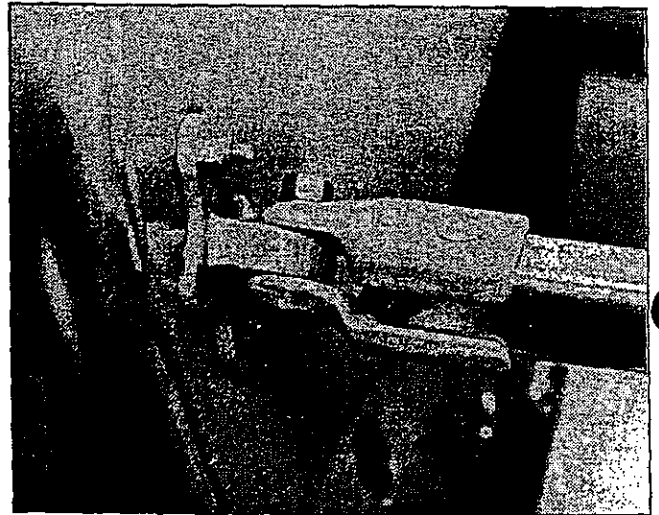
FIGURE 8

Check all handlebar hinge castings, as shown in Figure 8, to be sure all are free from cracks, and replace any where cracks are showing.

We have received some reports of cracks developing in the side of the seat around the screws which hold the "F" hinge casting to the side of the seat.

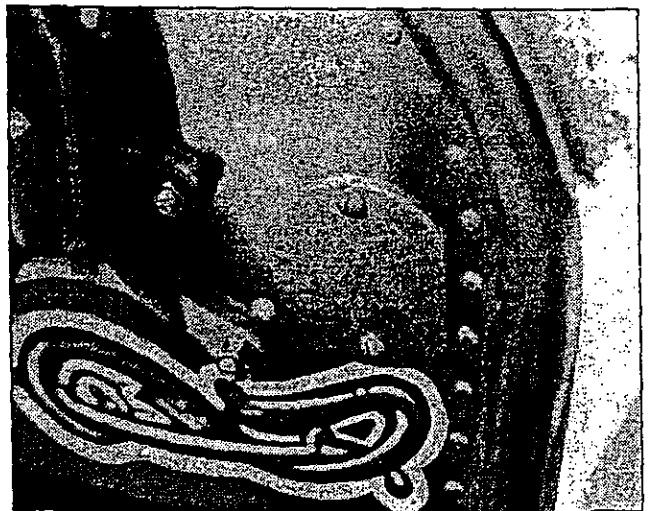
FIGURE 9

We have prepared disks, such as shown in Figure 9, which can be added easily to the outside of the seat to spread the load out. It appears that the cracking is more likely to occur on aluminum seats but there have been some reports of this happening in steel seats.

IF YOU FIND CRACKS AROUND THE SCREWS HOLDING THE "F" HINGE CASTING TO THE SIDE OF THE SEAT, INSTALL HINGE DOUBLER DISKS, WHICH ARE AVAILABLE FROM ELI BRIDGE COMPANY.

Before installation, drill a 1/8" hole at the end of each crack. This will help prevent the crack from growing longer.

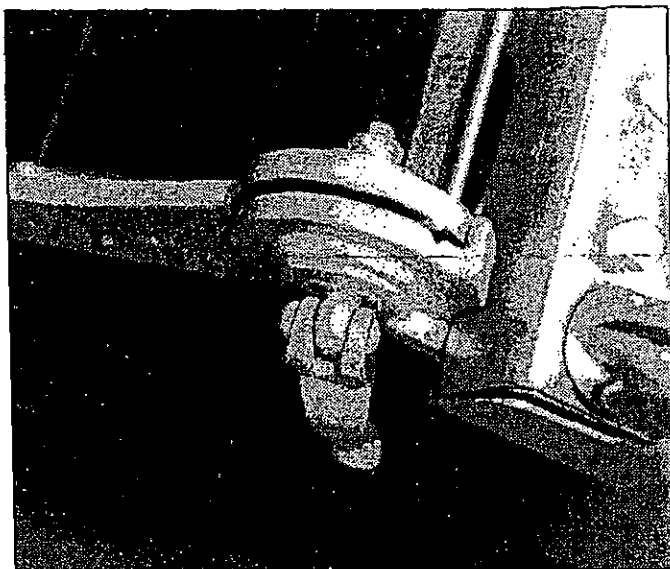
FIGURE 10

Check all of the malleable footbottom hinge castings to be sure that none are cracked. The raised rib in the hinge is sometimes worn smooth so that the footbottom cannot be locked securely. See Figure 10. IF THE LOCKING RIB IS WORN OFF OR IF ANY CASTING IS CRACKED, REPLACE IT.

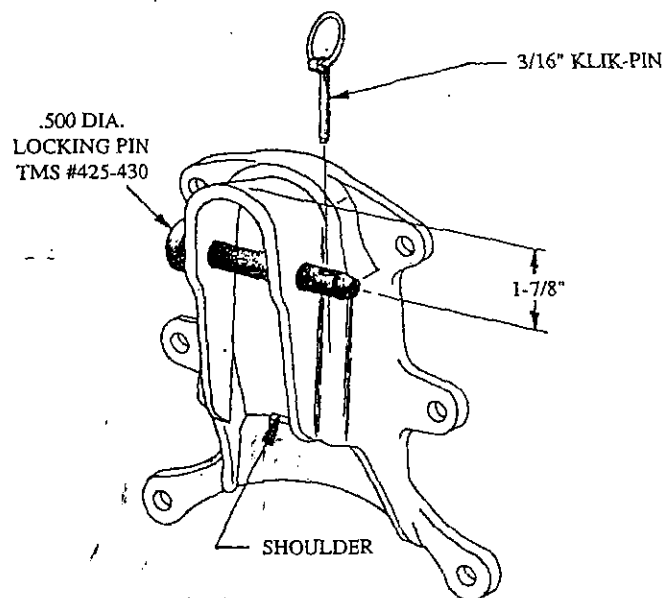
FIGURE 11

Securely locking the "MYNY" seat locks into position required sharp edges on the locating surfaces, and a spring in good condition for wedging the seat lock in the proper locking position. Extended wear tended to round off the sharp edges, and the springs occasionally failed to retain their strength, all of which caused deterioration of the locking capability.

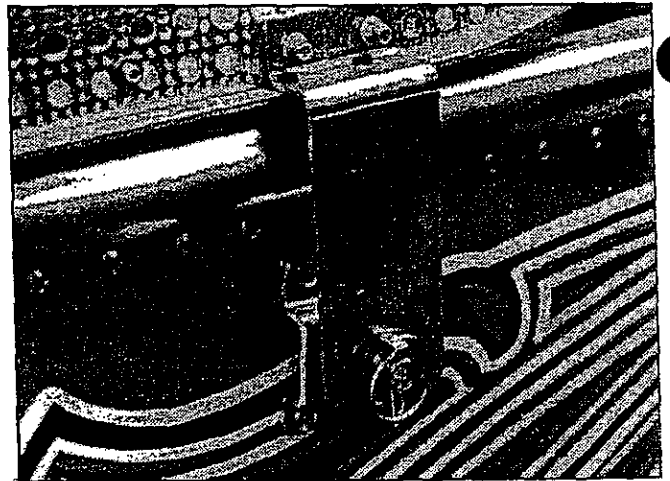
FIGURE 12

As can occur to any equipment exposed to the general public, there have been instances where hair guard perforated sheets have been deliberately cut, leaving sharp edges. If this should happen, repair or replace the hair guard or perforated sheet as soon as possible because the cut edges could be very hazardous.

Earlier models of the hair guards were each held to the seat with two Air-loc quarter-turn fasteners. These provided secure attachment but for easier assembly the Air-locs were replaced on a later design with studs on the seats over which the hair guards were slipped, and then secured with a Klik-pin on each stud, as shown in Figure 12.

On one occasion which has been reported to us a passenger laid his hand across the back side of the seat behind the hair guard, and removed the Klik-pin, which allowed the hair guard to get loose and jam against other parts of the Wheel. CHECK FREQUENTLY TO BE SURE THAT ALL KLIK-PINS ARE IN EVERY HAIR GUARD. AN UNSECURED HAIR GUARD CAN BE VERY HAZARDOUS TO THOSE IN THE SEAT, THOSE IN OTHER SEATS, OR THOSE ON THE GROUND.

You might want to consider replacing your hair guards with ones in which the perforated metal has been replaced with clear Lexan polycarbonate plastic. This material is virtually unbreakable, and provides a clear unobstructed view. Over a period of years the Lexan when exposed to direct sunlight does tend to become more brittle, but its superior properties easily justify its use. While we do not have long term use data, we believe the impact resistance of the Lexan should be checked after five years of use, and replaced if the impact resistance has been lost.

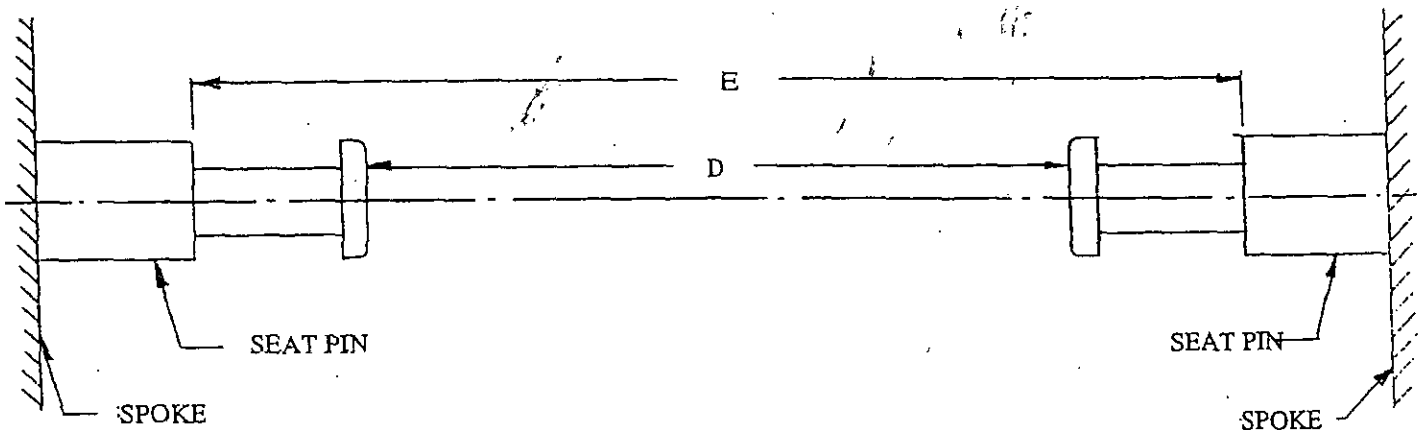
FIGURE 16

In Figure 16 the distance "D" between the seat pins is intentionally not a fixed rigid dimension. There is some flexibility in the outer end of each spoke, and each seat will show increasing deflection as weight is added in the seat. The passenger weight tends to deflect the bottom of the seat downward, and this in turn tends to pull the sides of the seat toward each other. If the spoke could not deflect to follow the seat deflection this would cause excessive wear in the "Y" castings and the seat pins.

Measuring from outside to outside on the "Y" seat hanger castings is a more predictable dimension, but even that has varied depending upon the construction of the seat. The original wooden seats measured 52" outside to outside, the steel seats measured 52-5/16", and the aluminum seats are 51-15/16". With an empty seat hanging on seat pins, the least distance between the outer shoulders of the two seat pins, dimension "E", would be the same as the above seat dimensions since the shoulder on the seat pin would be against the end of the "Y" casting.

In our view these dimensions are not relevant because of the inherent flexibility of the structures, and because of their ability to conform to each other. If there is significant misalignment this should show up as excessive wear on the inner or outer end of the place where the seat pin rides (dimension "B" of Figures 2 and 3). There may also be wear of the seat pin itself. Evidence of wear is of primary significance, and the nominal distance between the seat pins, dimension "D", is of considerably less importance than evidence of wear.

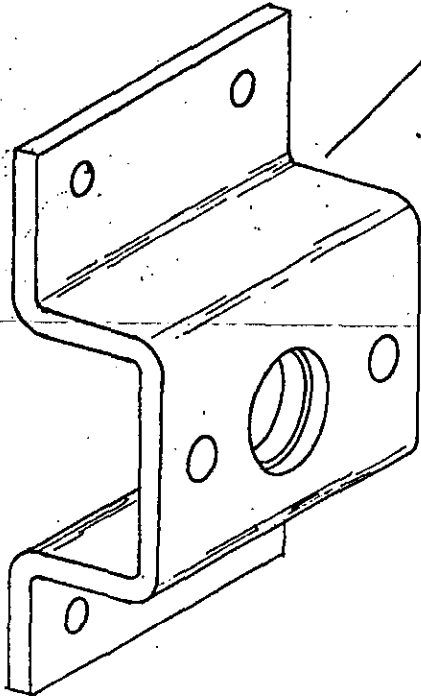
OLD BRACKET

Eli Bridge Company has found that not all installations have been made according to these instructions, and that the brackets were located with the flanges to the left and right, and the open ends at the top and bottom.

Improper installation of the brackets, plus lack of inspection of the completed Wheel before carrying passengers, appear to have caused an accident involving one fatality. What appears to have happened is that in hanging the seat on the Wheel the right end (off-tower side) was not hung on the seat pin but on the improperly installed hair guard bracket. The seat pin has a large diameter on the end which can just slip inside the hairguard bracket when it is improperly installed with the open end down. A glance at the end of the seat would have shown that the seat was not hanging properly, but such an inspection obviously was not made. Consequently, after the Wheel had turned two or three times the seat pin apparently rolled out of the bracket, allowing that end of the seat to drop.

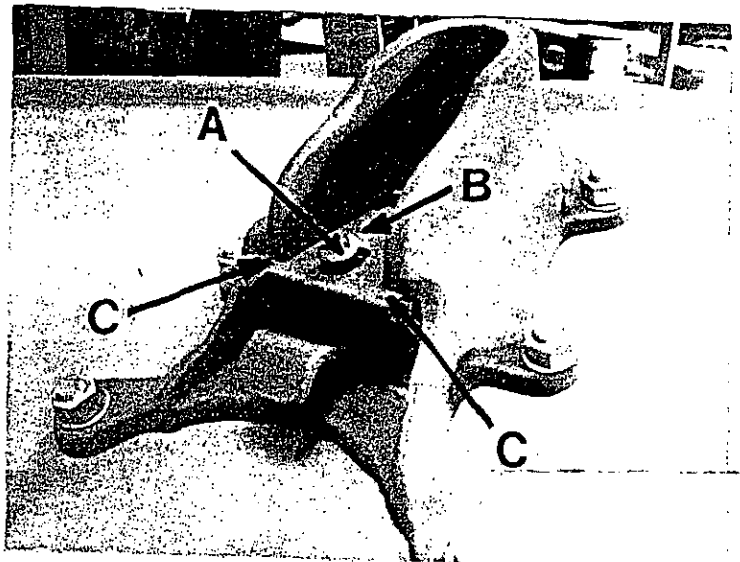
We immediately began an investigation to determine what the situation was. We found that on our last production run completed on April 28 some of the pins marked "A" were slightly shorter than the standard length. The hinged part, "B", was prevented from pressing against the shoulders, marked "C", because "B" was touching pin "A". Therefore, even though the seat lock did lock in the seat hanger casting, it was not as firmly locked as we feel it should be.

Our records indicate only five customers have been shipped seat locks since that production run was completed, and you are one of them. It is possible that you received one or more of these short-pin seat locks, and we ask that you check each one to be sure that the hinged part "B" is touching the seat hanger casting at points "C". Those that do not touch points "C" should be replaced.

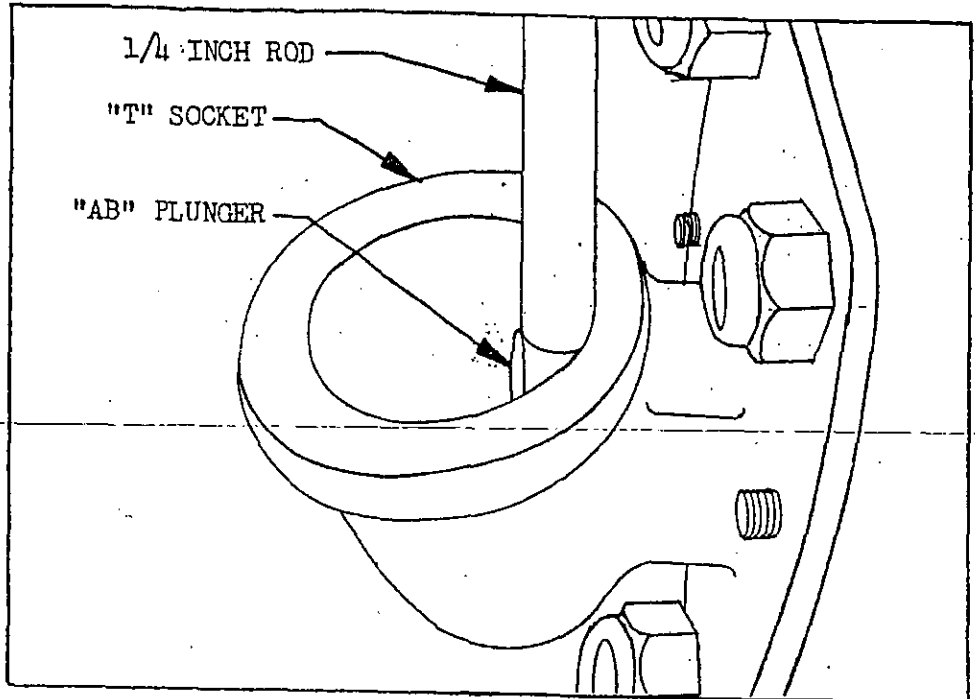
the way there may not be enough engagement of the plunger in the "J" lock. If it appears you have a weak spring, do not hesitate to replace it.

The slot milled in the "J" lock is cut deeper than absolutely necessary to allow for a plunger extension of 5/16 inch or more. A depth measurement of 9/32 inch at the bottom of the slot is of no consequence, if the plunger extends 1/4" into the "T" socket as specified above.

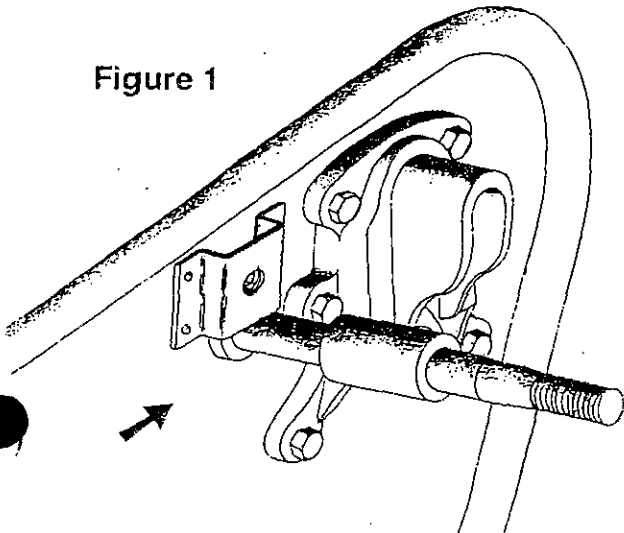
Figure 1

In the other case, the owner had installed the hair guard bracket incorrectly: he had rotated the bracket one-quarter turn so that the opening under the bracket was on the bottom instead of on the side where it should have been. The operator then lowered the seat into position, but instead of the seat pin entering the "Y" casting the head of the pin was inserted inside this hair guard bracket. This is shown in Figure 1.

If your Wheel does not have hair guards, we consider it mandatory that they be used. If the hair guard bracket on either side of the seat has been located as shown in Figure 1, then it should be replaced. The hair guard brackets on the back of the seat can be turned either way because safety is not affected.

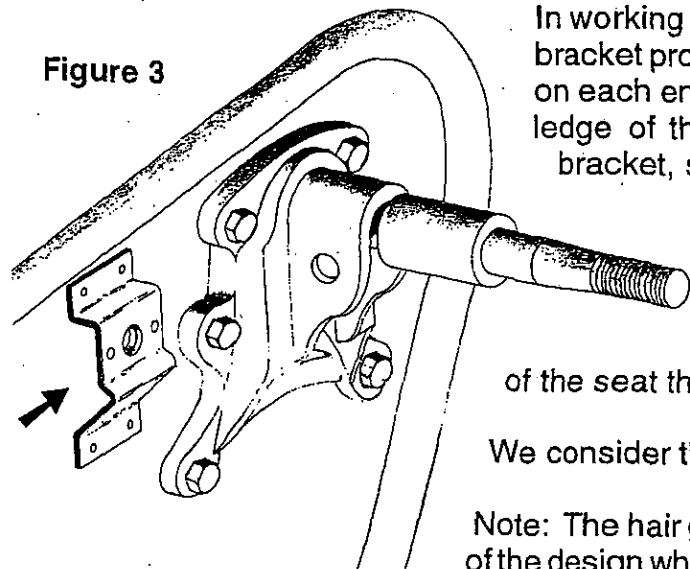
Figure 3

In working out these modifications we found that, with the original bracket properly installed, with the opening under the bracket open on each end, it might be possible to rest a seat pin on the bottom edge of the bracket. Consequently, we developed the longer bracket, shown in Figure 3, which has no ledge on the bottom side. If an attempt is made to rest the seat pin on the bottom side of the bracket, it will simply slide up the bracket. This longer hair guard bracket, shown in Figure 3, is needed only on the sides of the seat, and not on the back. If the shorter brackets are on the sides of the seat they should be replaced with the longer brackets.
