TMS SCRAMBLER BULLETIN NUMBER 1

SUBJECT: BREAKAGE OF LANDING GEAR CYLINDERS STACK VALVE

TMS SCRAMBLER BULLETIN NUMBER 4

SUBJECT: UNIT POLE AND SPLIT RING WEAR

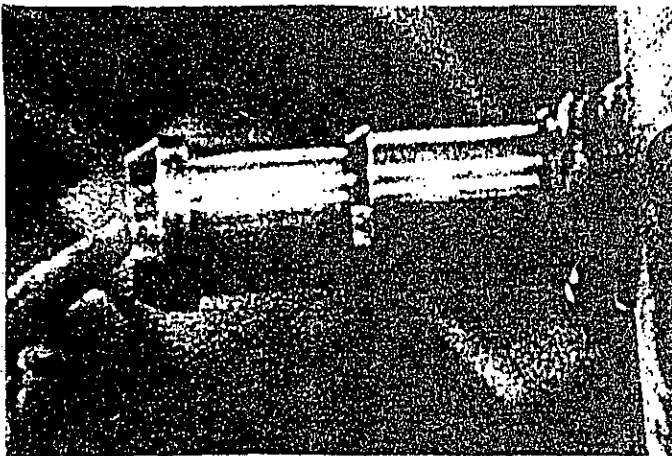
Picture No. 1 shows the top of the unit pole. The shoulder on the left end is machined to a diameter of 2.938", while the smaller diameter is 2.500".

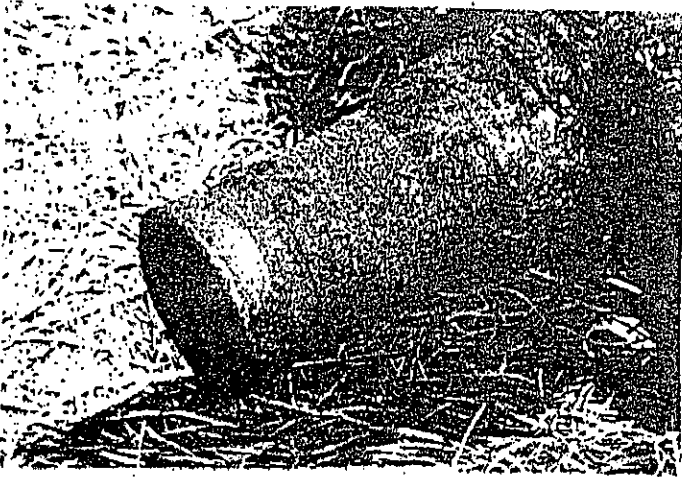
Picture No. 2 shows the top end of the unit pole which dropped through the bearing. Notice that the shoulder on the left end has been completely worn away. Here the diameter measured 2.485". The smaller diameter which started out as 2.500" was worn down to 2.290" at one point.

This type of wear was unknown on ground model Scrambler rides. We are not absolutely certain what has caused this wear on the TMS Scramblers, but we believe we know what has happened. We feel that this wear does not occur when the ride is in operation, but takes place while it is traveling on the highway. The bottom of each unit pole is supported on the floor of the trailer, but the top sweep hangs on the top of the unit pole. There is

some clearance built in, and as the trailer travels on the highway the normal bouncing of the trailer causes the unit pole and top sweep to pound against each other. This pounding has a peening effect which wears away the metal.

It is our feeling that this peening can be minimized by preventing this pounding from taking place. Accordingly, we have designed a tightening structure, as shown in Picture No. 4. Turning the handle at the top pushes a pad on the other end against the top of the unit pole. It is to be tightened while traveling on the highway, and loosened when the ride is operating. Picture No. 4 has the rain shield removed so the interior details can be seen. A cylindrical rain shield has been added in Picture No. 5.

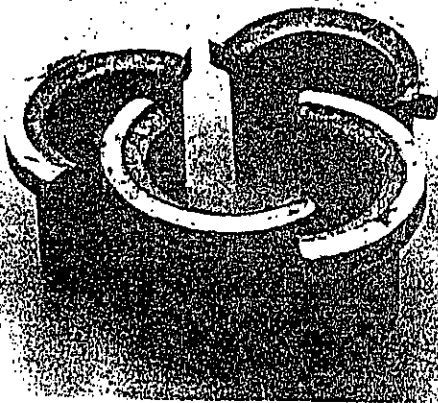
Picture No. 3

The top of the split ring was worn as shown in Picture No. 3. Originally the top of the split ring was flat.

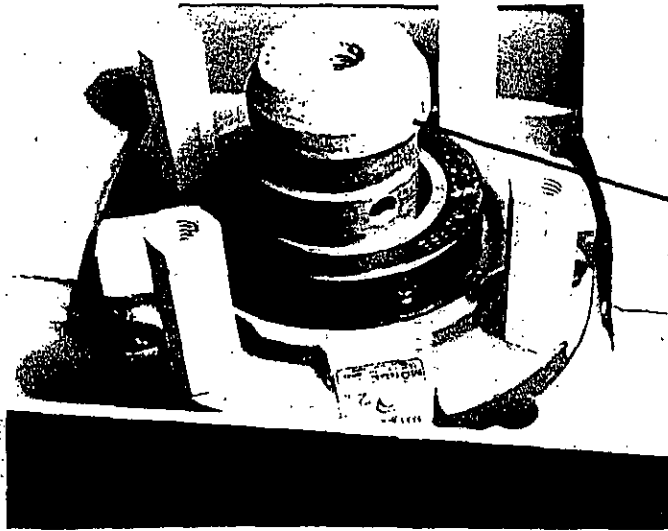
PICTURE NUMBER 7

From the bottom of the shoulder to the top of the unit pole was originally 1" high. The tapered part was 1/2" high and the straight part was 1/2" high. Wear on the shoulder will cause the straight part to get shorter. When the straight part has been shortened to 5/16" high (13/16" from the shoulder to the top of the unit pole), then wear is approaching the danger point. If you find this kind of wear, contact the factory.

WEAR AT THIS SHOULDER

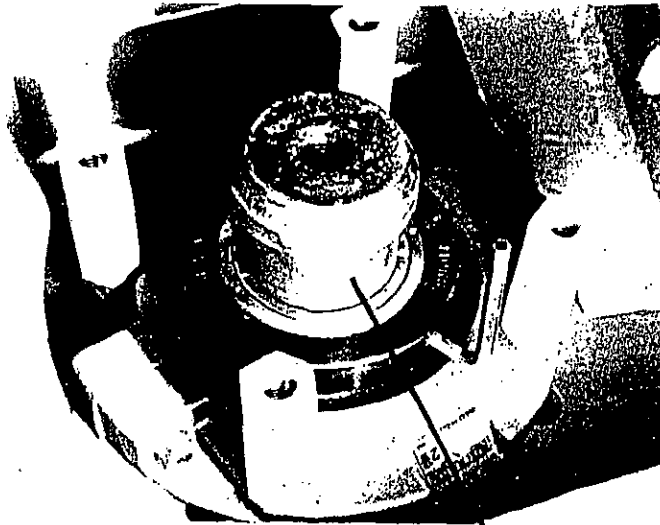
PICTURE NUMBER 8

The original diameter was 2.493" to 2.495". If this diameter is badly grooved or worn down to 2.480" diameter, contact the factory.

WEAR ON THIS DIAMETER.
