ALL STEEL PORTABLE
Big Eli
FERRIS WHEELS

Scramblers
E.L.I. POWER UNITS

SAFETY BULLETIN

URGENT WARNING

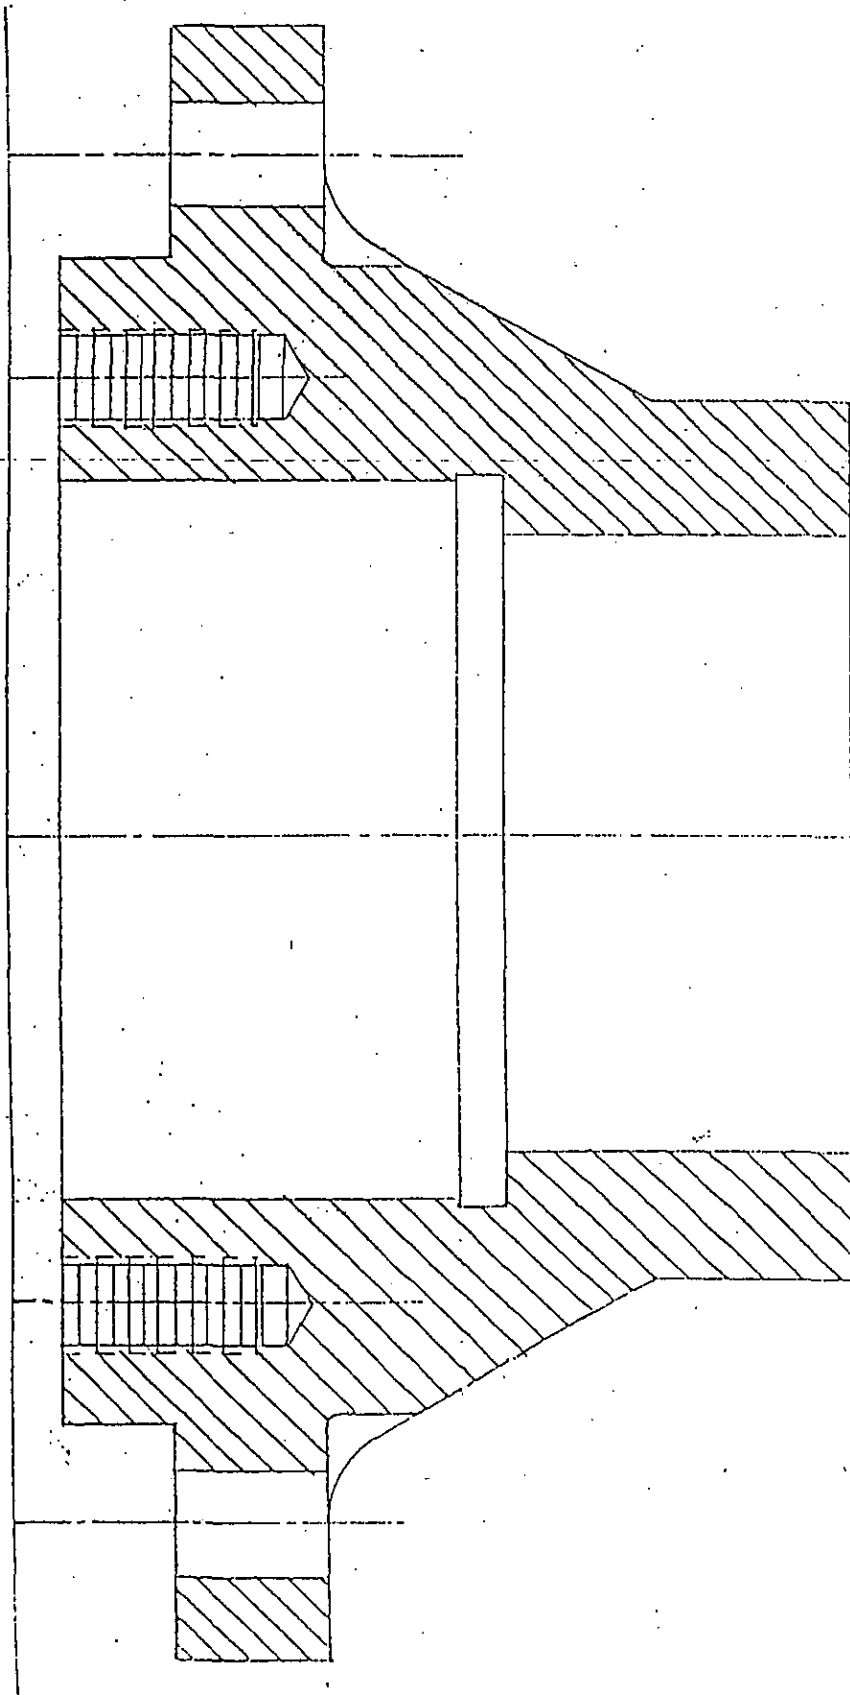
The original seal used in the pinion casting assembly was a Chicago Rawhide "Perfect" oil seal Part No. 15245. The manufacturer discontinued that seal, and we could not find an interchangeable replacement from any other manufacturer. The closest seal in size was a Chicago Rawhide Part No. 15250. The original seal had an outside diameter of 3.066", and the replacement had an outside diameter of 3.130".

3.125
±.0015 DIA

Therefore, to replace the seal it is necessary that the pinion casting assembly be disassembled and the casting re-bored to $3.125" \pm .0015"$.

The pinion casting was originally machined by gripping the casting at the small end in a three-jaw chuck. All the turned faces on the casting were finished from that one setup except for the facing off of the small end, and that was done after the rest of the machining was completed by reversing the casting in the chuck and gripping it on the large diameter locating shoulder. To re-bore the casting to the new larger diameter, grip the casting in a three-jaw chuck on the large diameter as if you were going to face off the small end. Check the original seal diameter with a dial indicator to be sure that the bore is running true before re-boring to $3.125" \pm .0015"$.

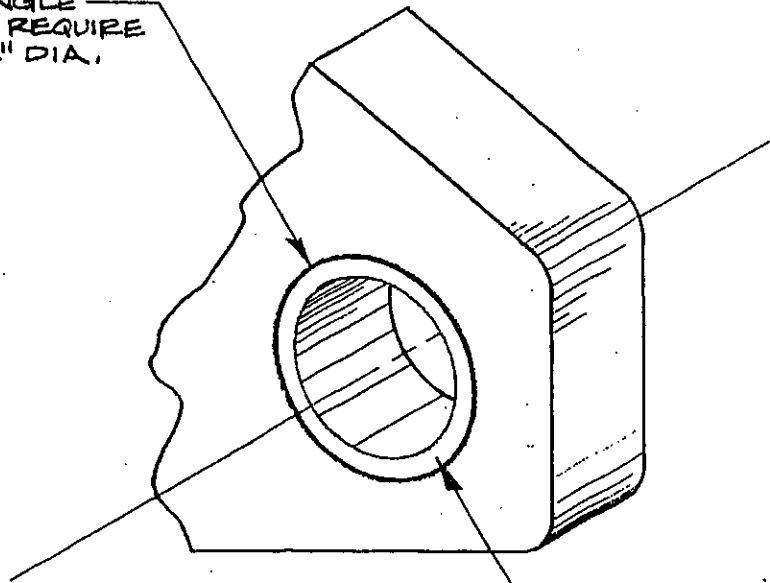
TYPICAL MOUNTING DETAIL SINGLE TAB BUSHING

BUSHING IN PLACE - SILVER SOLDER - BOTH SIDES OF TAB

1 LINE REAM ALL SINGLE TAB HOLES THAT REQUIRE BUSHINGS TO $1\frac{1}{4}$ " DIA.

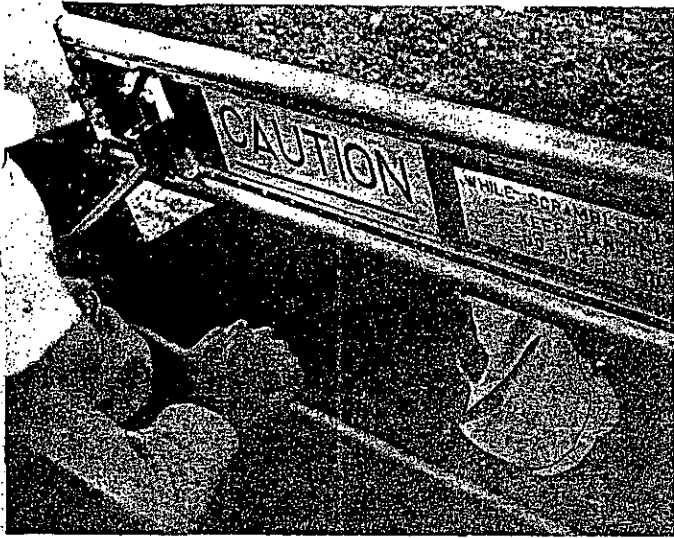
Picture No. 1

LAP BAR FOR SCRAMBLER SEAT

The lap bars have been designed to be installed on aluminum handlebars which were first furnished on 1959 Model Scrambler Serial No. 102. While they can be added to all earlier Scramblers with steel handlebars, it is recommended that the owner change to aluminum handlebars if he still has steel bars. The aluminum handlebars have given trouble-free service from the first time they were used.

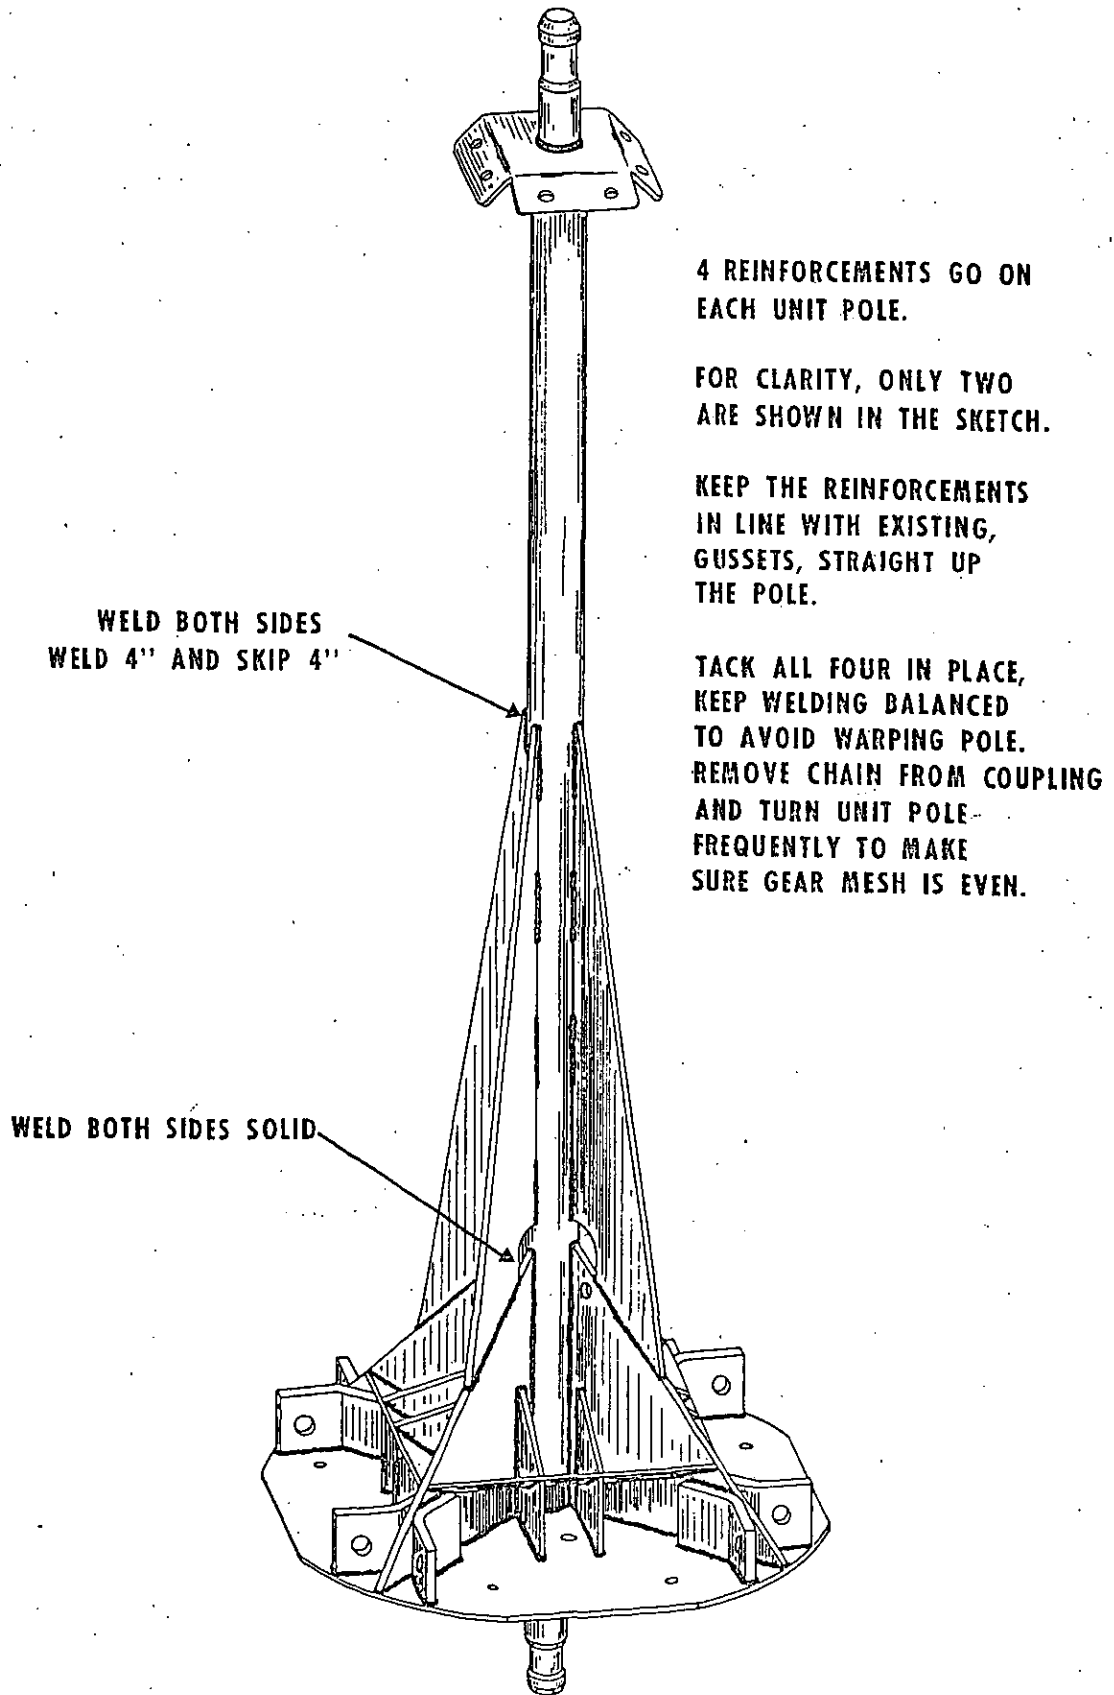
UNIT POLE MODIFICATION

In limited instances it has been reported to us that a slight crack, and even a complete break, has occurred in one or more of the three Unit Poles of a Scrambler ride. When this happens it can be a severe hazard to any passengers who may be riding at the time.

In all cases known to us the crack or break has occurred immediately above the top of the four gusset plates of the Unit Pole. Due to the seriousness and similarity of this problem, we turned the matter over to an outside firm of consulting engineers for critical study and solution. Their investigation revealed that this failure is caused by operation of the ride at speeds in excess of that which is recommended by Eli Bridge Company.

This finding is further supported by the fact that, to date, the failure has occurred only on Scrambler rides that have been powered by gasoline motor. It seems operators have the ability to bypass factory-set speed limitation on gasoline motors and "goose" the ride to excess speeds, but have difficulty doing this when the ride is equipped with electric motor power. But there is no way to guarantee that this problem will not occur on electric motor powered Scrambler rides in the future.

To avoid this problem in the future, the consulting engineers have made two recommendations. First, DO NOT allow your operator to "goose" the ride to speeds in excess of those recommended by the factory (the centerpole of the ride should not turn more than 11 rpm when powered with gasoline motor, or, 11.4 rpm when powered with electric motor). Second, they have strongly recommended that all Scrambler rides presently in operation be equipped with additional gusset plates, as shown on the attached drawing. These extensions to existing gusset plates are designed to give the Unit Poles proper strength and safety - even though a crack may have already begun to form immediately above the original gussets.

It has been plainly stated that this failure is caused by improper operation, not by a design failure. However, we do recommend and strongly encourage that you immediately add these extension gusset plates to your Scrambler ride - BEFORE you begin your 1968 season's operation. These plates can easily be installed in your own winterquarters, or by a local machine/welding shop.

4 REINFORCEMENTS GO ON EACH UNIT POLE.

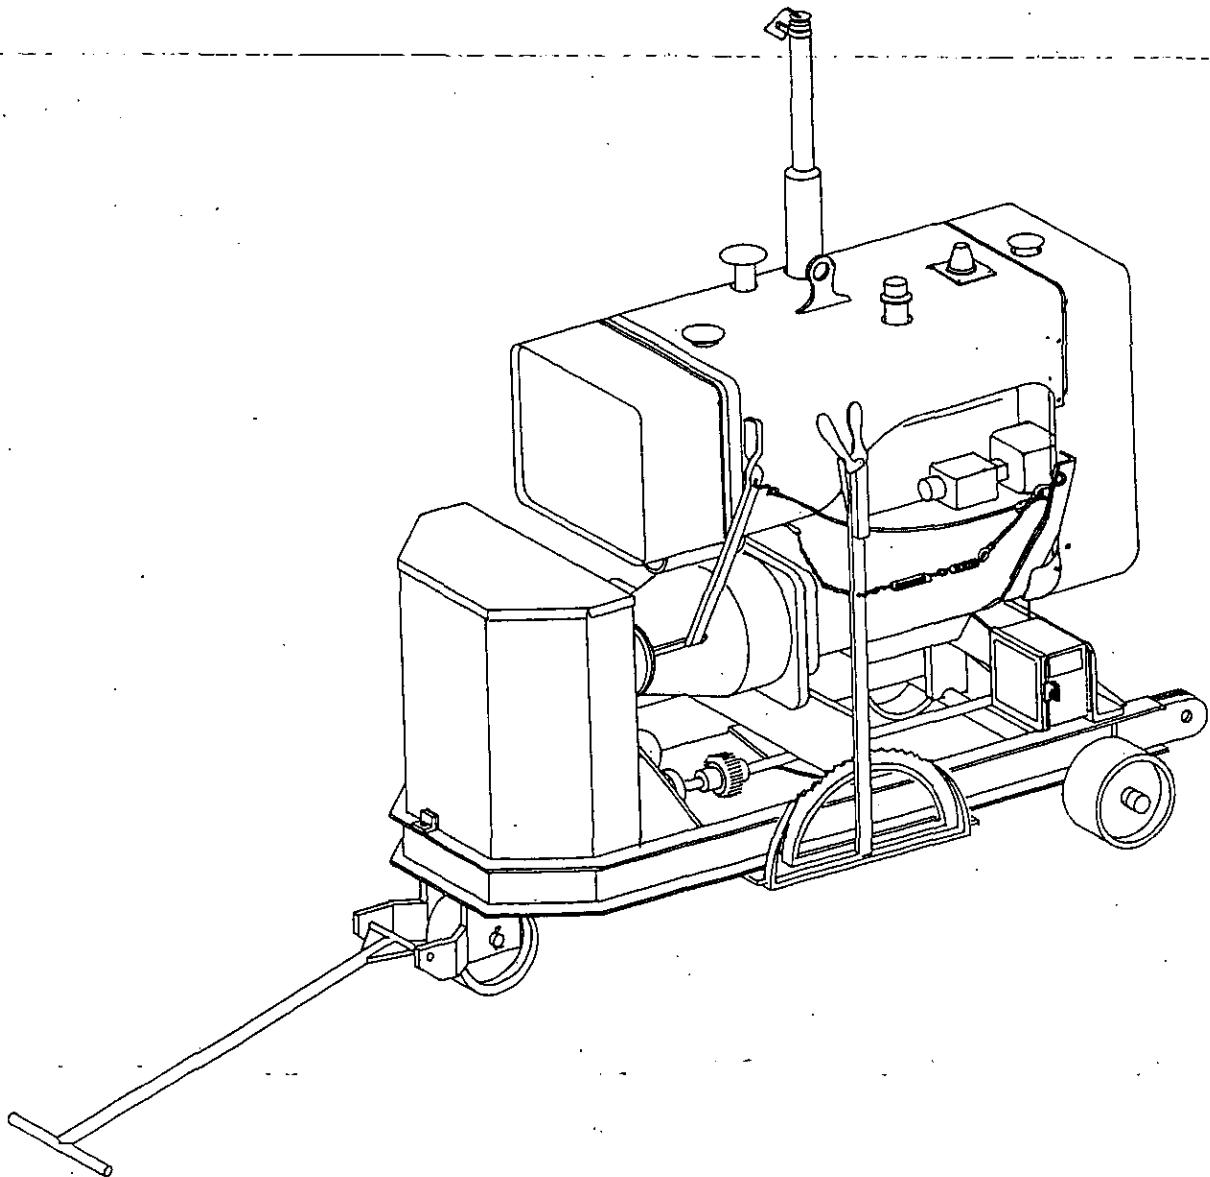
FIGURE NINE

OVERSPEED SWITCH MOUNTED ON ALLIS-CHALMERS POWER UNIT

The Scrambler Overspeed Switch is an electronic sensor that mounts on the Scrambler Power Unit. It receives speed information directly off the ignition system. When the engine is run above the recommended speed, the Overspeed Switch momentarily shuts down the engine and lights the warning lamp. The switch has been designed to fit all Allis-Chalmers Generator Equipped Power Units that retain their original equipment. When properly installed and maintained, the Overspeed Switch will insure operation of your Scrambler within recommended RPM. Any attempt to overspeed the Scrambler beyond its rated maximum centerpole speed of 11 RPM will cause the warning light to go on and the engine to slow to the recommended speed.
