# AMUSEMENT RIDE SAFETY ALERT!

### EYERLY AIRCRAFT "OCTOPUS, SPIDER & MONSTER RIDES" August 16, 1994

EYERLY AIRCRAFT  
"OCTOPUS, SPIDER & MONSTER RIDES"  
September 13, 1994

MANUFACTURERS OF AMUSEMENT RIDES

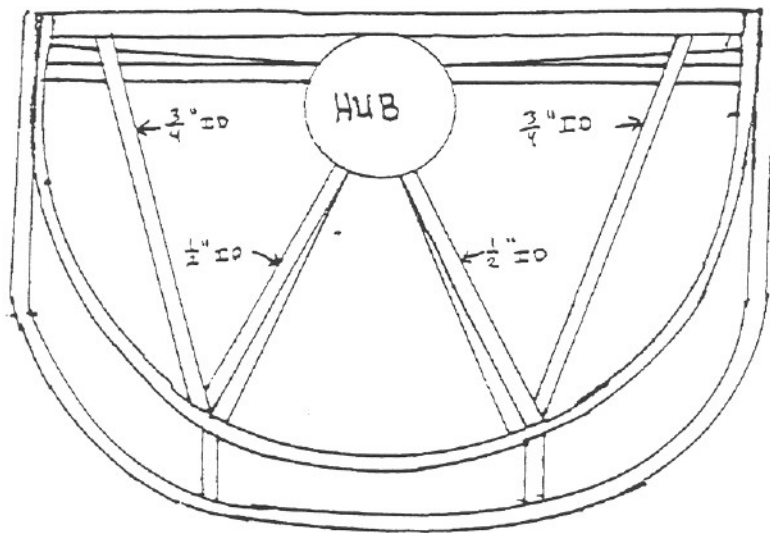
SCHEMATIC BASED ON EYERLY AIRCRAFT COMPANY  
DRAWING O-913 "OCTO & SPIDER CAR BACK SECTION"

1. The critical areas are identified as the four tubes under the car seat that are covered by fiberglass. The tubes are shown in the attached schematic based on the Eyerly Aircraft Company drawing O-913 entitled "Octo & Spider Car Back Section."

1. THE  $\frac{3}{4}"$  ID AND  $\frac{1}{2}"$  ID TUBES ARE COVERED BY FIBERGLASS ON THE UNDERSIDE OF THE CAR BACK SECTION
2. NUMEROUS FILLET WELDS JOIN THE TUBES

2. Inspection by radiography is recommended if ride owners do not want to remove the fiberglass covering the car's tubing. It is recommended to have the radiography done by a class III technician. NOTE: Ultrasonic inspection is not recommended as tube roughness may make an accurate interpretation extremely difficult.

3. A visual inspection of the tubing may be done, but the fiberglass covering the tubing would need to be removed first for an adequate inspection.
4. Fiberglass removal techniques must be obtained from Oregon Rides prior to removing any fiberglass.

5. If excessively corroded or cracked tubing is found during the inspection, those tubes or the car should be replaced.
6. It is our understanding that a retrofit/fiberglass repair kit is being developed by Oregon Rides, Inc. CPSC will be evaluating the adequacy of this repair kit.

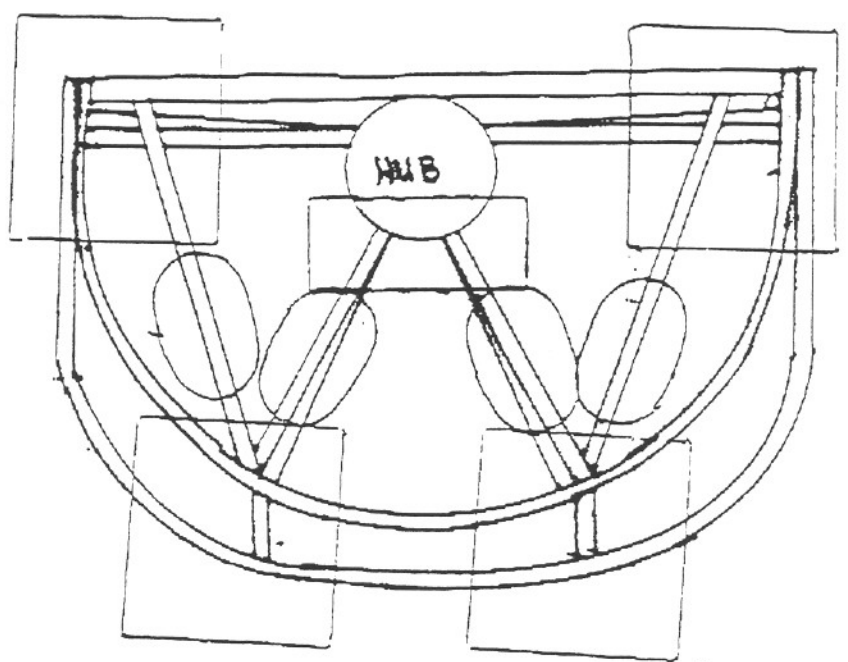
Attachment 11 - Examination Areas for Destructive/Non-Destructive and  
Visual/ Magnetic Particle Techniques

- Areas to be examined by visual or magnetic particle  
inspection techniques

- Areas to be examined by destructive or non-destructive  
radiographic techniques

Destructive examination of the tubing is intended to be only destructive to the fiberglass matting that bonds the tubing to the underside of the fiberglass seat. It is destructive because the examination entails the incremental removal of 1-inch wide strips of fiberglass matting with a blade. The tubing and the fiberglass seat material is not to be cut. The destructive examination should be accomplished by:

- (1) - The non-destructive examination involves radiography of the underside tubing through the fiberglass seat and fiberglass matting covering the underside tubing. The examination can be done by a Level II or III Inspector qualified in radiography.

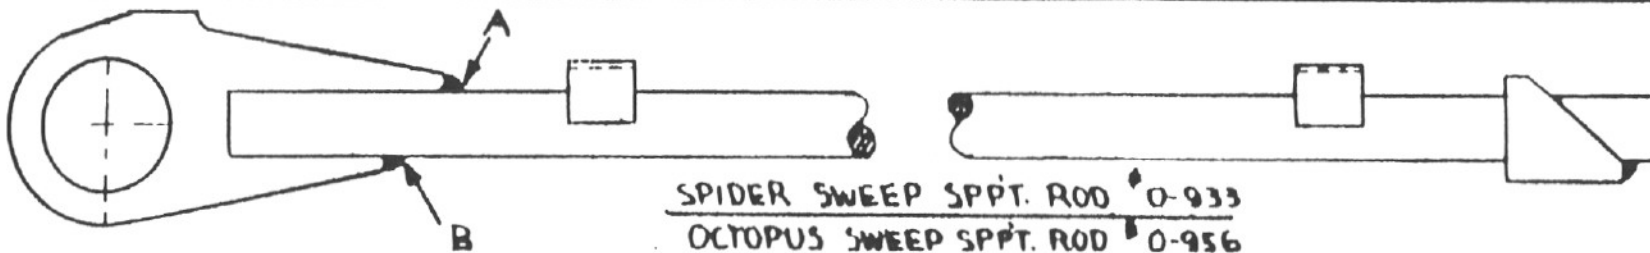
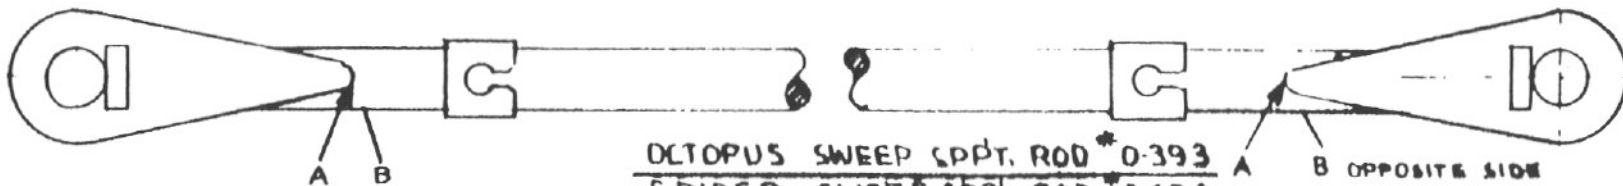
Octo./ Spider Sweep Support Rod Bulletin.

SPIDER SWEEP SPPT. ROD \*0-933  
 OCTOPUS SWEEP SPPT. ROD \*0-956

OCTOPUS SWEEP SPPT. ROD \*0-393  
 SPIDER SWEEP SPPT. ROD \*0-624  
 A B OPPOSITE SIDE

OPERATION OF THE SPIDER OR OCTOPUS AMUSEMENT RIDE WITH DEFECTIVE SWEEP SUPPORT RODS, (CRACKED, BENT OR OTHERWISE DEFORMED) WILL RESULT IN FAILURE OF THE ROD AND WILL PERMIT THE SWEEP TO FALL WITHOUT WARNING DURING OPERATION. ALL GREASE, GRIME AND DIRT SHOULD BE REMOVED FROM AREAS "A" AND "B" SHOWN, AND N.D.T. TESTED, USING MAGNETIC PARTICAL PROCESS. ALL CRACKED OR OTHERWISE DEFECTIVE RODS MUST BE REPLACED BEFORE OPERATION. FIELD REPAIRS ARE NOT RECOMMENDED. IT IS RECOMMENDED THAT A VISUAL CHECK BE MADE EACH SET-UP OR EVERY SEVEN DAYS, SPECIFICALLY IN AREA SHOWN.

ALL RODS SHOULD BE CHECKED EVERY 200 HOURS OF OPERATION USING THE ABOVE MAGNETIC PARTICAL METHOD. ANY DEFECTIVE ROD FOUND SHOULD BE REPLACED WITH A NEW FACTORY ROD ONLY.

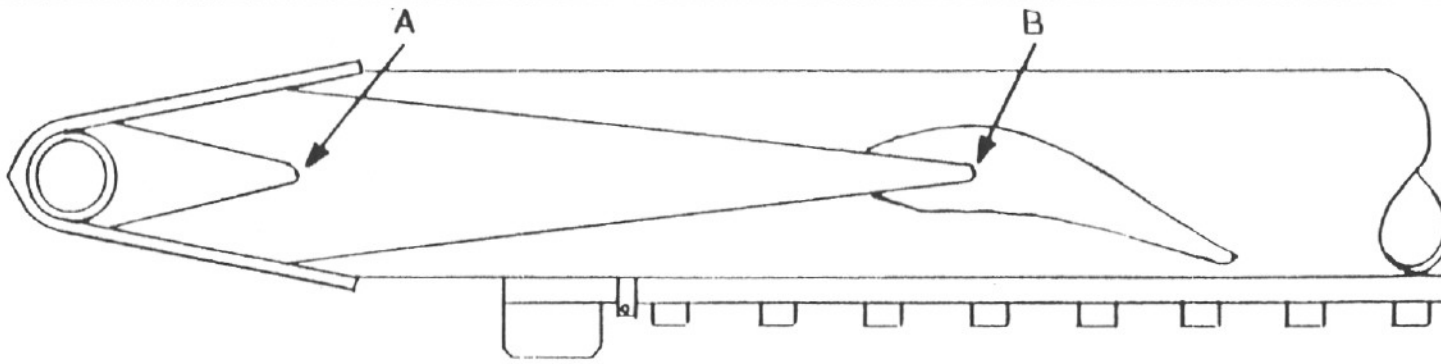
### Spider Sweep #0-619 Bulletin

WE HAVE BEEN ADVISED OF SOME HAIRLINE CRACKS THAT HAVE DEVELOPED IN THE WELDMENTS AT POINTS 'A' AND 'B' (BOTH SIDES) OF THE SPIDER SWEEP, PART 0-619. IT IS IMPERATIVE THESE POINTS BE THOROUGHLY INSPECTED IMMEDIATELY UPON RECEIPT OF THIS BULLETIN. IT IS RECOMMENDED THE INSPECTION BE MADE BY QUALIFIED AND APPROVED TESTING PERSONNEL, EMPLOYING MAGNETIC PARTICLE, X-RAY, OR RADIOGRAPH PROCEDURES. IF THE INSPECTION REVEALS ANY IRREGULARITIES, OPERATION OF THE DEVICE SHOULD BE DISCONTINUED IMMEDIATELY. REPAIR IS TO BE DONE BY A QUALIFIED FACILITY KNOWLEDGEABLE IN APPROVED METHODS OF A.W.S. - A.S.M.E. STANDARDS.

IT IS RECOMMENDED THAT A VISUAL INSPECTION BE MADE AT EACH SET-UP OR EVERY SEVEN DAYS OF OPERATION, SPECIFICALLY IN AREAS NOTED.

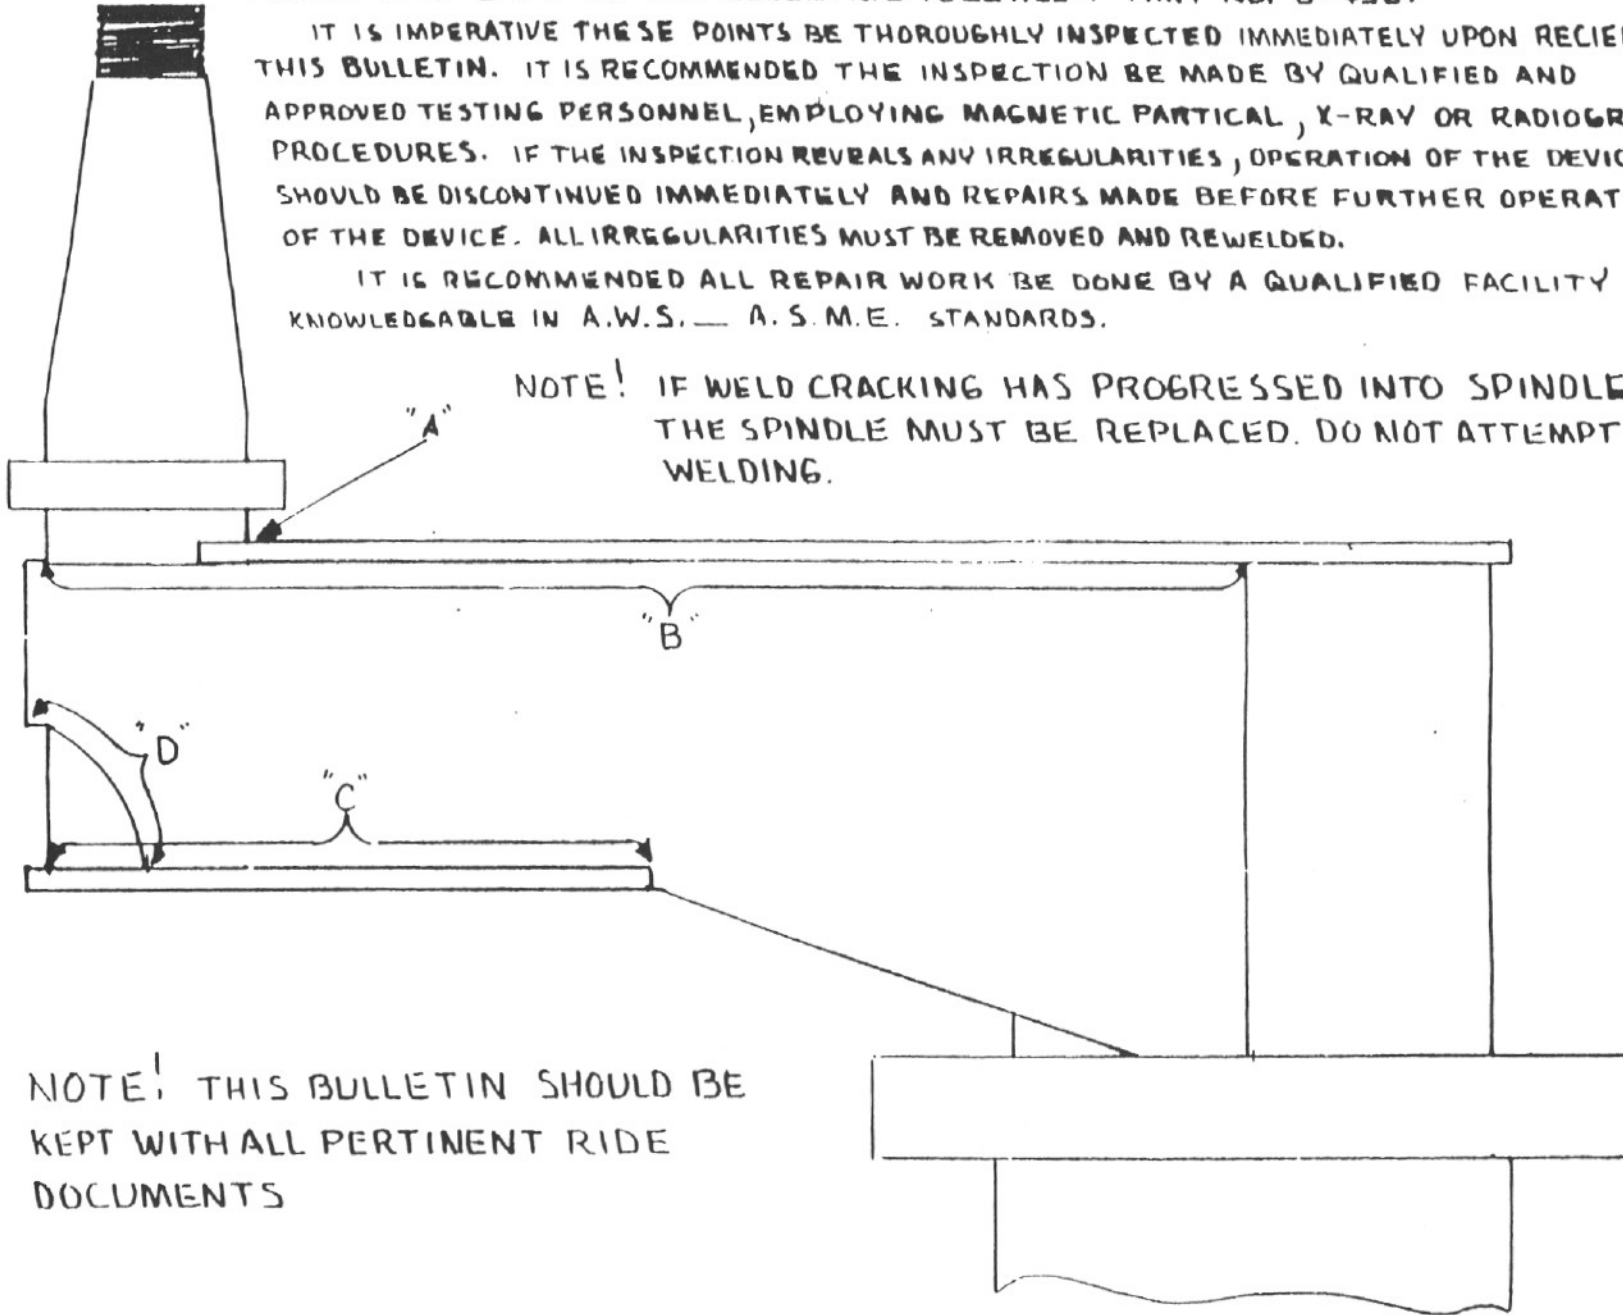
ECCENTRIC CRANK #O 436 BULLETIN

WE HAVE BEEN ADVISED OF SOME HAIRLINE CRACKS THAT HAVE DEVELOPED IN THE WELDMENTS AT POINTS "A B C & D" OF THE ECCENTRIC TUBE ASS'Y PART NO. O-436.

NOTE! IF WELD CRACKING HAS PROGRESSED INTO SPINDLE, THE SPINDLE MUST BE REPLACED. DO NOT ATTEMPT WELDING.

IT IS IMPERATIVE THESE POINTS BE THOROUGHLY INSPECTED IMMEDIATELY UPON RECEIPT OF THIS BULLETIN. IT IS RECOMMENDED THE INSPECTION BE MADE BY QUALIFIED AND APPROVED TESTING PERSONNEL, EMPLOYING MAGNETIC PARTICAL, X-RAY OR RADIOGRAPH PROCEDURES. IF THE INSPECTION REVEALS ANY IRREGULARITIES, OPERATION OF THE DEVICE SHOULD BE DISCONTINUED IMMEDIATELY AND REPAIRS MADE BEFORE FURTHER OPERATION OF THE DEVICE. ALL IRREGULARITIES MUST BE REMOVED AND REWELDED.

IT IS RECOMMENDED ALL REPAIR WORK BE DONE BY A QUALIFIED FACILITY KNOWLEDGEABLE IN A.W.S. — A.S.M.E. STANDARDS.

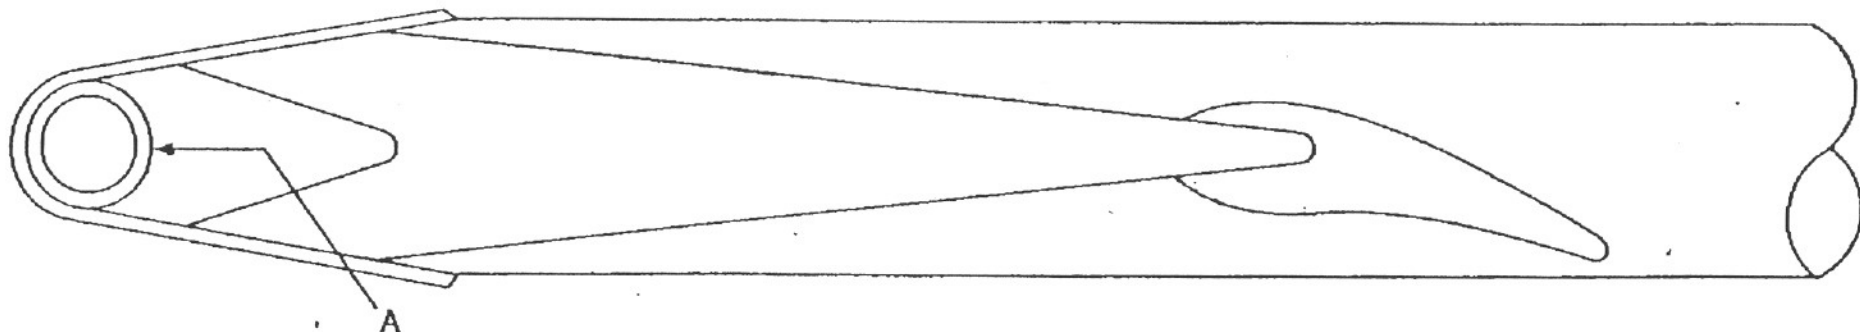
SPIDER SWEEP 0619				JV INDUSTRIES Inc.  BULLETIN NO. <b>8-88-1</b>
Dr. By	JPM			
Date	8-88	S.D.D. By		
		S.D.S.

WE HAVE LEARNED OF A SWEEP FAILURE ON A SPIDER DEVICE  
 MANUFACTURED BY EYERLY AIRCRAFT COMPANY.  
 THE FAILURE OCCURED AT THE HINGE PIN WELDMENT. Note: Fig. "A"  
 AS A PUBLIC SERVICE TO THE INDUSTRY, JVI IS ISSUING BULLETIN NO.8-88-1,  
 RELATIVE TO THE EYERLY AIRCRAFT CO. 0-619 SWEEP WITH THE 16" HINGE PIN.  
 IT IS ADVISED THAT YOU IMMEDIATELY INSPECT THE SWEEPS  
 FOR FAILURE IN THIS AREA, (BOTH SIDES). IF CRACKING IS FOUND, NOTE LOCATION  
 AND LENGTH, AND ADVISE JV INDUSTRIES (503) 399-0817 IMMEDIATELY

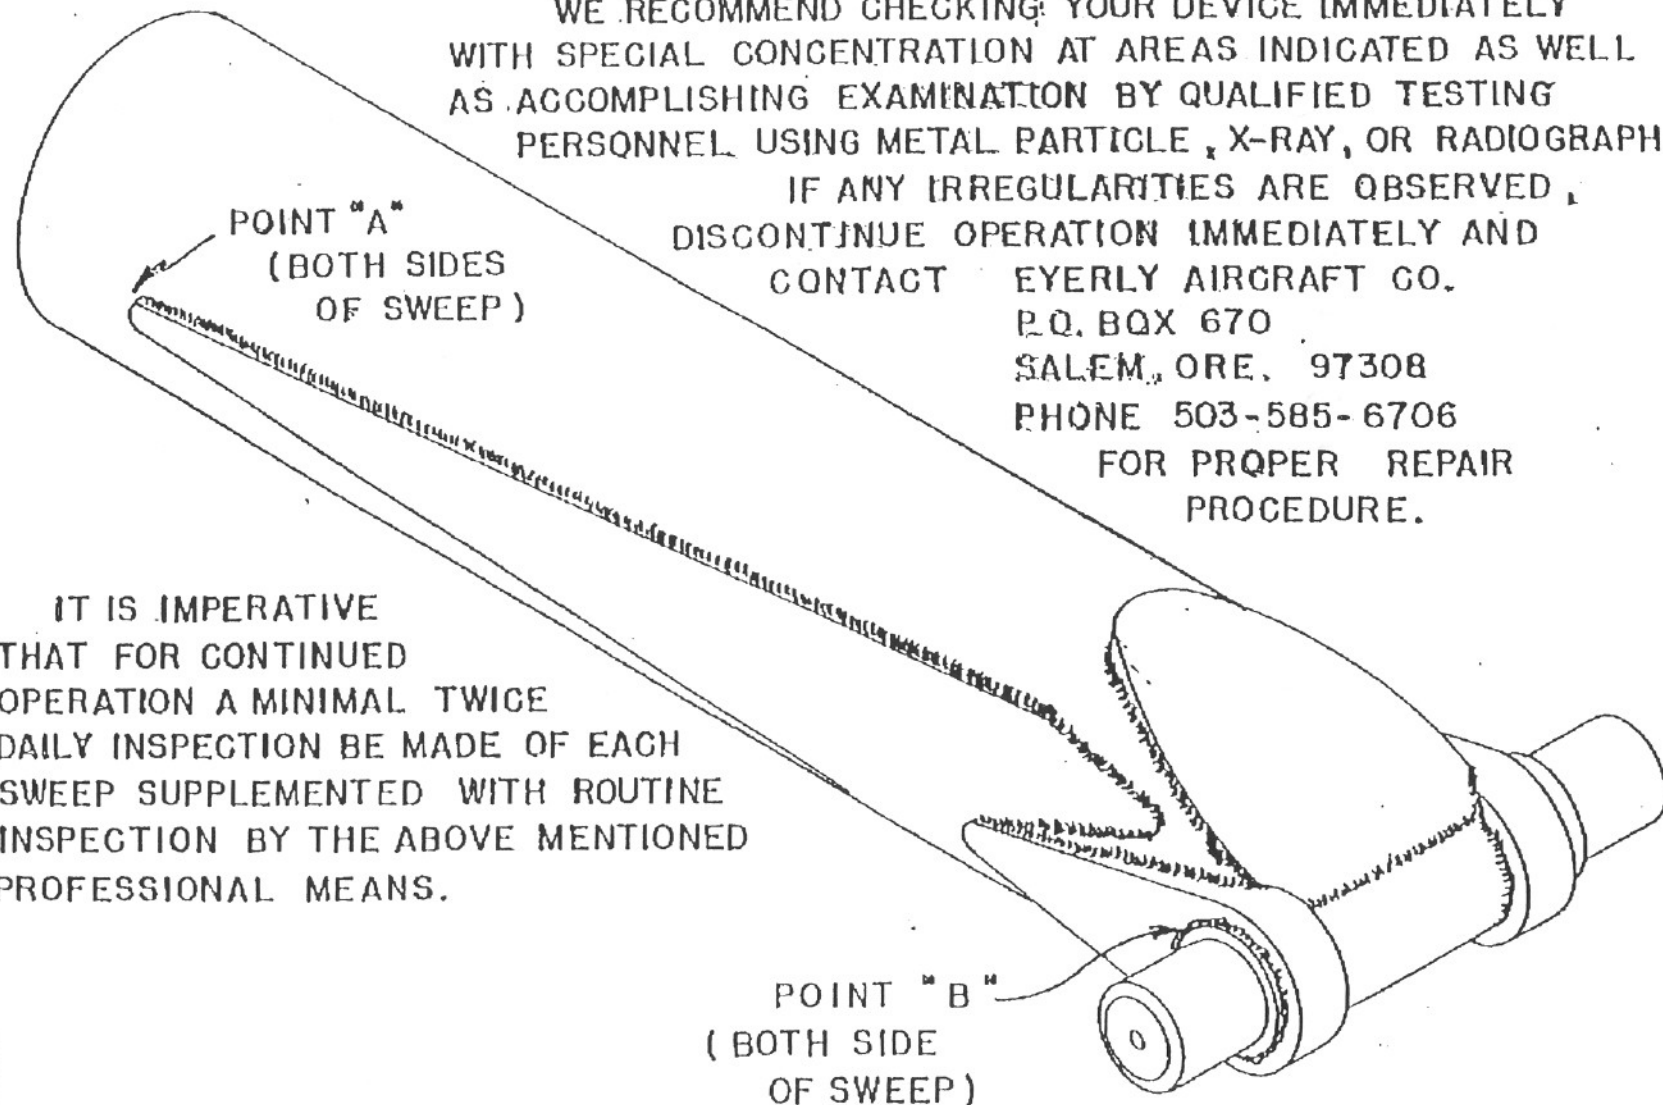
BULLETIN O-39-74

WE HAVE BEEN ADVISED OF A CURVED SWEEP FAILURE WITH INDICATION OF ORIGINAL BREAKING AT POINT "A" AS SHOWN BELOW. ALSO, SOME HAIRLINE CRACKS HAVE BEEN REPORTED IN THE AREA OF ATTACHMENT OF THE SWEEP SPINDLE TO THE REINFORCING TEARDROP GUSSETS DESIGNATED AS POINT "B" BELOW.

WE RECOMMEND CHECKING YOUR DEVICE IMMEDIATELY WITH SPECIAL CONCENTRATION AT AREAS INDICATED AS WELL AS ACCOMPLISHING EXAMINATION BY QUALIFIED TESTING PERSONNEL USING METAL PARTICLE, X-RAY, OR RADIOGRAPH.

IF ANY IRREGULARITIES ARE OBSERVED, DISCONTINUE OPERATION IMMEDIATELY AND CONTACT EYERLY AIRCRAFT CO.  
P.O. BOX 670  
SALEM, ORE. 97308  
PHONE 503-585-6706  
FOR PROPER REPAIR PROCEDURE.

IT IS IMPERATIVE THAT FOR CONTINUED OPERATION A MINIMAL TWICE DAILY INSPECTION BE MADE OF EACH SWEEP SUPPLEMENTED WITH ROUTINE INSPECTION BY THE ABOVE MENTIONED PROFESSIONAL MEANS.
