Bulletin #	SR - 5H - 903
Release Date	March 26, 1999
Effective Date	March 26, 1999
Supersedes	
Completion Date	June 30, 1999
Page	1 of 2

# SAFETY ALERT

Ride Manufacturer	Frank Hrubetz & Co., Inc. Killinski Mfg. Company Man-Co Mfg., Inc.	Affected Production Dates	1973 until 1991
Ride Name	Hurricane	Affected Serial #'s	All
Model Number	All

Product: Hurricane

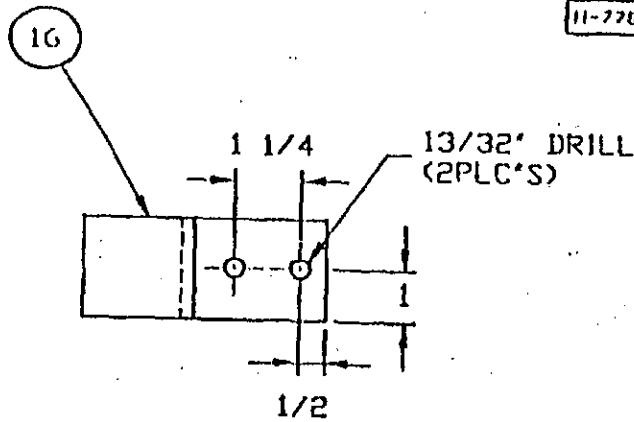
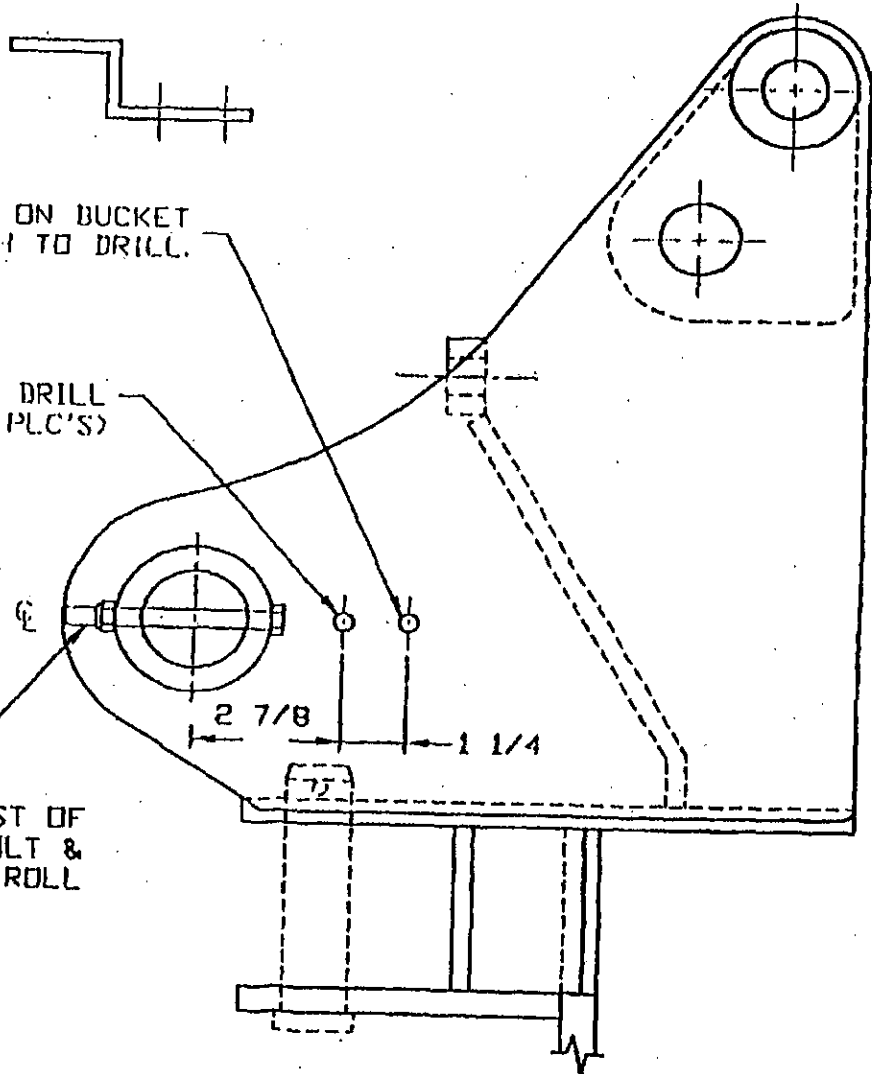
Page 2 shows the pin retainers that must be bolted to both sides of the car buckets that are attached to the end of the sweeps on all Hurricanes. With the pin retainers in place the shaft will be retained in position in the sweep even without the proper functioning of the pin locating bolt. Using an electric drill, drill one hole in both sides of the sweep bucket. The location of these holes is shown in Page 2 at 2 7/8". Bolt the pin retainer on with one bolt so that the tab of the retainer covers the end of the bucket pin. Now use the retainer as a jig to drill through for the lineup of the second 3/8 hole. Bolt the retainer in place using grade 8 bolts, grade 8 nyloc nuts and flat washers as called out in the material list on page 2. Insert the bolt from the inside to the outside of the bucket. Place the nyloc nut on the outside face of the bucket so it can be easily inspected. Torque to 40 ft. lbs. The flat washers are located under the bolt head and under the Nyloc nut.

POSITION ITEM 16 ON BUCKET  
& CENTER PUNCH TO DRILL.

13/32 DRILL  
(2 PLC'S)

ITEM #20

ITEM #20 CONSIST OF  
3/8 GRADE 8 BOLT &  
NYLOCK NUT OR ROLL  
PIN.

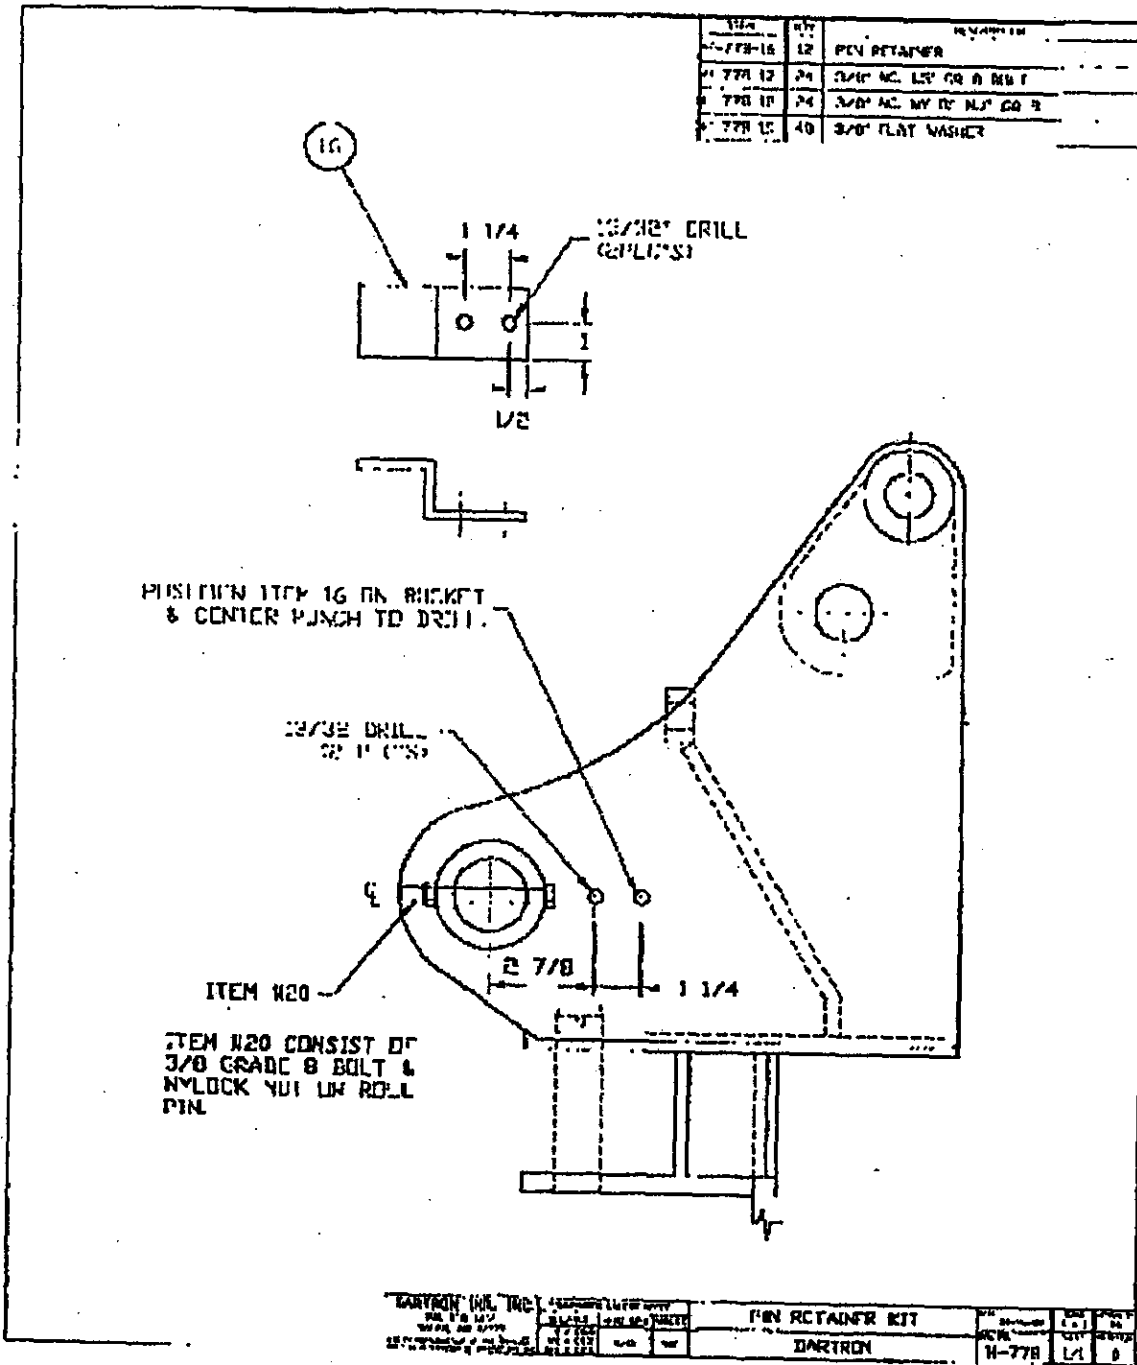
Attachment I shows the pin retainers that must be bolted to both sides of the car buckets that are attached to the end of the sweeps on all Hurricanes. With the pin retainers in place the shaft will be retained in position in the sweep even without the proper functioning of the pin locating bolt. Using an electric drill, drill 1 hole in both sides of the sweep bucket. The location of these holes is shown in Attachment I at 2 7/8". Bolt the pin retainers on with one bolt so that the tab of the retainer covers the end of the bucket pin. Now use the retainer as a jig to drill through, for the lineup of the second 3/8 hole. Bolt the retainer in place using grade 8 bolts, grade 8 nyloc nuts and flat washers, as called out in the material list in Attachment I. Insert the bolt from the inside to the outside of the bucket. Place the nyloc nut on the outside face of the bucket so it can be easily inspected. Torque to 40 ft lbs. The flat washers are located under the bolt head and under the nyloc nut.

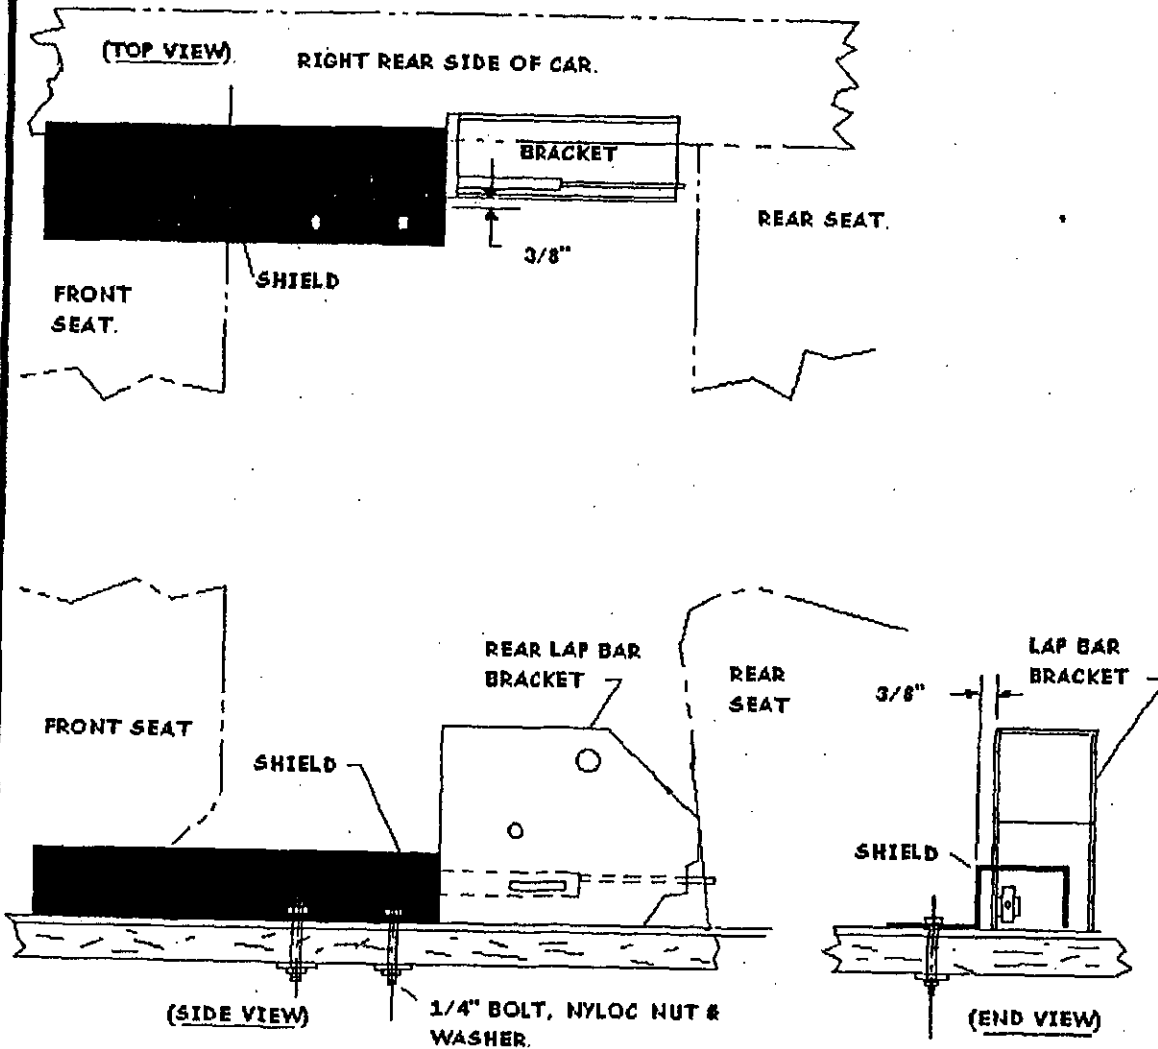
SAFETY ALERT  
BULLETIN # SR-SH-005  
PAGE 2 OF 2

**Reason For Release:** It may be possible for a passenger in the back seat to release one or both passenger restraints by using a foot to maneuver the restraint release linkage rod.

POSITION THE SHIELD SO THAT IT IS AGAINST THE REAR LAP BAR BRACKET AND 3/8" OUT FROM THE FACE OF THE BRACKET. (AS SHOWN ABOVE)

Using the holes in the shield flange as templates, drill 2 holes 17/64" dia. through the floor of the car. Install bolts, washers, and locking nuts as shown below. Tighten bolts to no more than 100 in lbs of torque. **CAUTION:** Do not over-tighten nuts. They should be snug and not dimple fiberglass. **(SEE ATTACHED DRAWINGS)**
