Venture Cobra rusted structure

Posted 22-Sep-2008 - Last updated 4-Feb-2011

Posted By: [Florida Department of Agriculture](#)

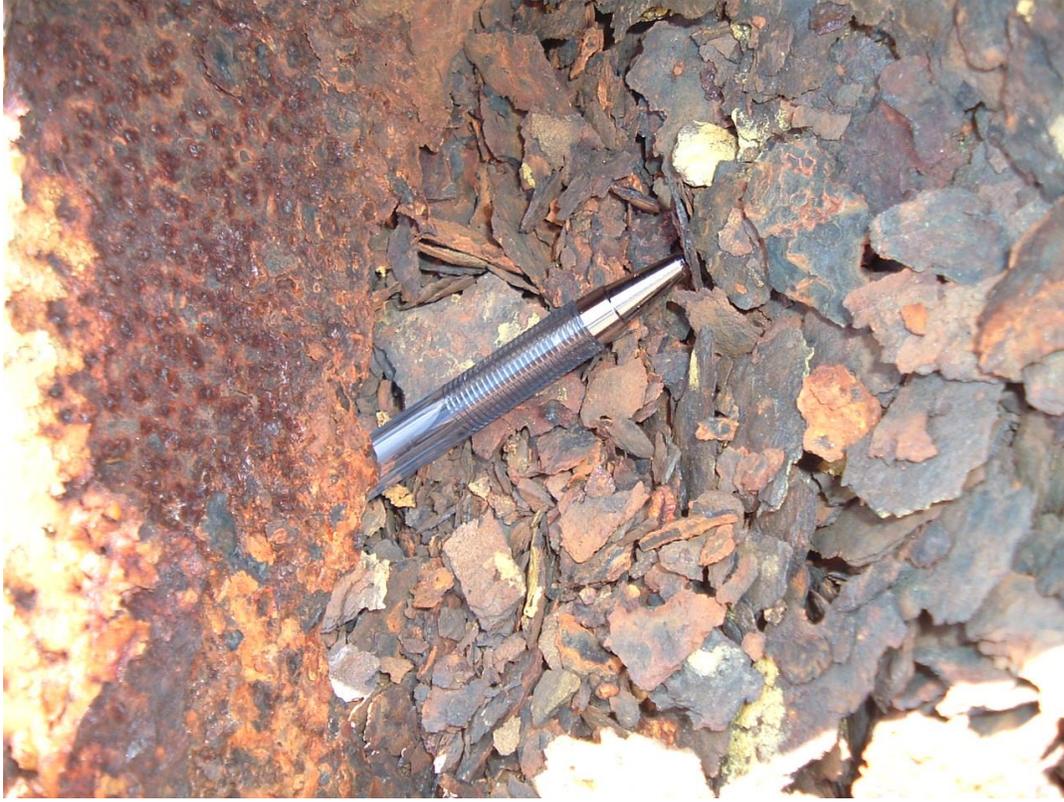
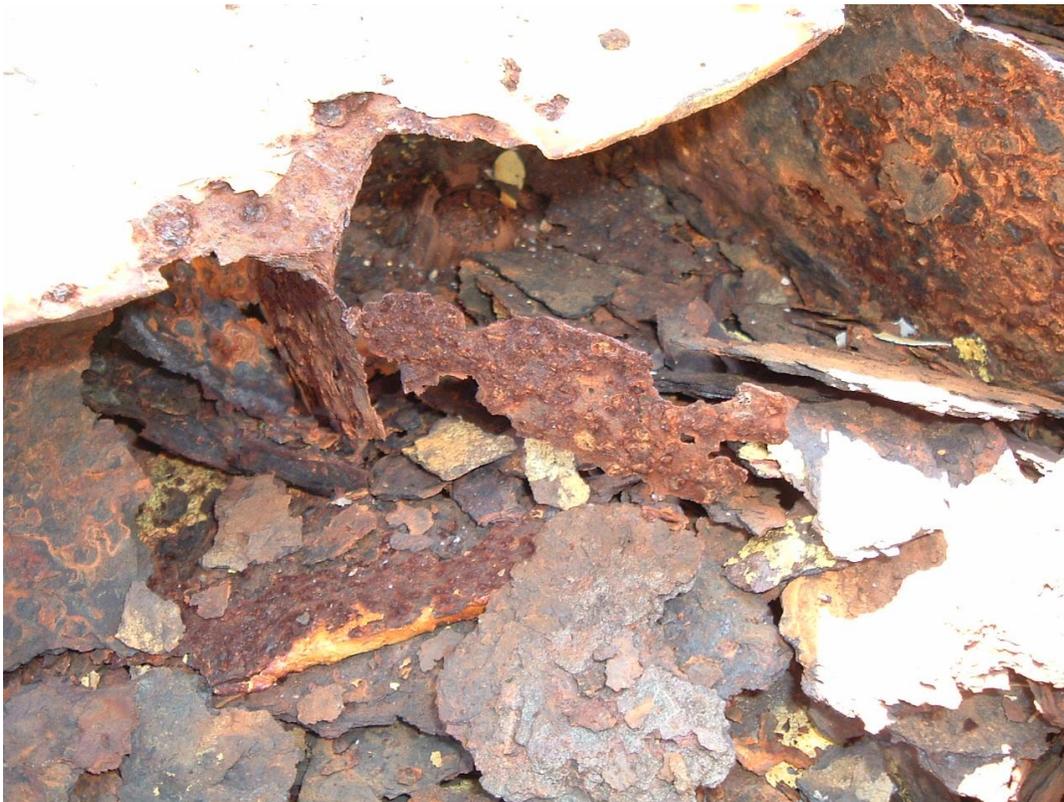
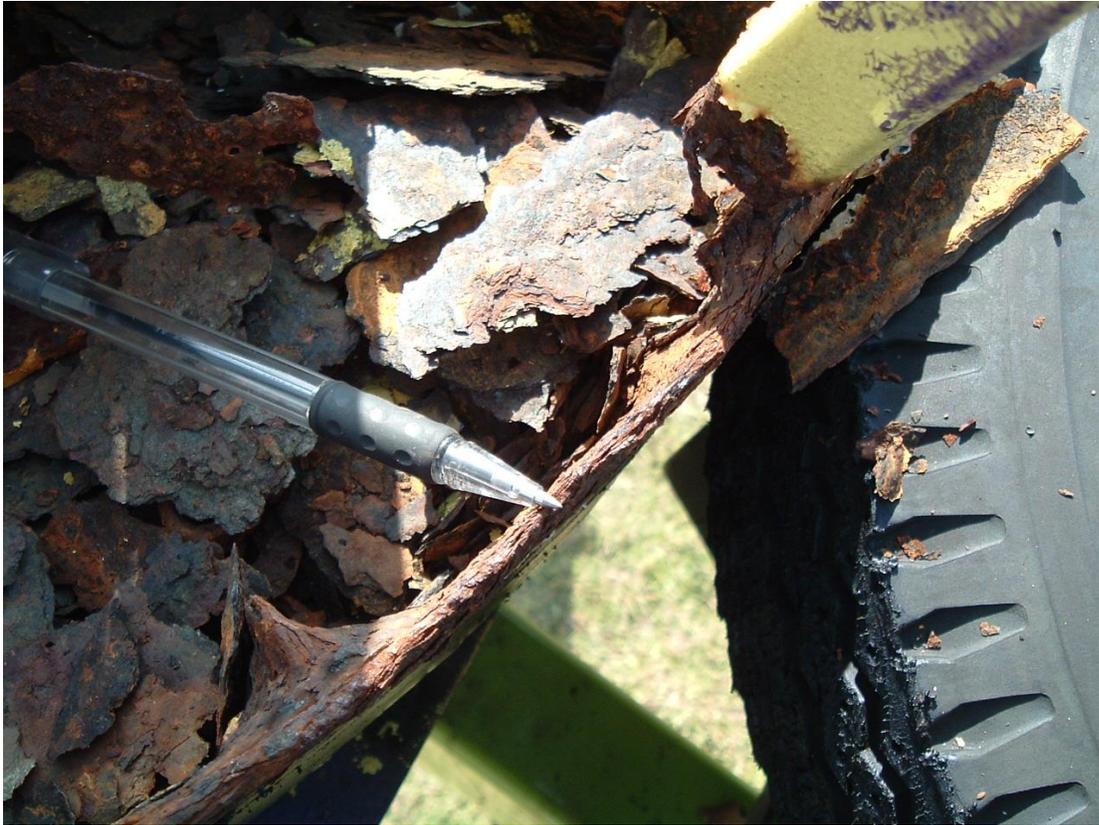
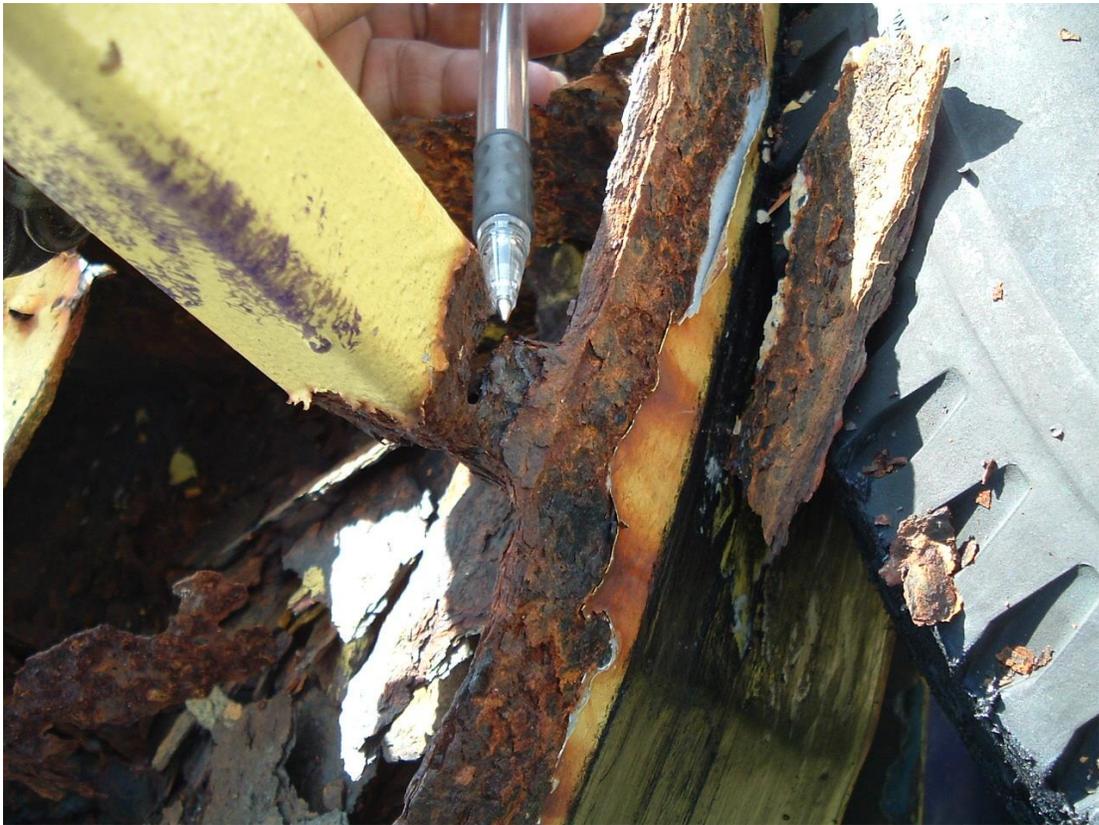
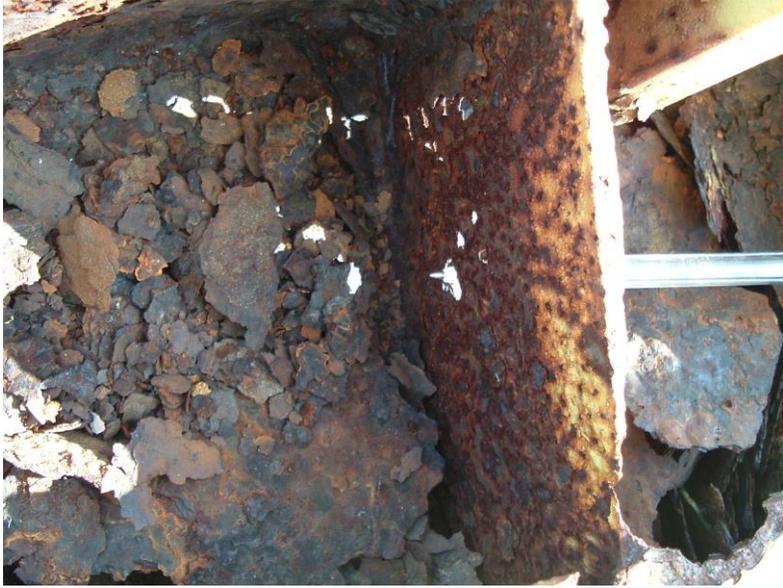
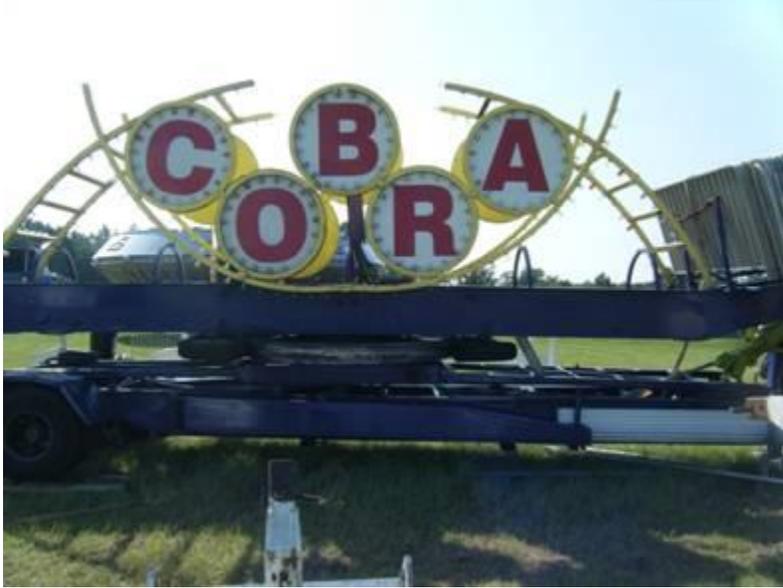
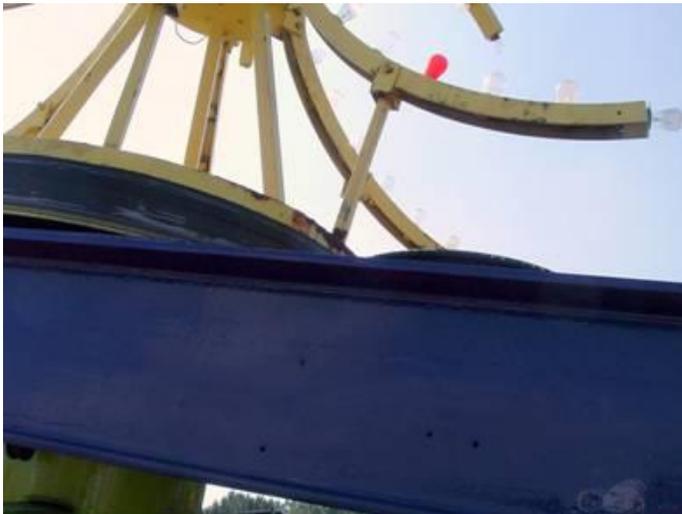
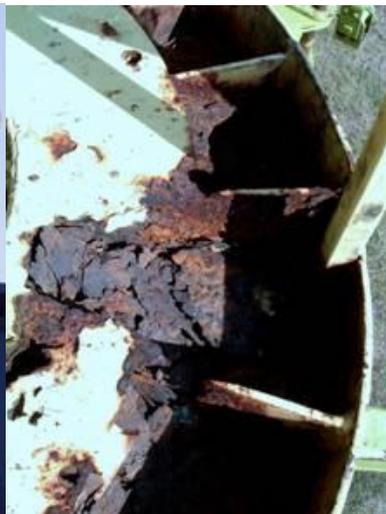
See attached pictures taken by one of our inspectors in Florida where they found rusted out structure components at both upper satellites on a "Cobra" ride manufactured by Venture Rides while inspecting at the Holmes County Fair in Florida. I contacted Mike Howard with High Lite corporation (bought out parts rights to Venture) who stated that he had another "Cobra" ride in their shop being repaired for the same problem.
