ATTENTION COBRA OWNERS.

SUBJECT: COBRA SEAT PINS

S A F E T Y B U L L E T I N

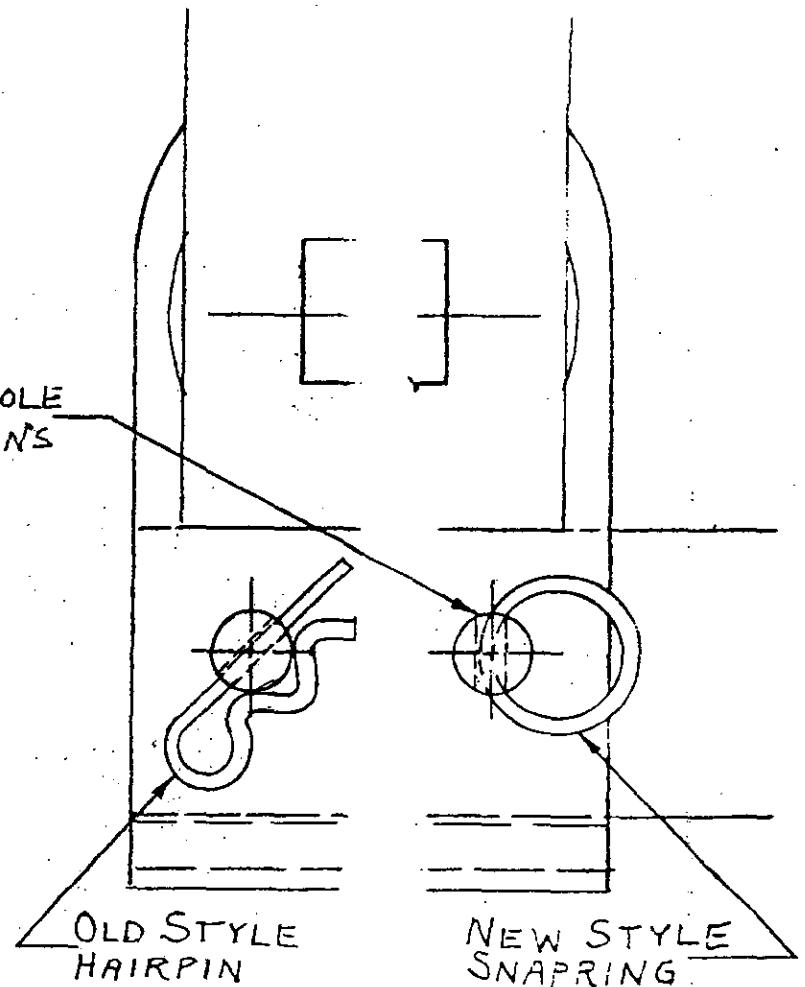
DRILL $\frac{5}{16}$ " HOLE
IN SEAT PINS

A CONDITION EXISTS WHERE IT IS POSSIBLE FOR A RIDE PASSENGER TO REMOVE THE HAIRPIN LOCKS IN THE SEAT PINS. THIS COULD CAUSE THE SEAT PINS TO COME OUT AND THE SEAT TO COME OFF.

TO PREVENT THIS WE RECOMMEND DRILLING A $\frac{5}{16}$ " HOLE IN THE SEAT PIN IN PLACE OF THE $\frac{3}{16}$ " HOLE AND USING A SNAPRING AS SHOWN ON THE RIGHT HAND SIDE OF THE ILLUSTRATION.

A $\frac{5}{16}$ " DRILL BIT AND 24 SNAPRINGS ARE FURNISHED BY VENTURE RIDE MFG., NO CHARGE.

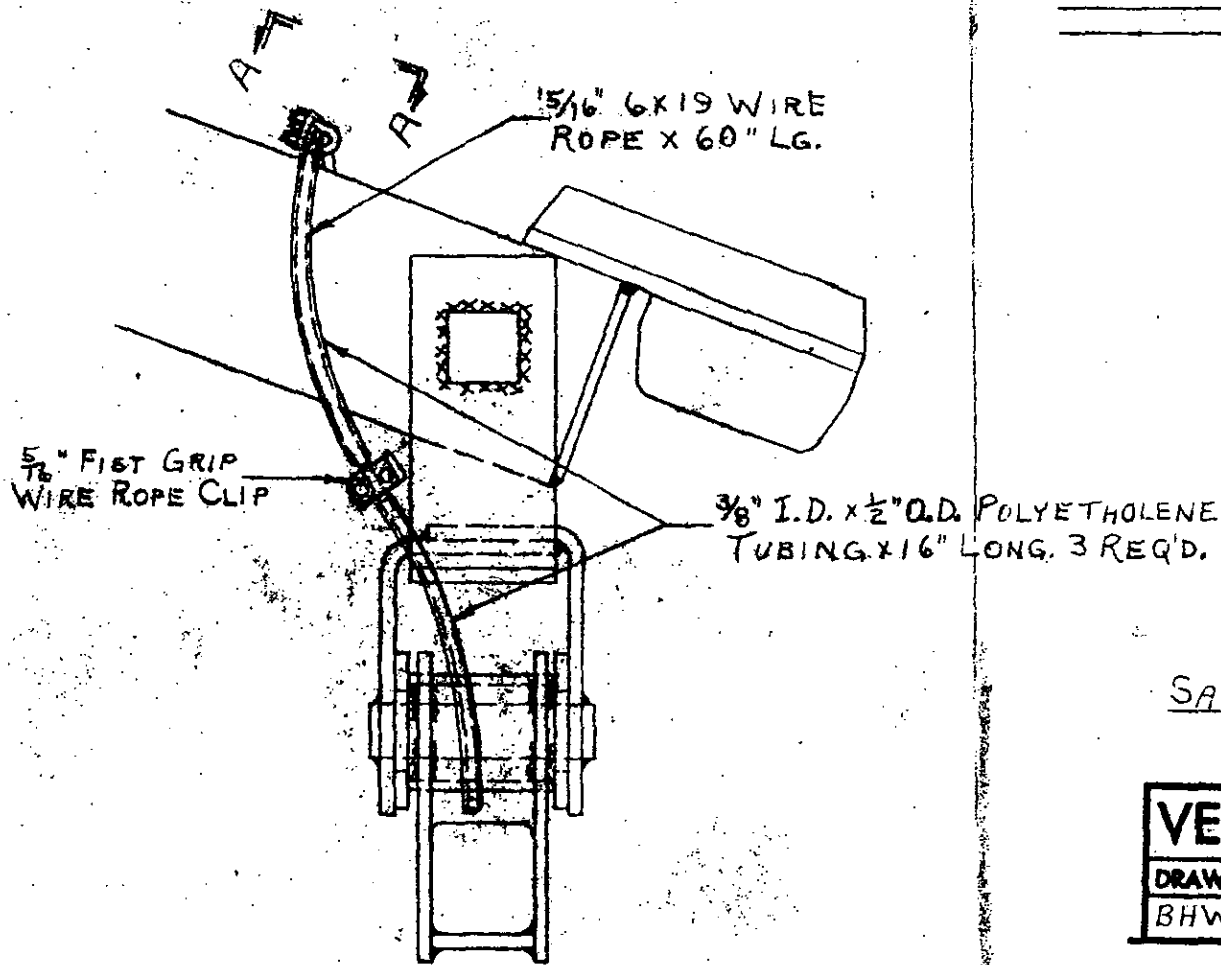
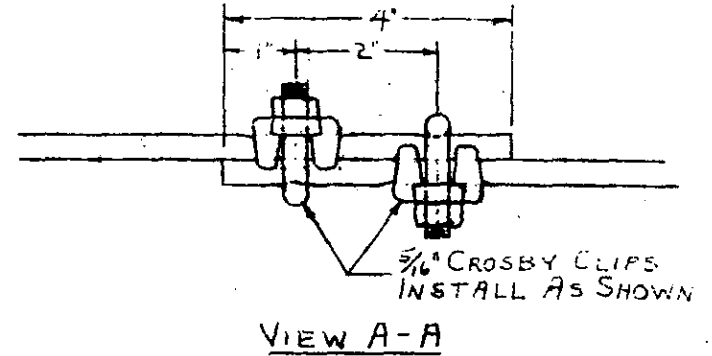
SAFETY CABLE INSTALLATION
FOR COBRA SEATS

Also, inspect the safety steel cables that keep the seat on the ride in case of a total seat hanger failure.

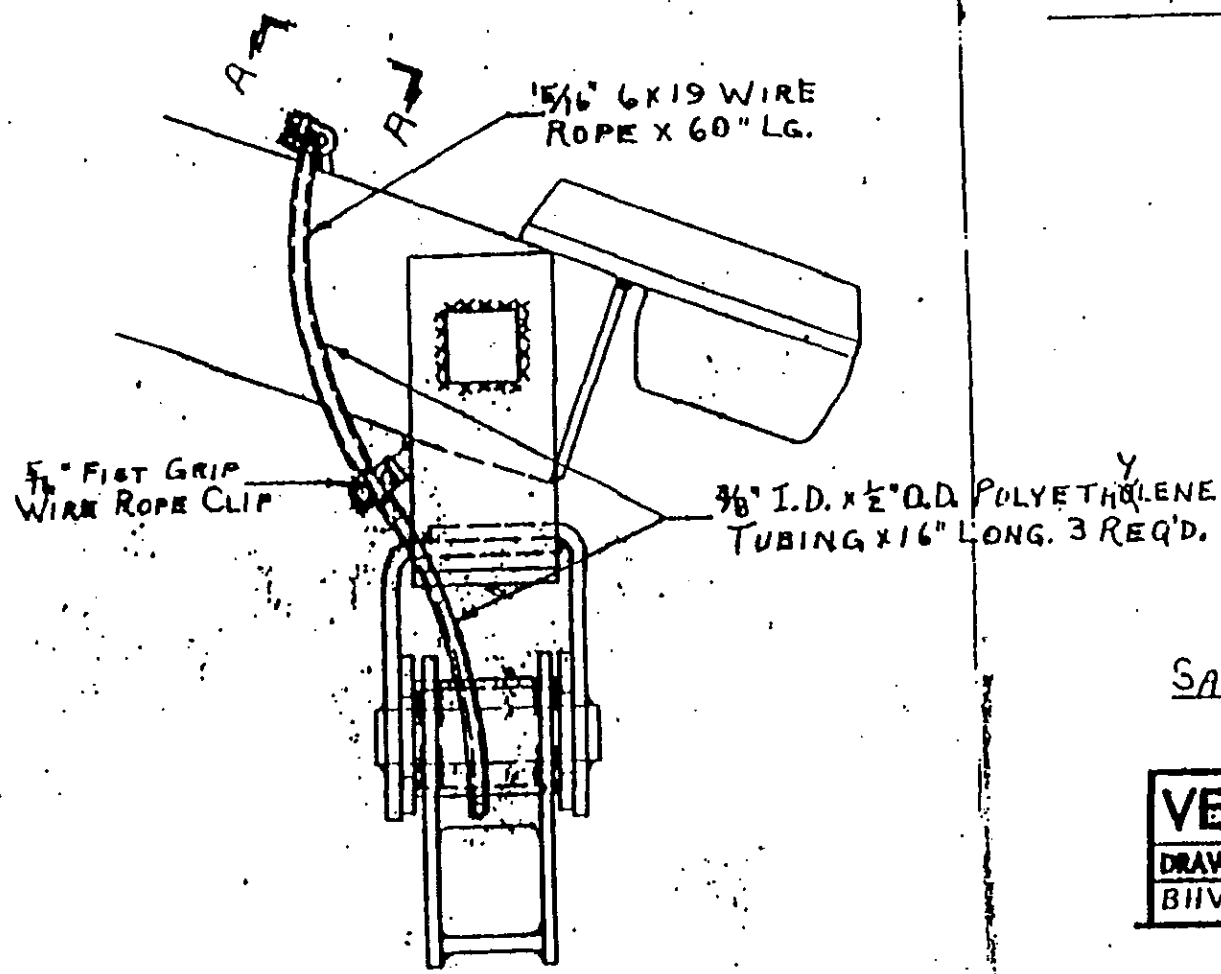
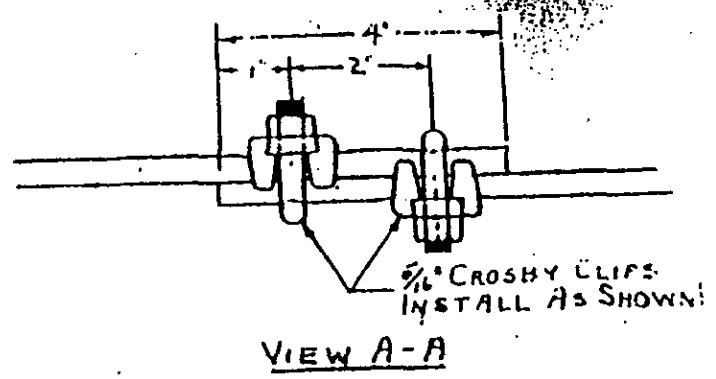
SAFETY CABLE INSTALLATION
FOR COBRA SEATS

The one item of new business is the Cobra safety cable on your drawing VRM-4058. I believe that additional clips should be required on the cable termination shown in View A-A, see enclosed letter from the Crosby Group Inc. The cable is assumed to be a loop and the Fist Grip is to keep it from sliding off the end of the sweep, if an accident should occur. The question is how the cable is looped and the Fist Grip is installed. Is the cable looped and the Fist Grip attached to make it hour-glass shaped? Or, is the cable shaped like a figure 8 and the Fist Grip controls the size of the loops? I also think that drawing should have a note stating that the clips should not be installed over the polyethylene tubing.
