ENTERPRISE RIDE INTERIM CORRECTIVE ACTION PLAN
U.S. Consumer Product Safety Commission
March 2, 1984 [Revised 7/15/93]

TO : J. A. DeMarco, CECA
THROUGH: Frank Brauer, EXCE
James I. Price, Director, ESME
FROM : Thomas E. Caton, ESME *Thomas E. Caton*
SUBJECT: PSA 8607, Huss Enterprise Ride Failure at Camden Park
REF : (a) SAE standard J517, "Hydraulic Hose", June 1980
(b) Status Report - Huss Enterprise Amusement Ride
Investigation, 13 February 1984

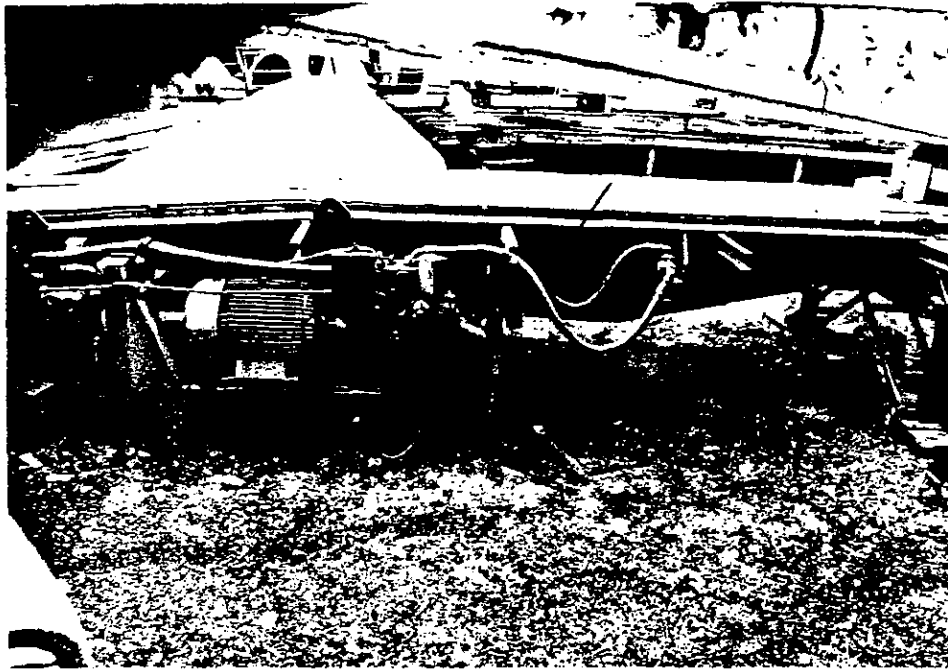
Figure 1 Location of the burst hydraulic hose.

The examination found that one hydraulic hose had burst with an approximately 3-inch long breach which opened toward the ride's structure (Figure 1). This burst hose is embossed with: "AEROQUIP FC136-24 EXCEEDS SAE 100R12 MSHA 2G-9C/1 1086". According to reference (a), SAE 100R12 designates a heavy duty, high impulse, 4-spiral wire reinforced, rubber cover hydraulic hose. The last four digits (1086) indicate the probable date of manufacture is the 108th day of 1986. The ride's other hydraulic hoses (Figure 1) are similarly marked. Huss Maschinenfabrik's September 10, 1987, Service Letter EN-10 states that hydraulic hoses should be replaced after 4000 hours of operation. The hours of operation on the burst hose was not provided.

that the burst hose was probably due to wear and tear. Huss Maschinenfabrik recommends that the hydraulic hoses on Huss Enterprises should be replaced after 4000 hours. The total use hours on the burst hydraulic hose was not provided.

a) Overall view hydraulic hoses (the inner hose in the right center of the photograph is the one that burst).

b) View of burst hose showing location of hose breach.

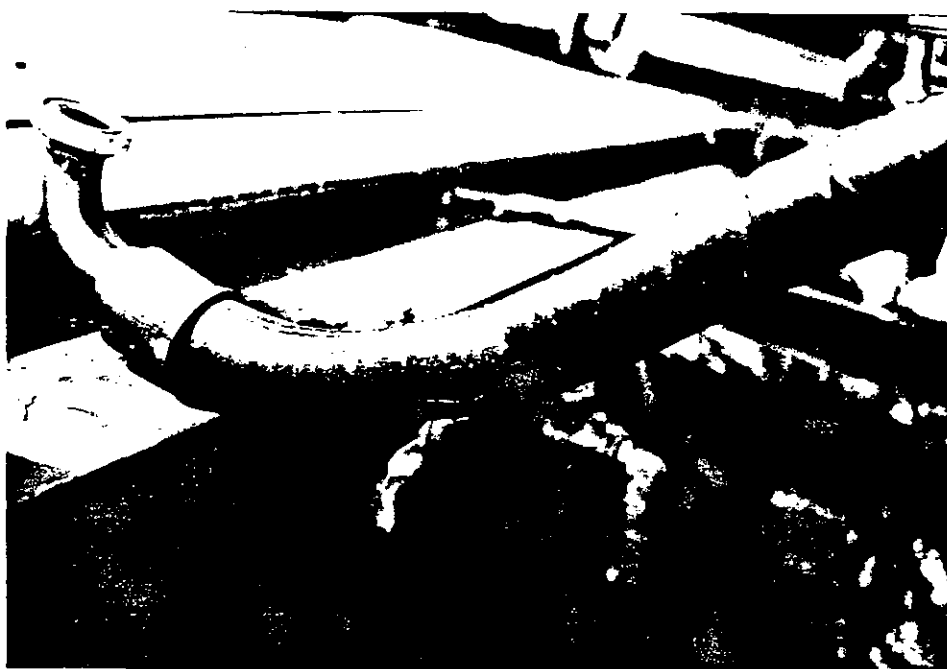
Figure 2 is a photograph of the burst hose. This hose was radiographed. The Kentucky state inspector examined the radiograph and said that the breach was due to wear and tear from flexing during use but that overall the hose appeared sound.

Figure 2 Photograph of the burst hydraulic hose showing the breach from the burst.

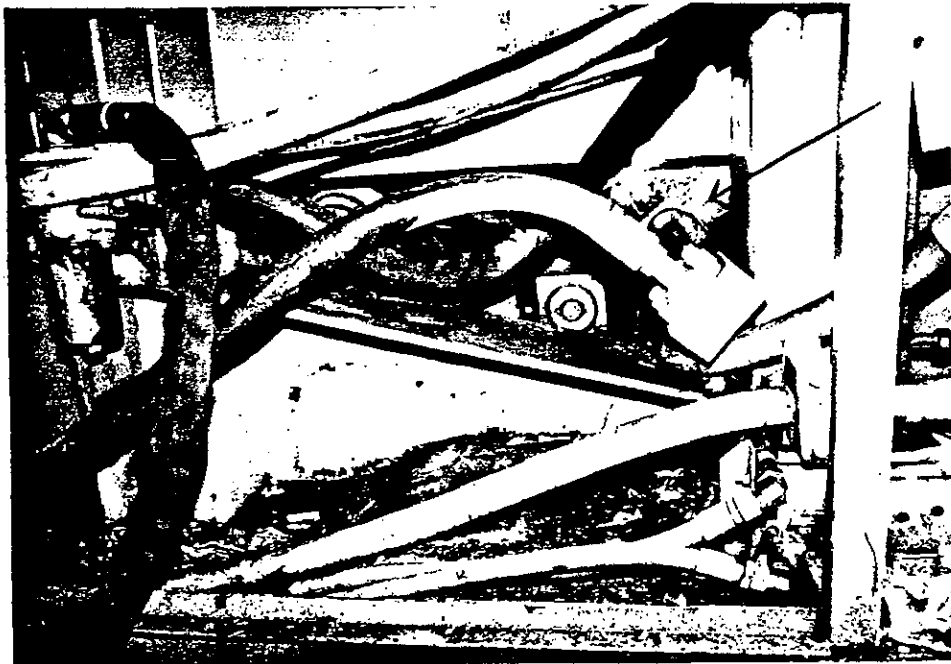
Figure 4 Photograph of pipe break valve location.

Camden Park personnel removed the pipe break valve from the ride (Figure 4). Figure 5 shows that the spring, screw, and nut of the pipe break valve are damaged and appear to have been damaged prior to the incident. This damage was sufficient to prevent proper functioning of the valve during the incident.

a) Covering over pipe burst valve.

b) Covering over pipe burst valve removed.

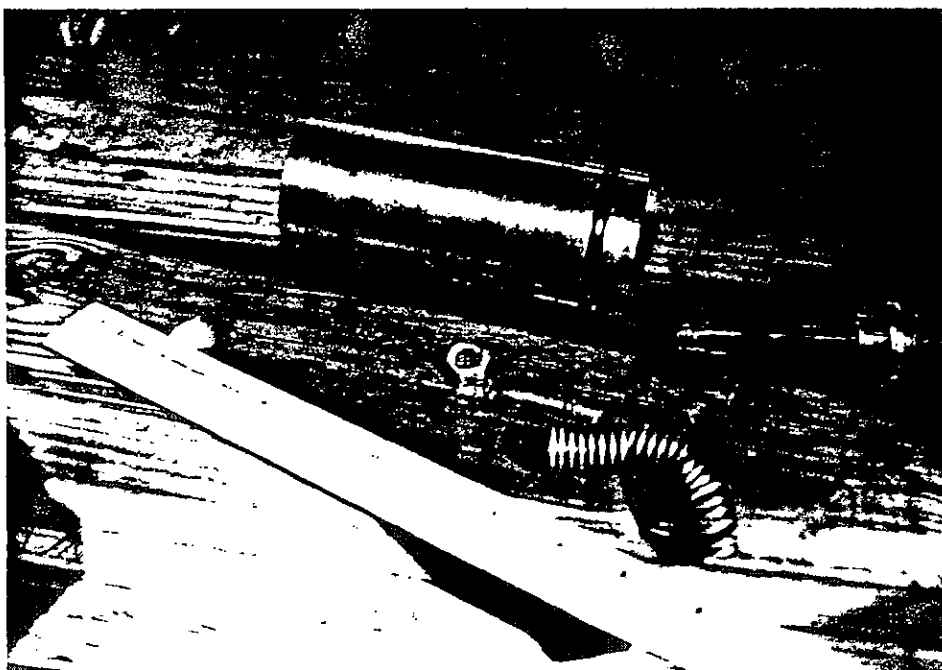
The pipe burst valve, which is meant to handle a sudden hydraulic pressure loss, was damaged at some unknown time prior to the incident and did not function properly during the incident. Huss Maschinenfabrik advises a visual pipe break valve check during the annual inspection, but they do not state how this is to be done. It is recommended that the visual check procedure be clarified by Huss Maschinenfabrik in a Service Letter.

a) Pipe break valve as-removed from the ride.

b) Disassembled pipe break valve.

Figure 5 Photograph of damaged spring, cap screw, and nut removed from disassembled pipe break valve.
