SERVICE LETTER 1

Subject FRISBEE Gondola Passenger Restraints (Shoulder Bars)

**Refurbishment Instruction for friction gear truss – Frisbee
Assemblies 29.009-1 and 29.009.E-1
Relating refurbishment drawing: 29.009.S-2**

Refurbishment Friction Gear
Drive - longitudinal section

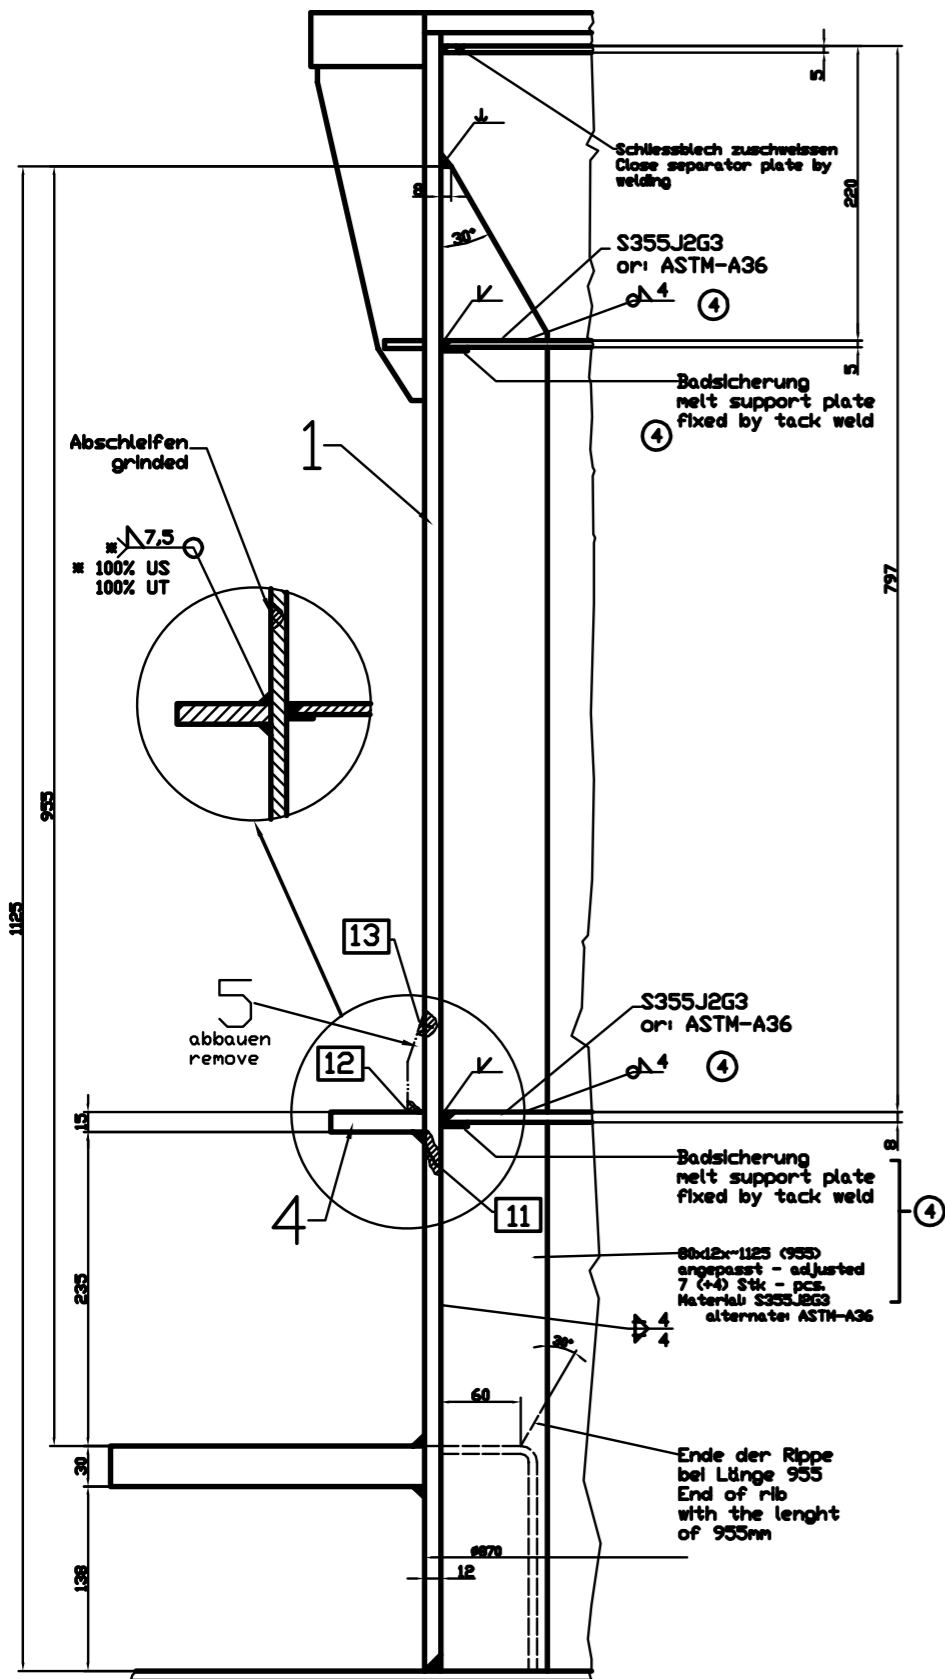
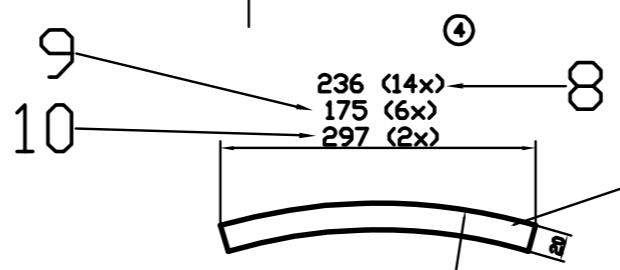
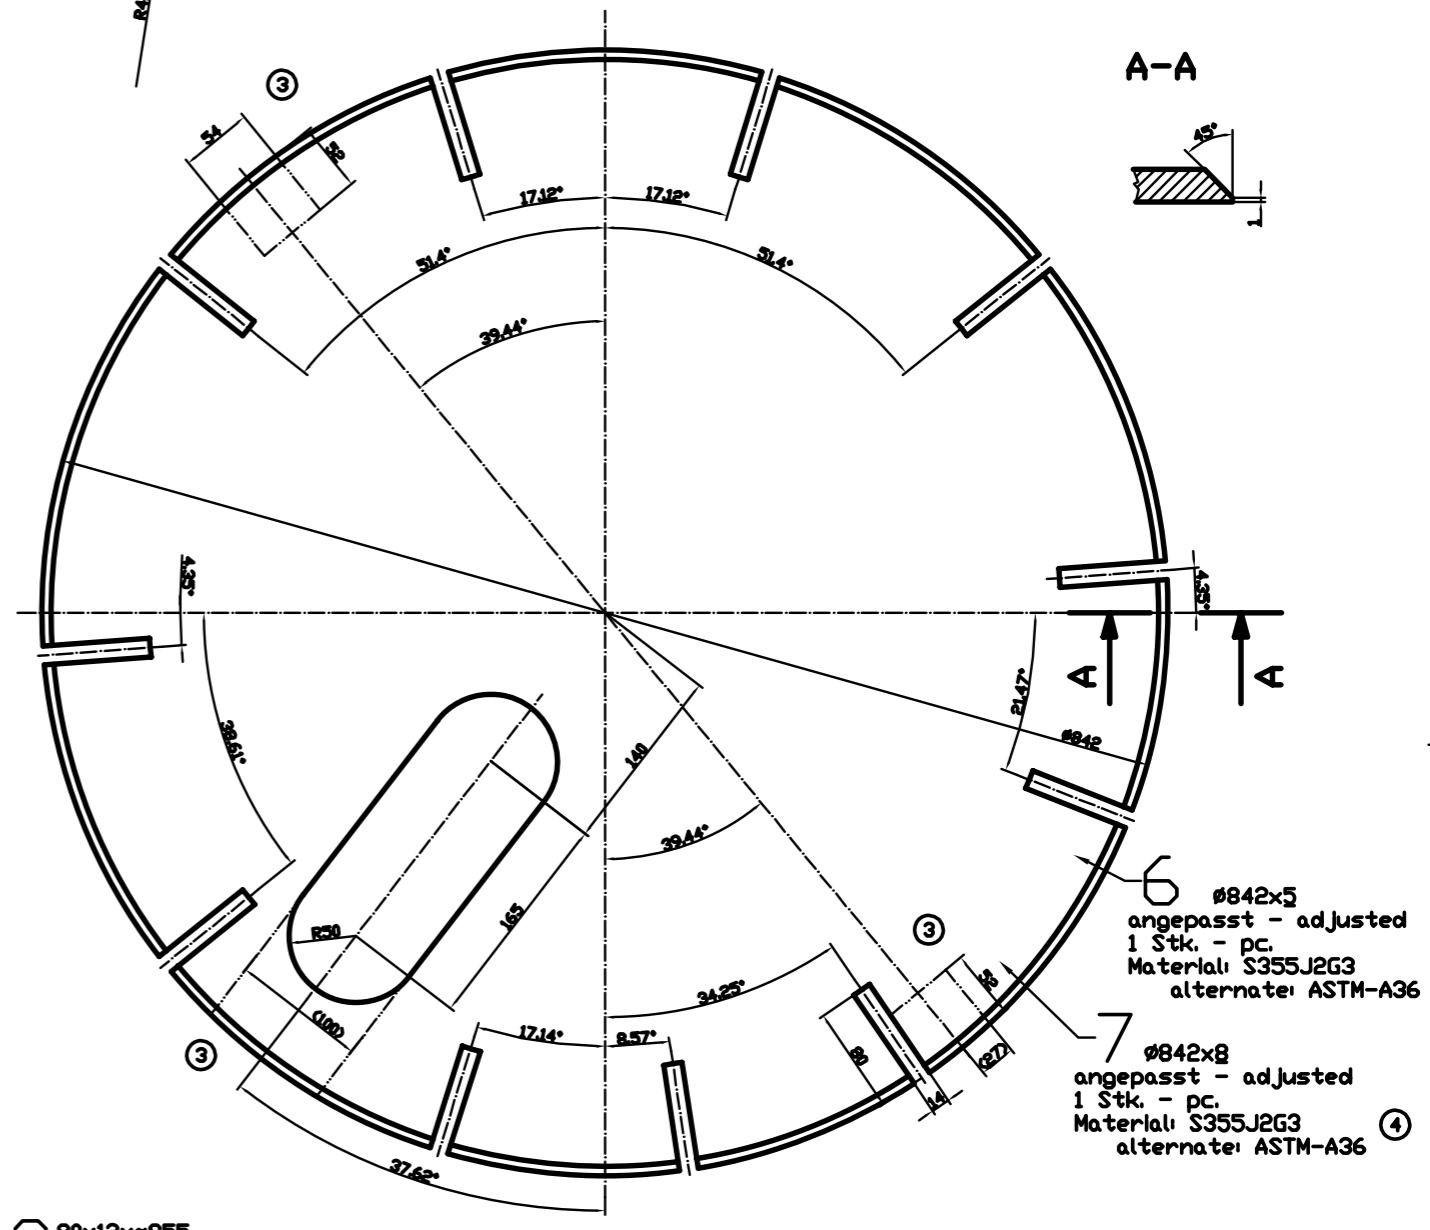
Basis for refurbishment is drawing no. 29.009.S-2. Damages might occur at two and/or three positions:

1. Crack in circulation direction inside the jacket plate (Pos. 1, 29.009.S-2), below the flange level (Pos. 4, 29.009.S-2).(marked with 11)
2. Crack at the edge of the seam between Pos. 5 and Pos. 4 outside the jacket plate (29.009.S-2) (marked with 12)
3. Crack in the seam between Pos. 5 and Pos. 1 (29.009.S-2) (marked with 13).

First, the crack under point 1 must be repaired. This must be worked out carefully, at least until a depth where the crack completely disappears. The assumed diffusion direction is going off beveled, possibly until the melting zone of the lower fillet weld between pos. 4 and Pos. 1. The adjacent interior faces of the jacket plate (Pos. 1) must be cleansed from rust and dirt. The welding is a continuous welding in several layers, whose surface must be finished evenly.

Secondly, the ring Pos. 5 must be deleted. For that purpose, the seams at the marks 12 and 13 must be abraded. At mark 12 it is a Half-V butt joint with not full cross-sections, i.e. dependant on the melting zone, a wedge-shaped countersinking with each 8-9 mm in the cross-section triangle blade would be sufficient (if not, the measurements of the countersinking shall be increased gradually until this part separates. Caution! The basic cross-section of Pos. 1 and 4 may – as far as possible – not be destroyed!) Afterwards, Pos. 5 must be cut at two areas in the reversed condition and deleted.

Now, the possible broadening of the cracks with marks 12 and/or 13 can be tested. Executing the refurbishment goes necessarily into the jacket plate until the end of the crack. The refilling refurbishment welding must recondition the basic cross-section thickness of Pos. 1 and 4. Furthermore, a fillet weld must be accomplished between Pos. 1 and Pos. 4. at the top around the released edge according to the drawing.

For reinforcing purposes, a total of 11 ribs must be welded afterwards from the interior to the jacket plate (see drawing 29.009.S-2). The new separation plates must, however, be adapted to the ribs, manufactured and welded into according to the drawing (Pos. 6 and 7).Therefore, the left-overs of the interior separation plates must be deleted kerf-free.

After the corrosion protection works only the upper closing plate must be welded into.
