CARES Notification

Subject: Cracking near gondola suspension bearing

Ride(s) affected: Huss Top Spin

Date: August 17, 2011

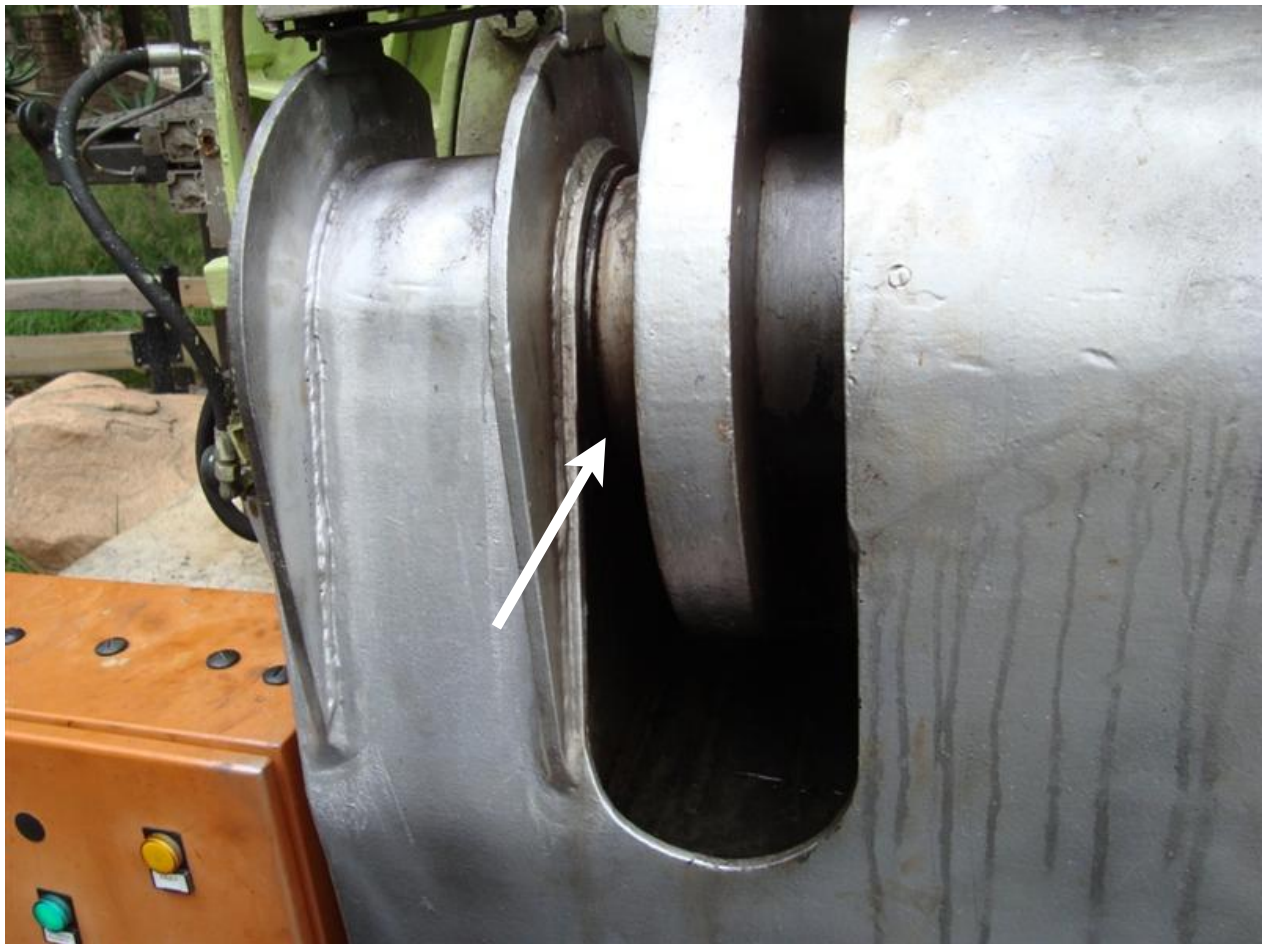
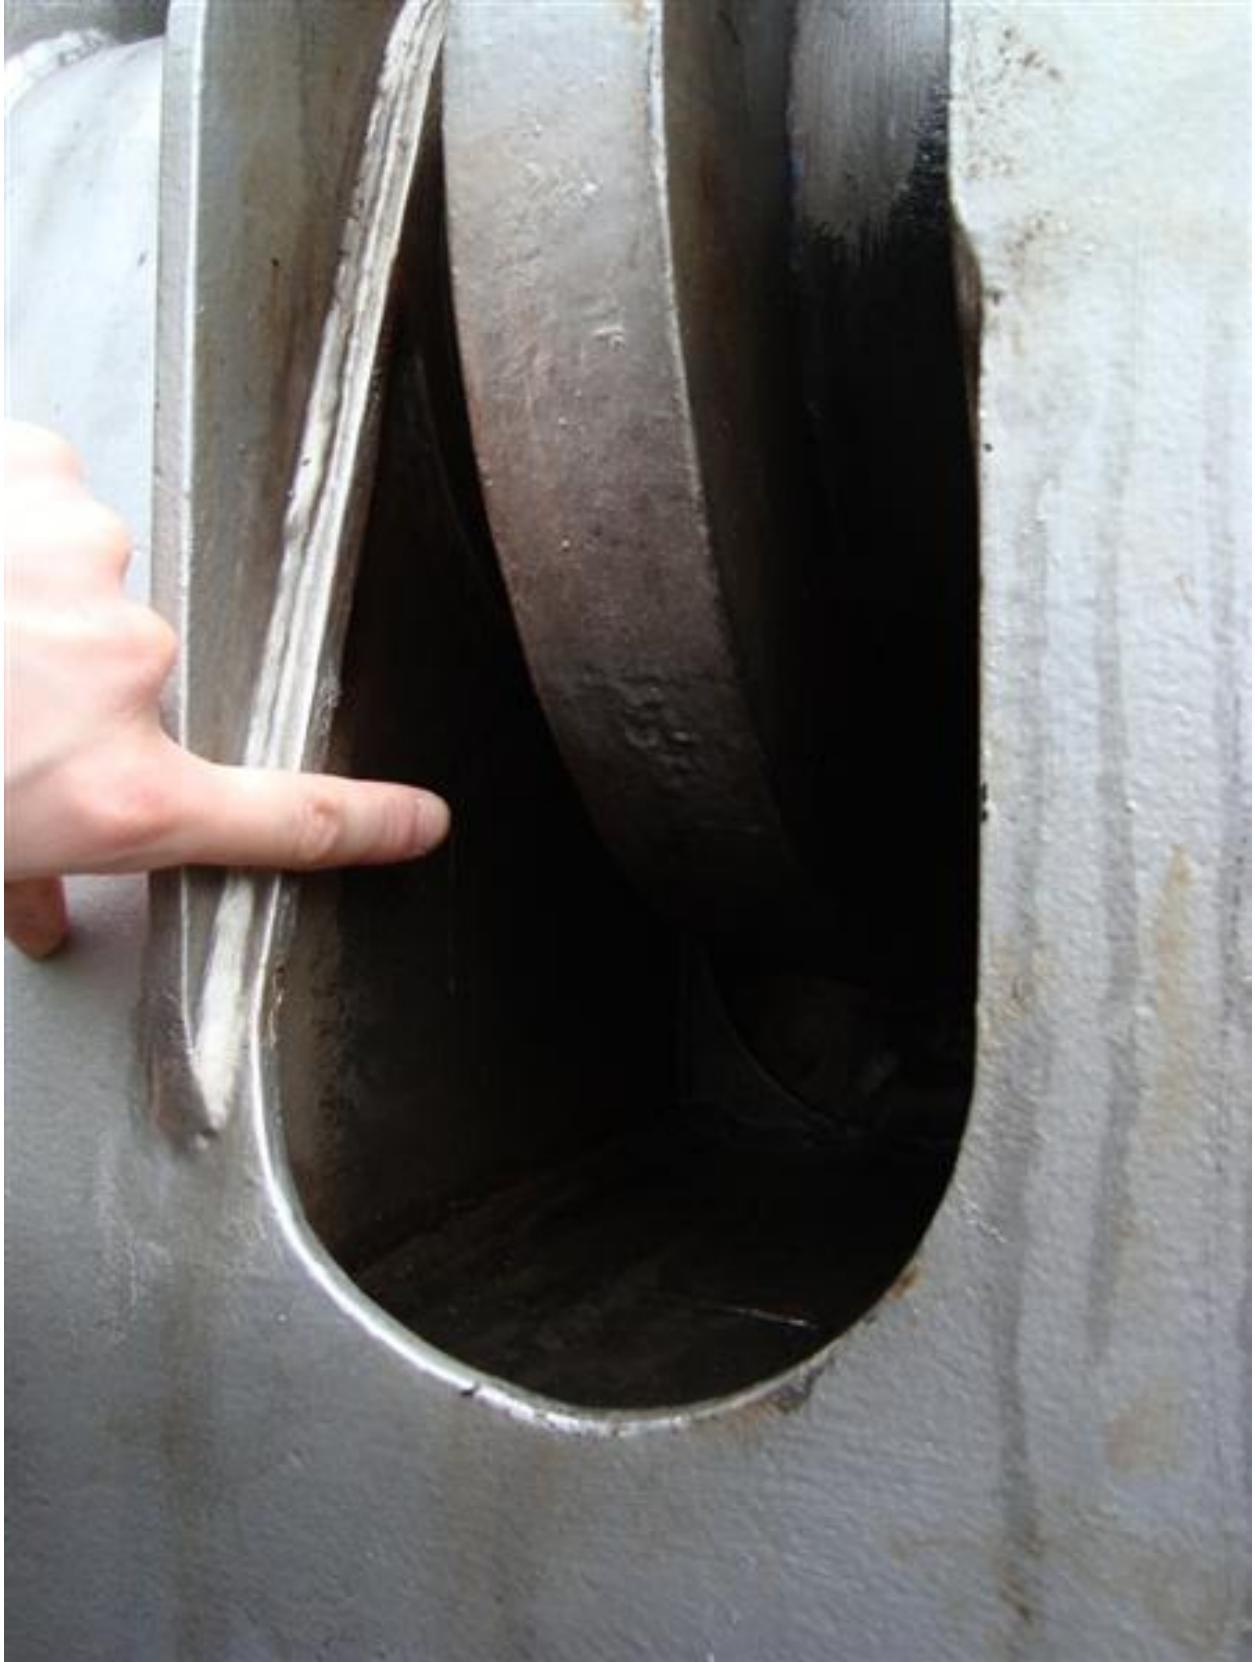
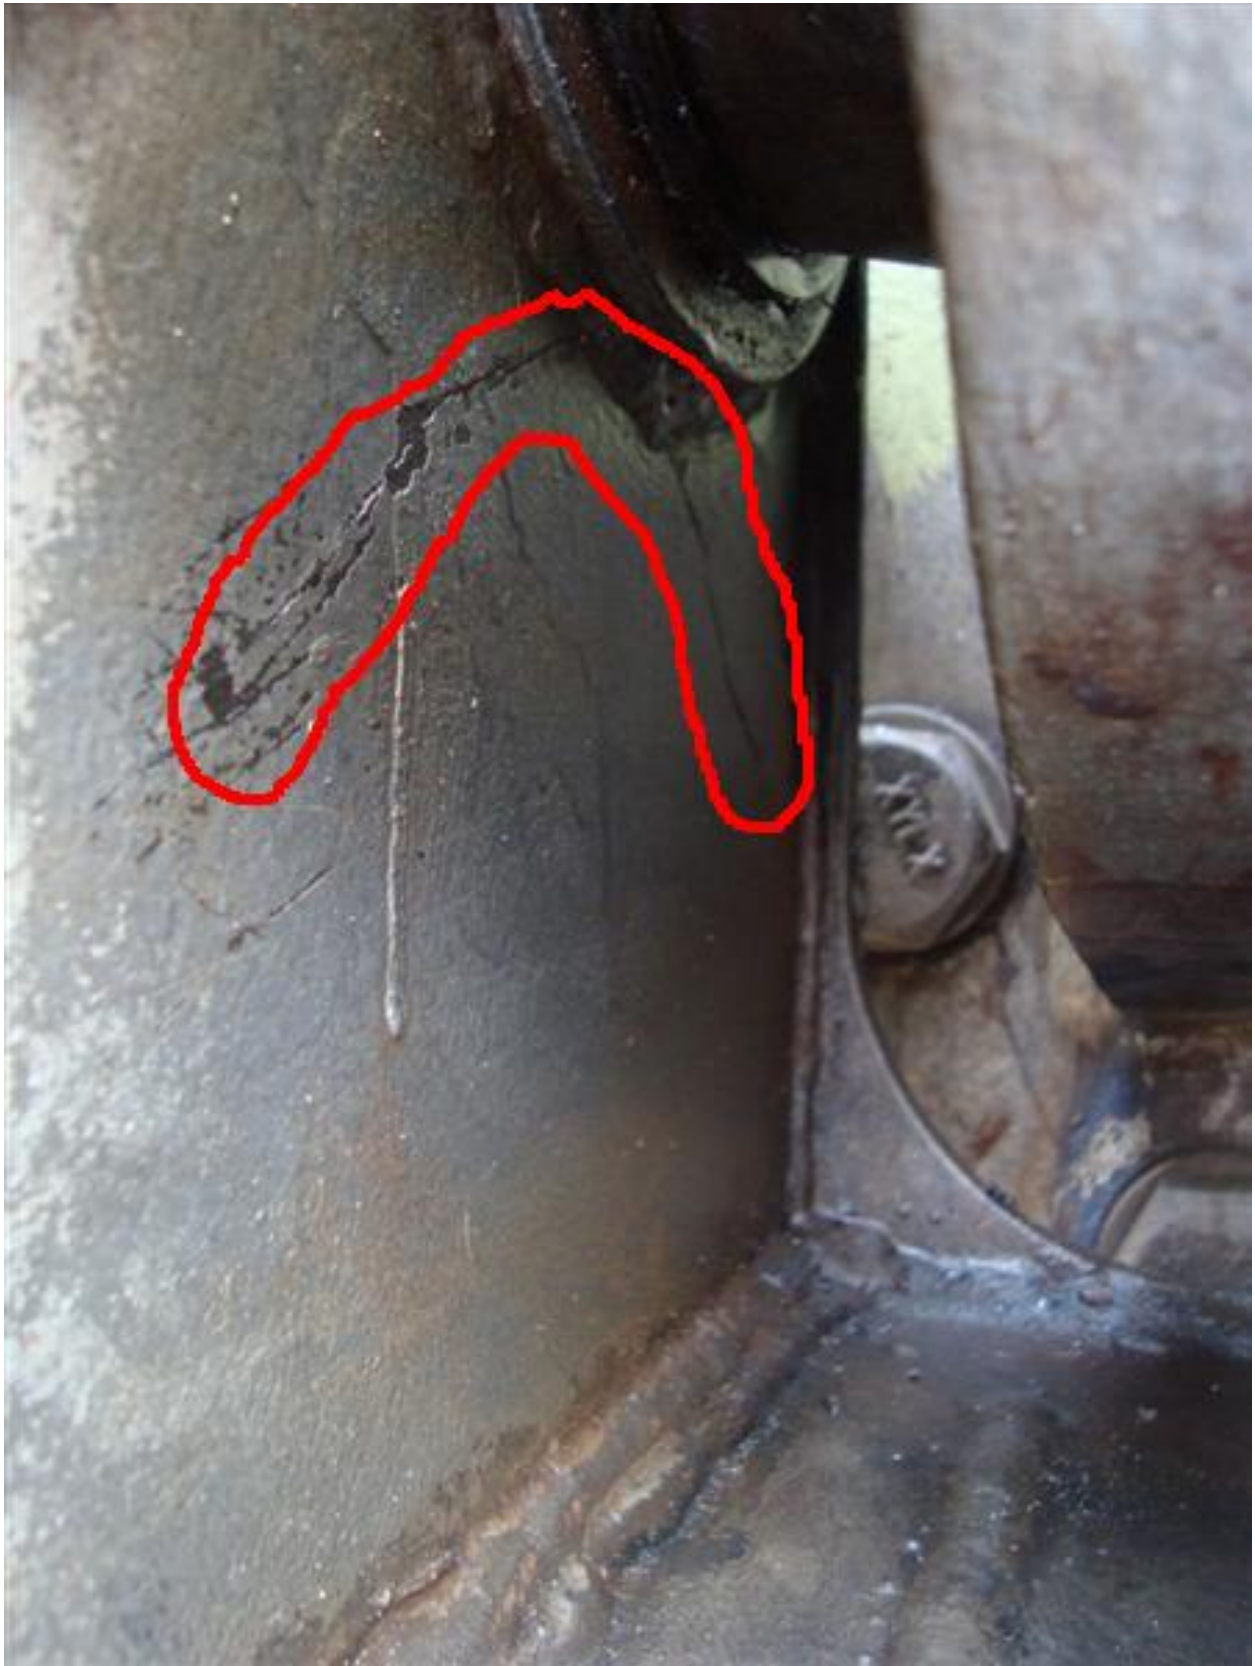
LTC has provided the following photographs of cracks found on a Huss Top Spin. The photographs were supplied by a ride inspection body in the UK without comment or further information.

Similar cracking has been observed on a ride operating in Canada. That ride has been closed pending an engineering review.
