SERVICE BULLETIN 89-1

SUPER LOOPS

SERVICE BULLETIN 89-2

SERVICE BULLETIN 89-4

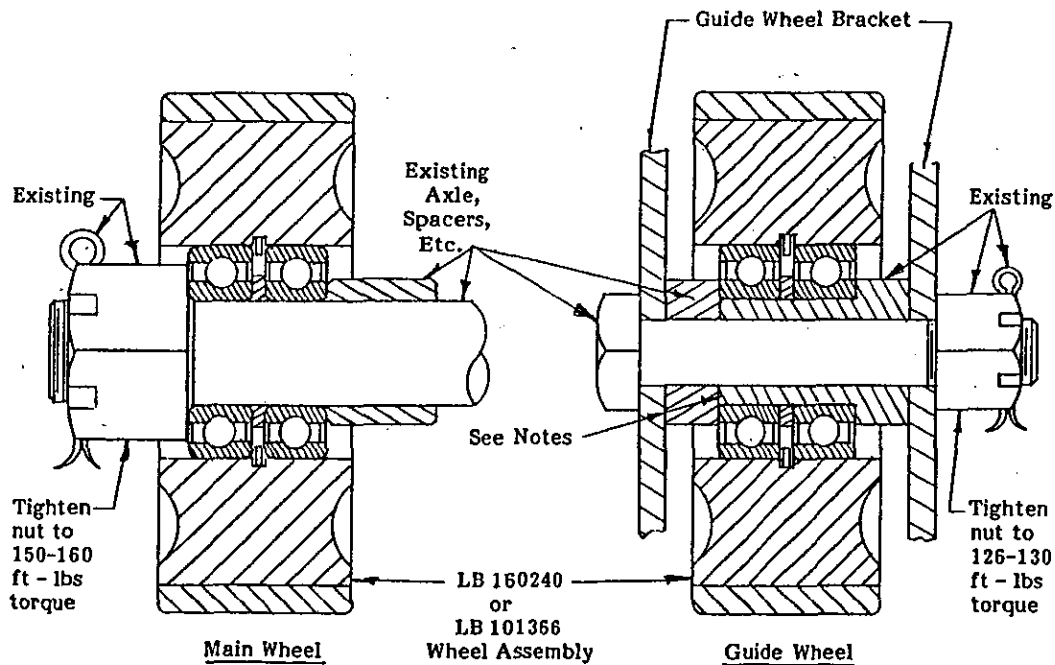
Starting immediately, replacement wheels for Super Loops will be either aluminum wheels with molded urethane tires, Part No. LB160240, or nylon wheels, Part No. LB101366. These wheels will come assembled with sealed ball bearings and internal spacers. This is a direct replacement for wheels with tapered roller bearings (Timken). These wheels are sold only as assemblies to insure proper installation of the bearings, retainer rings and spacer. Installation of the bearing is shown below and uses the existing spacer(s), axle and nut. Since these bearings are prelubricated and sealed, no further lubrication is required resulting in less maintenance and a cleaner ride.

- Notes:
1. Two piece spacer must make up solid to prevent bolt from turning in brackets.
 2. Check holes in brackets for wear if bolts have been allowed to spin. Repair if necessary.

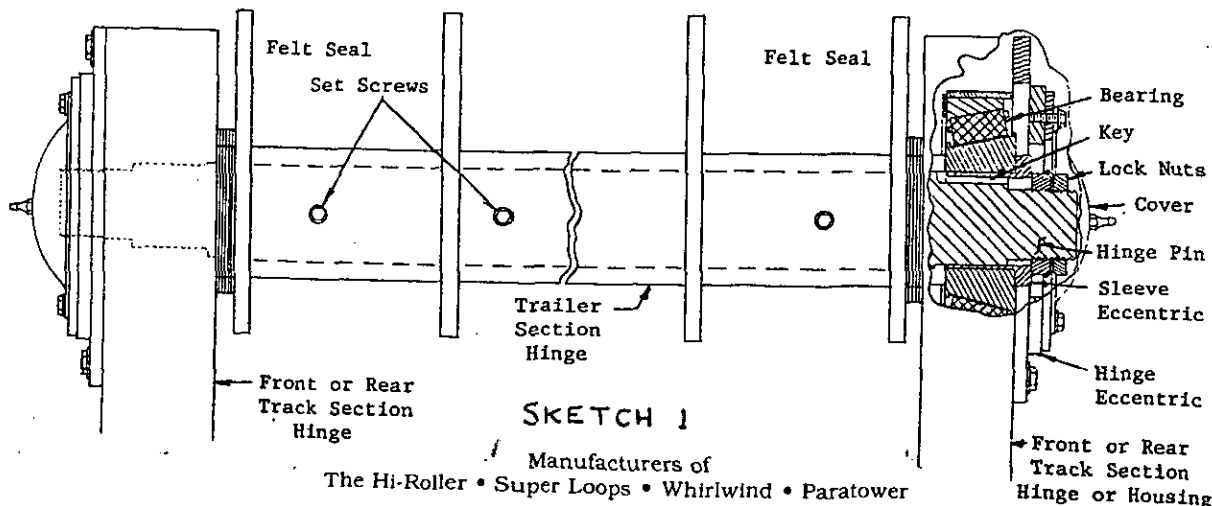
Fatigue cracks have been found in the hinge pins on some of the older Super Loops Amusement Rides. This fatigue could be caused by a number of factors. The two most obvious are: 1) the continual loading and unloading of the pin due to erection and lowering of the track and 2) improper support of the track during transport, allowing the hinge to take the majority of the bouncing load. With this in mind and in order to maintain a safe ride, the main hinge pins on the Super Loops must be inspected when the ride has been in operation for five (5) years and at five (5) year intervals thereafter. This inspection is to be a magnaflux inspection performed by an inspector certified in the use of magnaflux. Be sure and obtain a written copy of this inspection and keep it with your Super Loops manuals.

Remove the cover from each end of the hinge. See Sketch 1. Mark the position of the hinge pin, sleeve eccentric, hinge eccentric, and the hinge housings. Mark both ends and use different markings on each end so that the parts will not get mixed. A number stamp works well so that each pin and each end of each pin will have a different number. These markings must be oriented so that the parts will be replaced in the same place and direction as their original position.

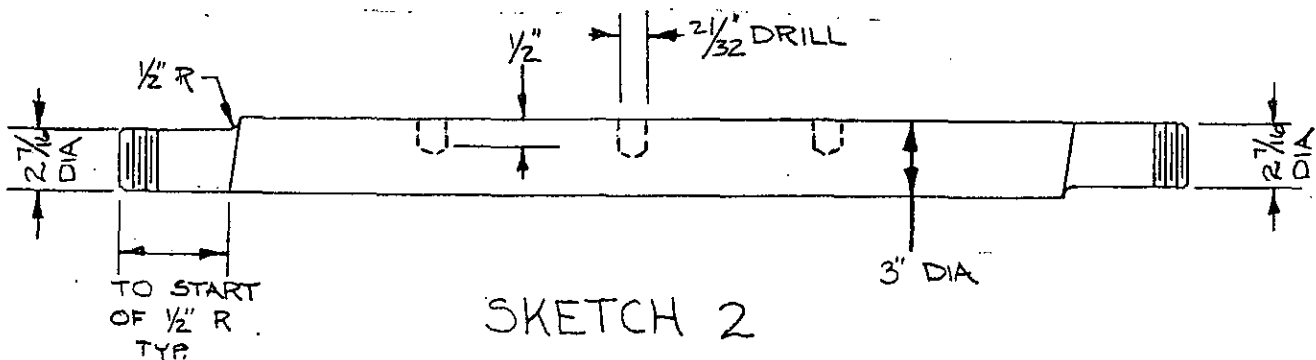
SKETCH 2

After the pin is removed, it must either be replaced or inspected by an inspector certified in the use of magnaflux. The primary areas of inspection are the shoulders located near each end. This shoulder is the point where the shaft changed diameter from 2 7/16 inches to 3 inches. If there is evidence of a crack, the pin must be replaced.

To reuse a pin that has been found free of cracks, it must be remachined as shown in Sketch 2. This increases the corner radius, reducing the stress concentration of that area. Reuse of a pin without this change is not permitted.

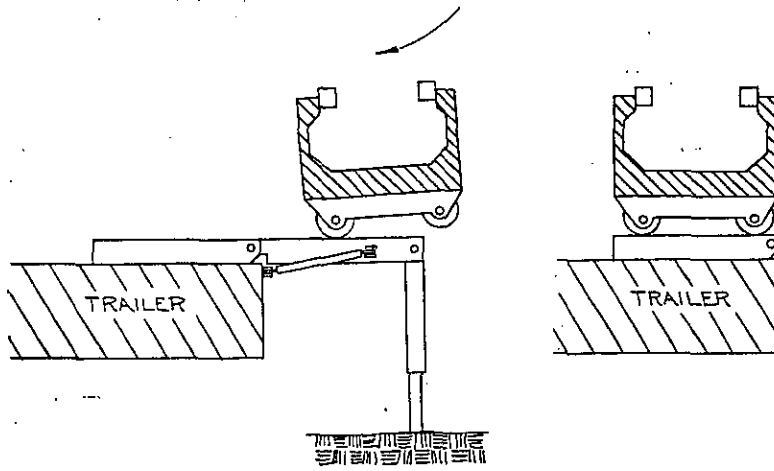
FIGURE 4

To help prevent fatigue cracks, all Super Loops were provided with transport carriers, Figure 4. When the track is lowered to the trailer for transport, a set of wheels mounted on the track engage a ramp, lifting the free end of the track onto the transport carrier. When the track is completely down, this carrier, through a parallelogram linkage, further lifts and supports the free end of the track. At this point, the ramp wheels should have some clearance (1/16 to 1/4 inch) with the ramp. If the ramp, ramp wheels, and/or the transport carriers are damaged or missing, they must be repaired or replaced. If the transport carrier does not lift the ramp wheels off the ramp, shim or modify as necessary.

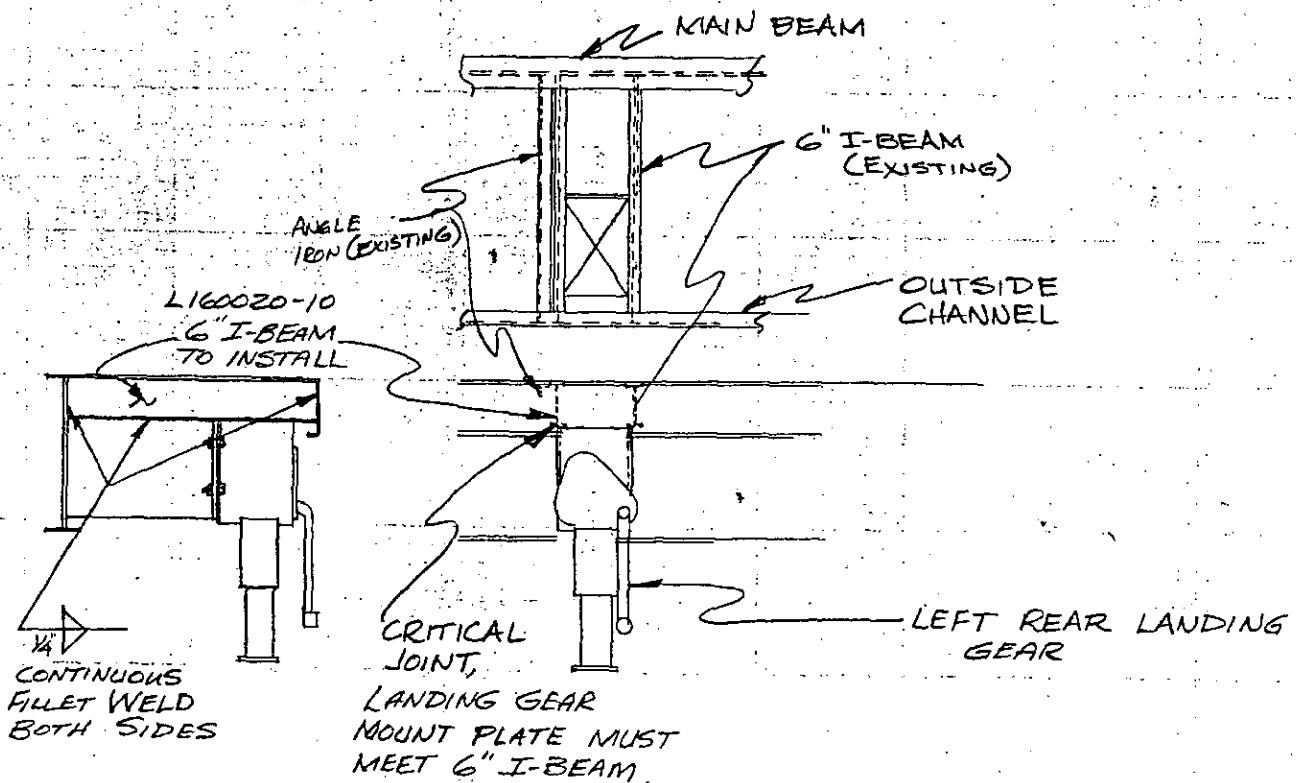
It has been brought to our attention that the landing gear on the left rear of the trailer may lack proper support. This situation should be investigated immediately. It involves Serial Numbers 44 through 50 trailers only.

SEE SKETCH BELOW. The landing gear should be tied into two (2) 6" I-beams. If the front I-beam is missing, there may be only an angle iron brace in its place, but will not be tied in to landing gear mount plate.

Please advise the manufacturer so that we can supply the ride operator with a 6" I-beam to repair the situation. If, upon inspection, there is no problem found, please let us know so it can be filed in our records.

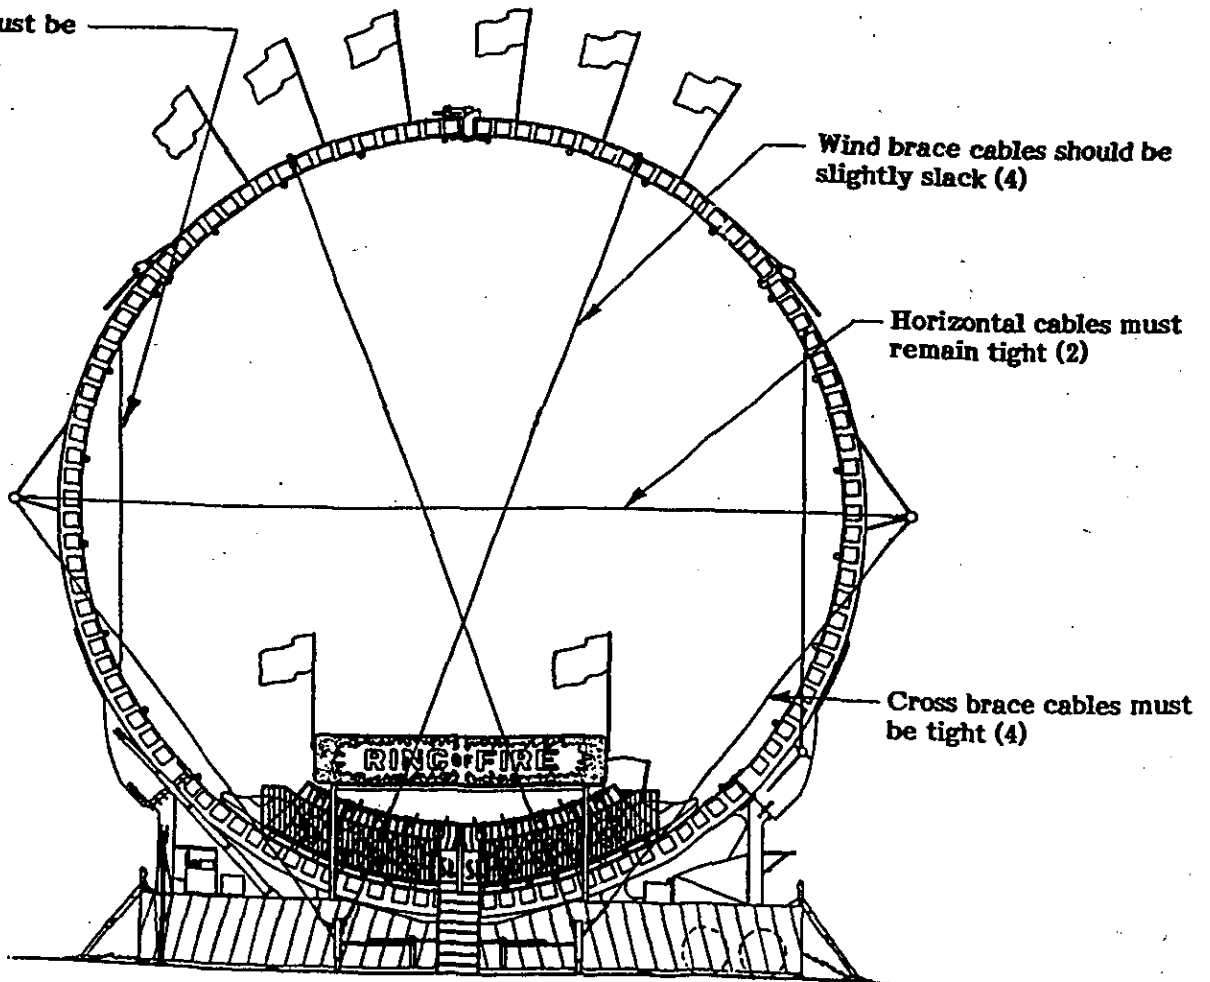
The reason the wind brace cables must not be tight is to keep the track a true circle. These cables, when overtightened, will crush the circle into an elliptical shape. This causes extreme pressures on the jactuators and the train axles during operation.

Erection cables must be removed for ride operation (2)

**CAUTION: THE ERECTION CABLES MUST ABSOLUTELY BE REMOVED FROM RIDE BEFORE PASSENGER OPERATION. DO NOT TIE ERECTION CABLES TO TRACK DURING OPERATION - REMOVE CABLES FROM RIDE!**

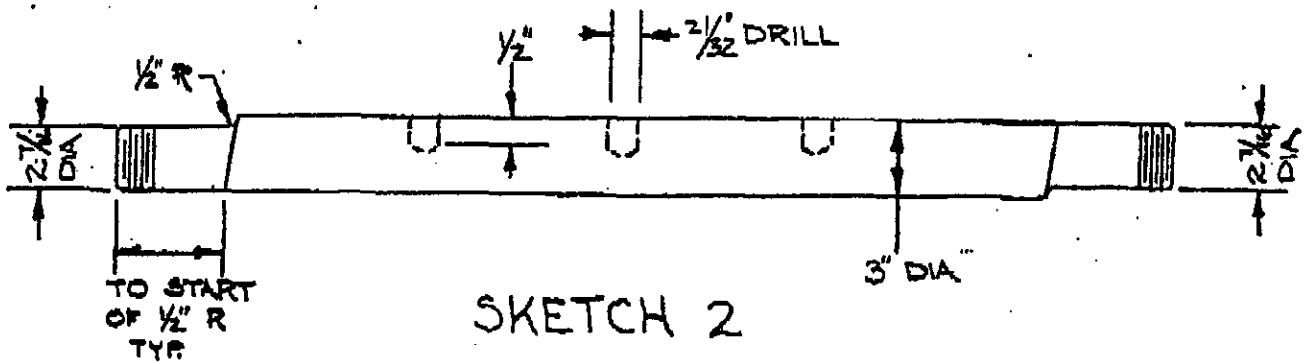
After the pin is removed, it must either be replaced or inspected by an inspector certified in the use of magniflux. The primary areas of inspection are the shoulders located near each end. This shoulder is the point where the shaft changed diameter from 2 7/16 inches to 3 inches. If there is evidence of a crack, the pin must be replaced.

To reuse a pin that has been found free of cracks, it must be remachined as shown in Sketch 2. This increases the corner radius, reducing the stress concentration of that area. Reuse of a pin without this change is not permitted.

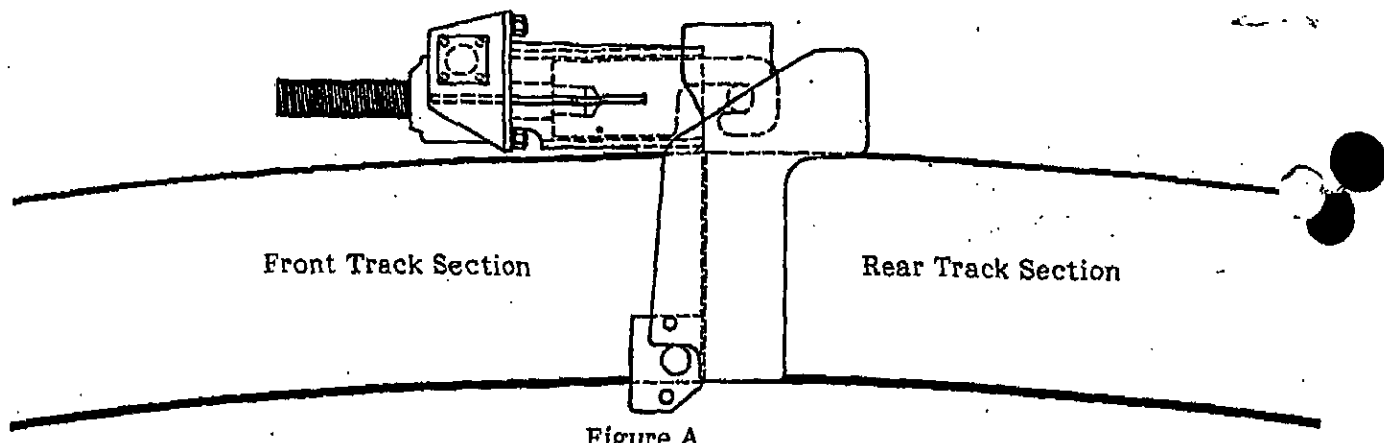
Figure A

Recently there have been several incidents of breaking the top hook. THERE IS NO WAY THE TOP HOOK CAN BE BROKEN UNLESS IT IS BY IMPROPER TEAR DOWN PROCEDURES. It is apparent that untrained personnel are being allowed to erect and tear down the Ring of Fire (Super Loops). It is imperative that all owners re-check the erection/tear down procedures and follow the instructions in the owners manual, on the decal at the control valves, and as shown in the erection video tape.

The only way the top hook can be broken is by extending it past the limits as marked by red paint and the operator trying to bring both sections down at the same time or bring the front section down first. The top hook should be extended only far enough to clear the guide rollers (See Figure B). The operator should then be able to lower the rear track section allowing the roller to come out of the top hook through the gap provided (See Figure C). If the roller remains at the outer end of the slot in the hook, then the leveling jacks must be adjusted so that the roller is at the back of the slot and free to come out of the gap when the track section is lowered, i.e. the hook should push the rear track section back thus opening the track and clearing the dowel pins. Roller must rotate freely and should have a coat of wheel bearing grease.

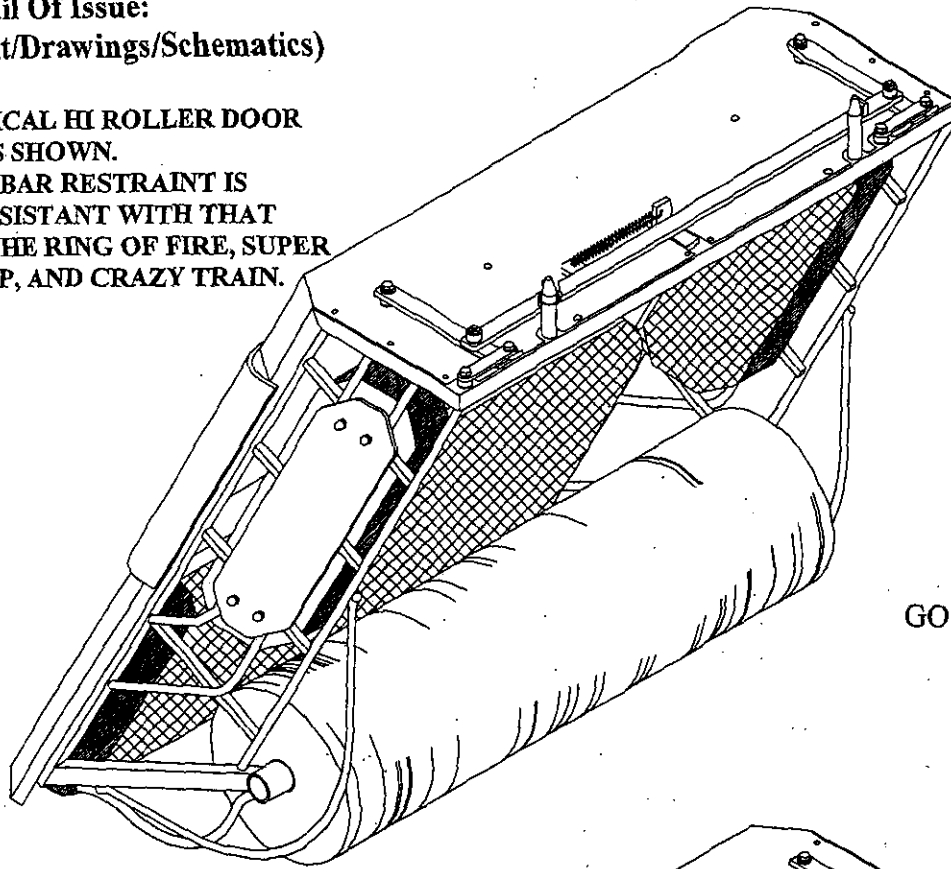
GOOD CONDITION

**Reason for Release:**  
**Certain operators have allowed rides to operate despite severely worn lap bar padding. This poses a threat of injury or death if the riders are not properly restrained due to worn padding.**

**Action To Be Taken:**  
**Inspect lap bar padding on a daily basis. Replace padding if:**

- 1. The foam padding does not hold its memory.**
- 2. The foam padding is worn or torn to the point it will not hold a passenger in their seat firmly.**
- 3. The foam padding is torn internally such that the padding hangs or sags from the shaft that is to run through the center of the padding.**
- 4. The foam padding is egg-shaped or sagging and is no longer cylindrical in shape.**

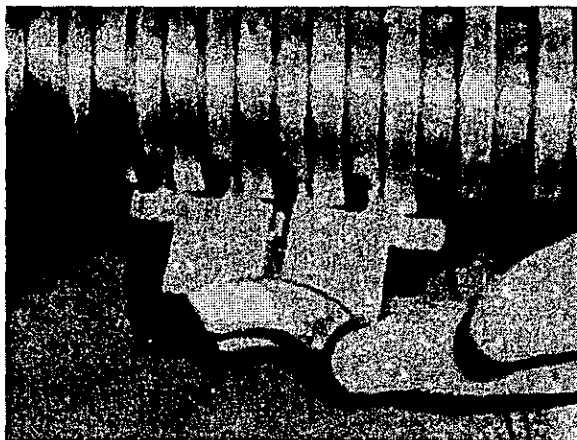
**UNACCEPTABLE**

**WARNING:** Replace brass gear if threads are less than  $3/16''$ .

If brass gear threads are less than  $3/16''$ , install new brass gear. If threads are acceptable, reinstall.
