October 3, 1989

SERVICE BULLETIN 89-4

SUPER LOOPS

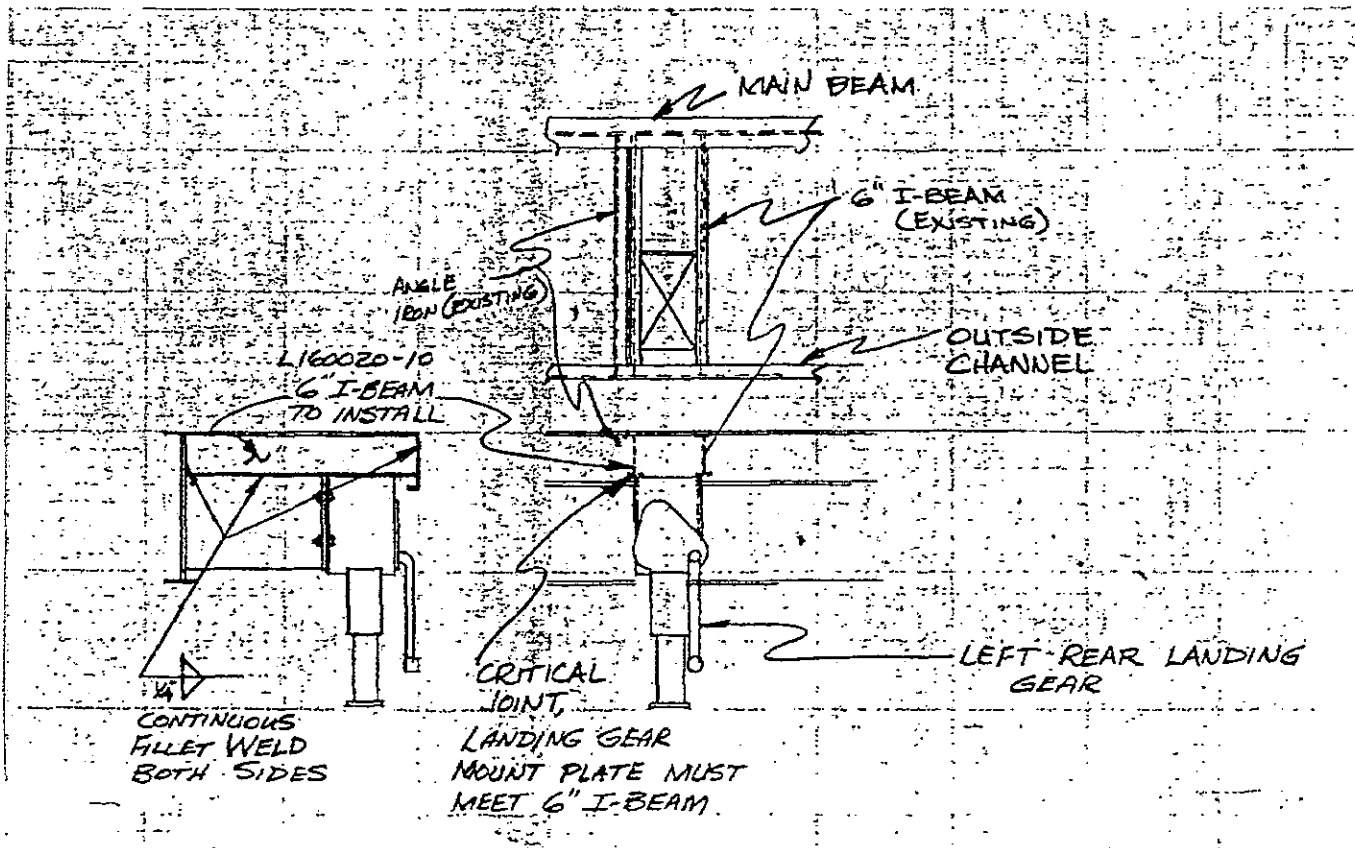
It has been brought to our attention that the landing gear on the left rear of the trailer may lack proper support. This situation should be investigated immediately. It involves Serial Numbers 44 through 50 trailers only.

SEE SKETCH BELOW. The landing gear should be tied into two (2) 6" I-beams. If the front I-beam is missing, there may be only an angle iron brace in its place, but will not be tied in to landing gear mount plate.

Please advise the manufacturer so that we can supply the ride operator with a 6" I-beam to repair the situation. If, upon inspection, there is no problem found, please let us know so it can be filed in our records.
