BULLETIN #6-133-MC

MAIN BOOM ROCKER SHAFT FOR ROUND-UP RIDES MANUFACTURED BY FRANK HUBERZ & CO., INC. AND KILINSKI MFG. CO.

BULLETIN: BU-135 MC

ANNUAL INSPECTION OF MAIN SPINDLE SHAFTS, ROCKER SHAFTS, CYLINDER ANCHOR SHAFTS

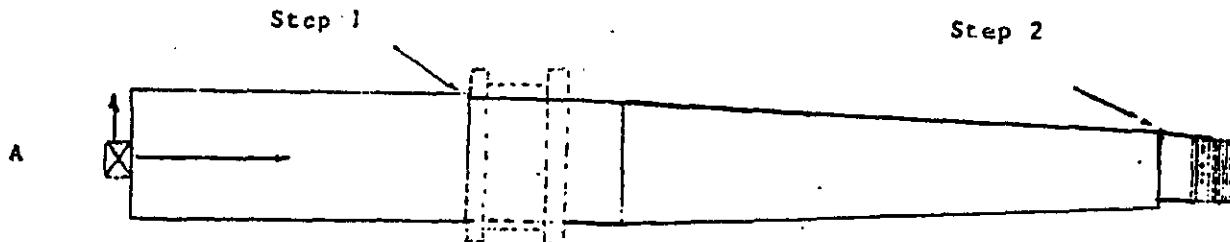
Figure 1

Calibration on test piece for Longitudinal Beam examination

1. A 3/4" Diameter - 5 MHz Transducer is recommended.
2. The search unit shall be placed on center of shaft area (A) and adjust second back reflection to 100%.
3. Move transducer towards edge of shaft (A)
 - 3.1 Step 1 should appear to be approximately 25%.
 - 3.2 If not, scan the perimeter and adjust to the average.

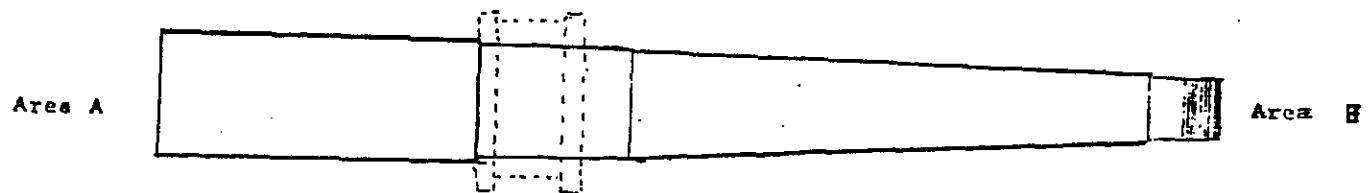
Figure 2

1. Longitudinal Beam Examination

- A. After calibration per Figure 1, areas (A) and (B) shall be scanned 100%.

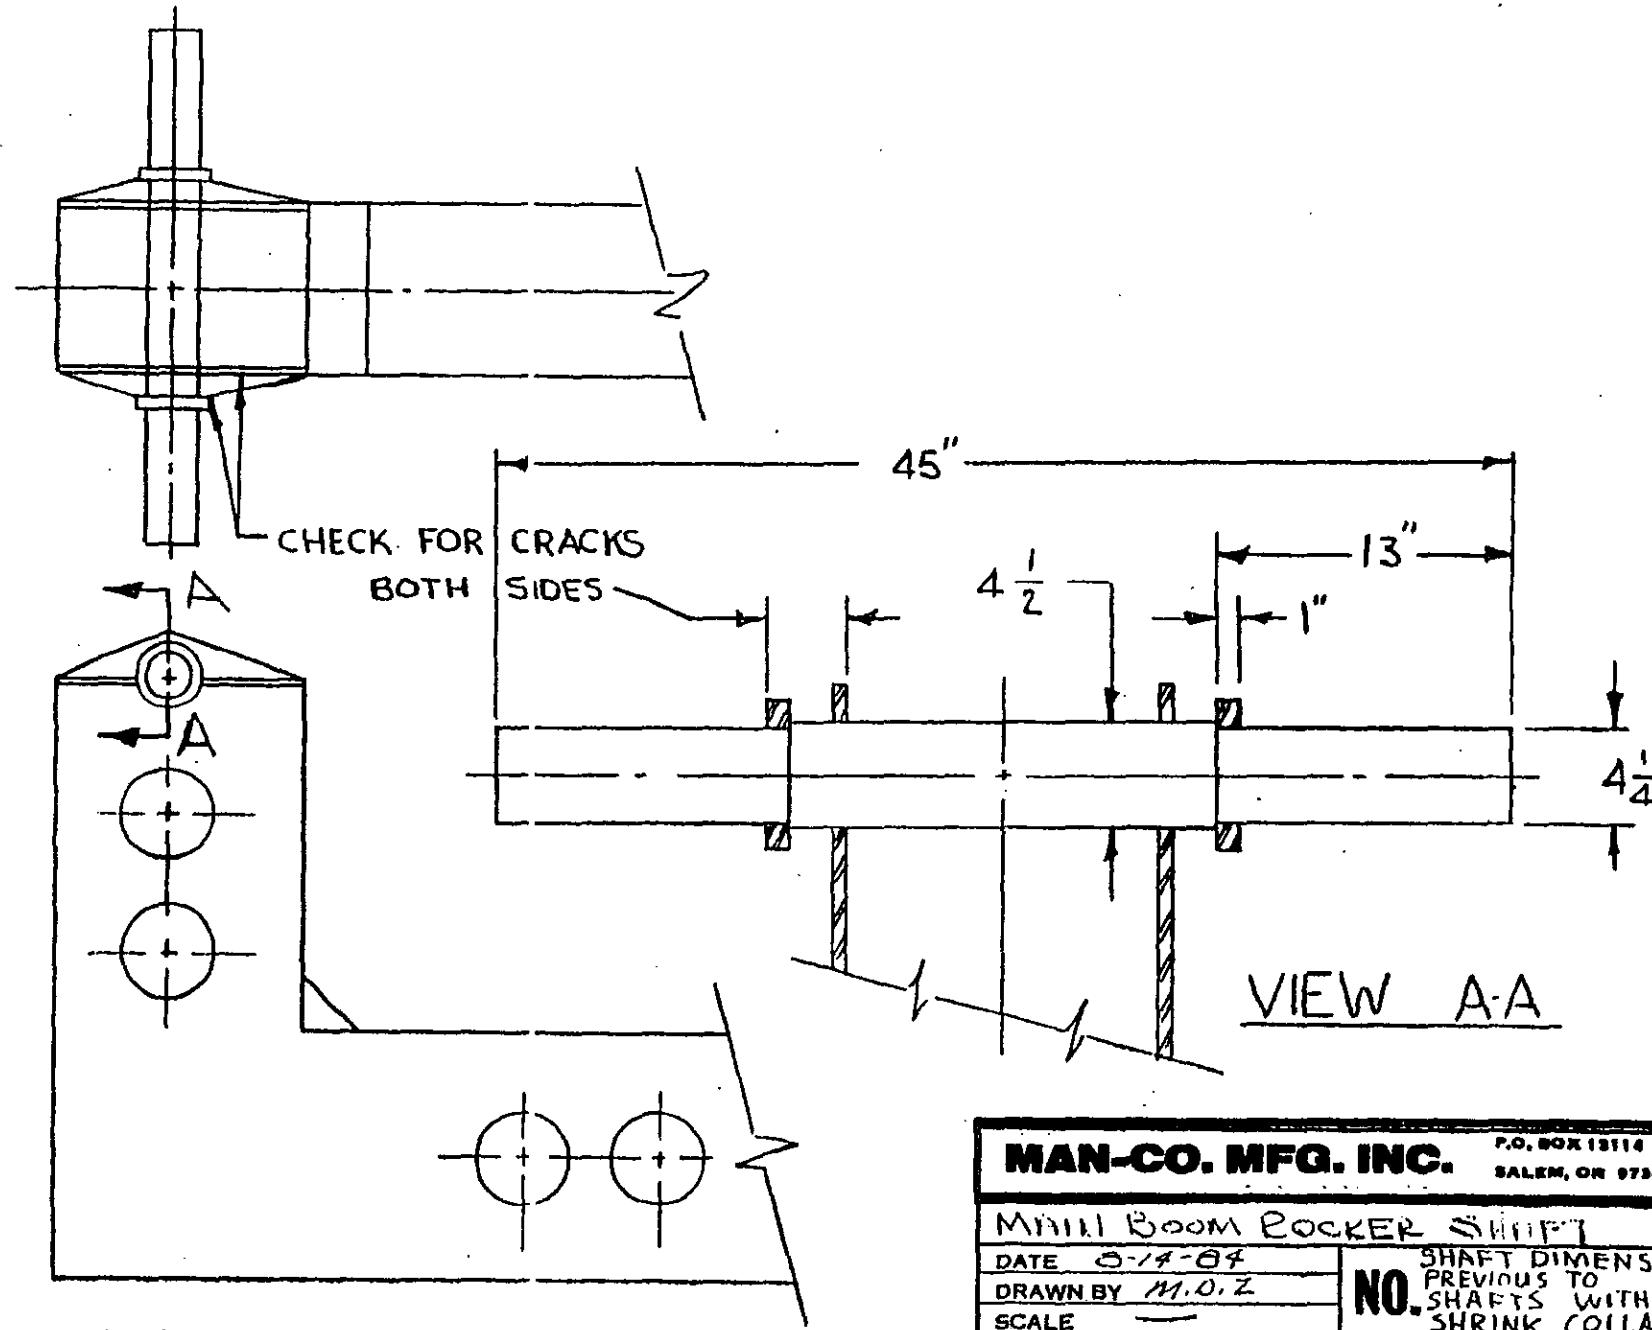
MAN-CO. MFG. INC.	
P.O. BOX 13114 SALEM, OR 97302	
MAIN BOOM ROCKER SHAFT	
DATE 5-14-04	SHAFT DIMENSIONS
DRAWN BY M.O.Z	PREVIOUS TO
SCALE —	SHAFTS WITH
NO. SHRINK COLLARS

A failure has been reported of the main boom rocker shaft on a Round Up manufactured by Frank Hubertz & Co., Inc. Although Man-Co Mfg., Inc. does not accept responsibility for rides built by Frank Hubertz & Co., Inc., or Kilinski Mfg., Co., we do feel that this is a potential safety problem sufficiently important to bring to your attention.

This test was performed on a Round-Up at Man-Co Mfg., Inc. by an independent testing lab. Using a 2.5 MHz transducer on the end of the shaft. The instrumentation was set up to produce a strong reflection from the opposite end of the shaft and calibrated so that the shoulder on the far end of the shaft registered approximately 15-20% of full scale. This would cause a crack at or near the closer shoulder to register significantly. The test was repeated at the other end of the shaft. A sketch of the shaft is on Sheet 2.

If you own a Round-Up, we strongly urge that you immediately inspect the main boom rocker shaft and the cylinder anchor shaft for cracks using Ultrasonic test. The test must be done by someone qualified to Level 2 ultrasonic testing. It is not necessary to disassemble the ride to perform the test on the main boom rocker shaft, or the cylinder anchor shaft.

If cracks are found in the shaft, it SHALL BE replaced immediately. Replacement shafts of the latest design may be purchased from Man-Co Mfg., Inc.

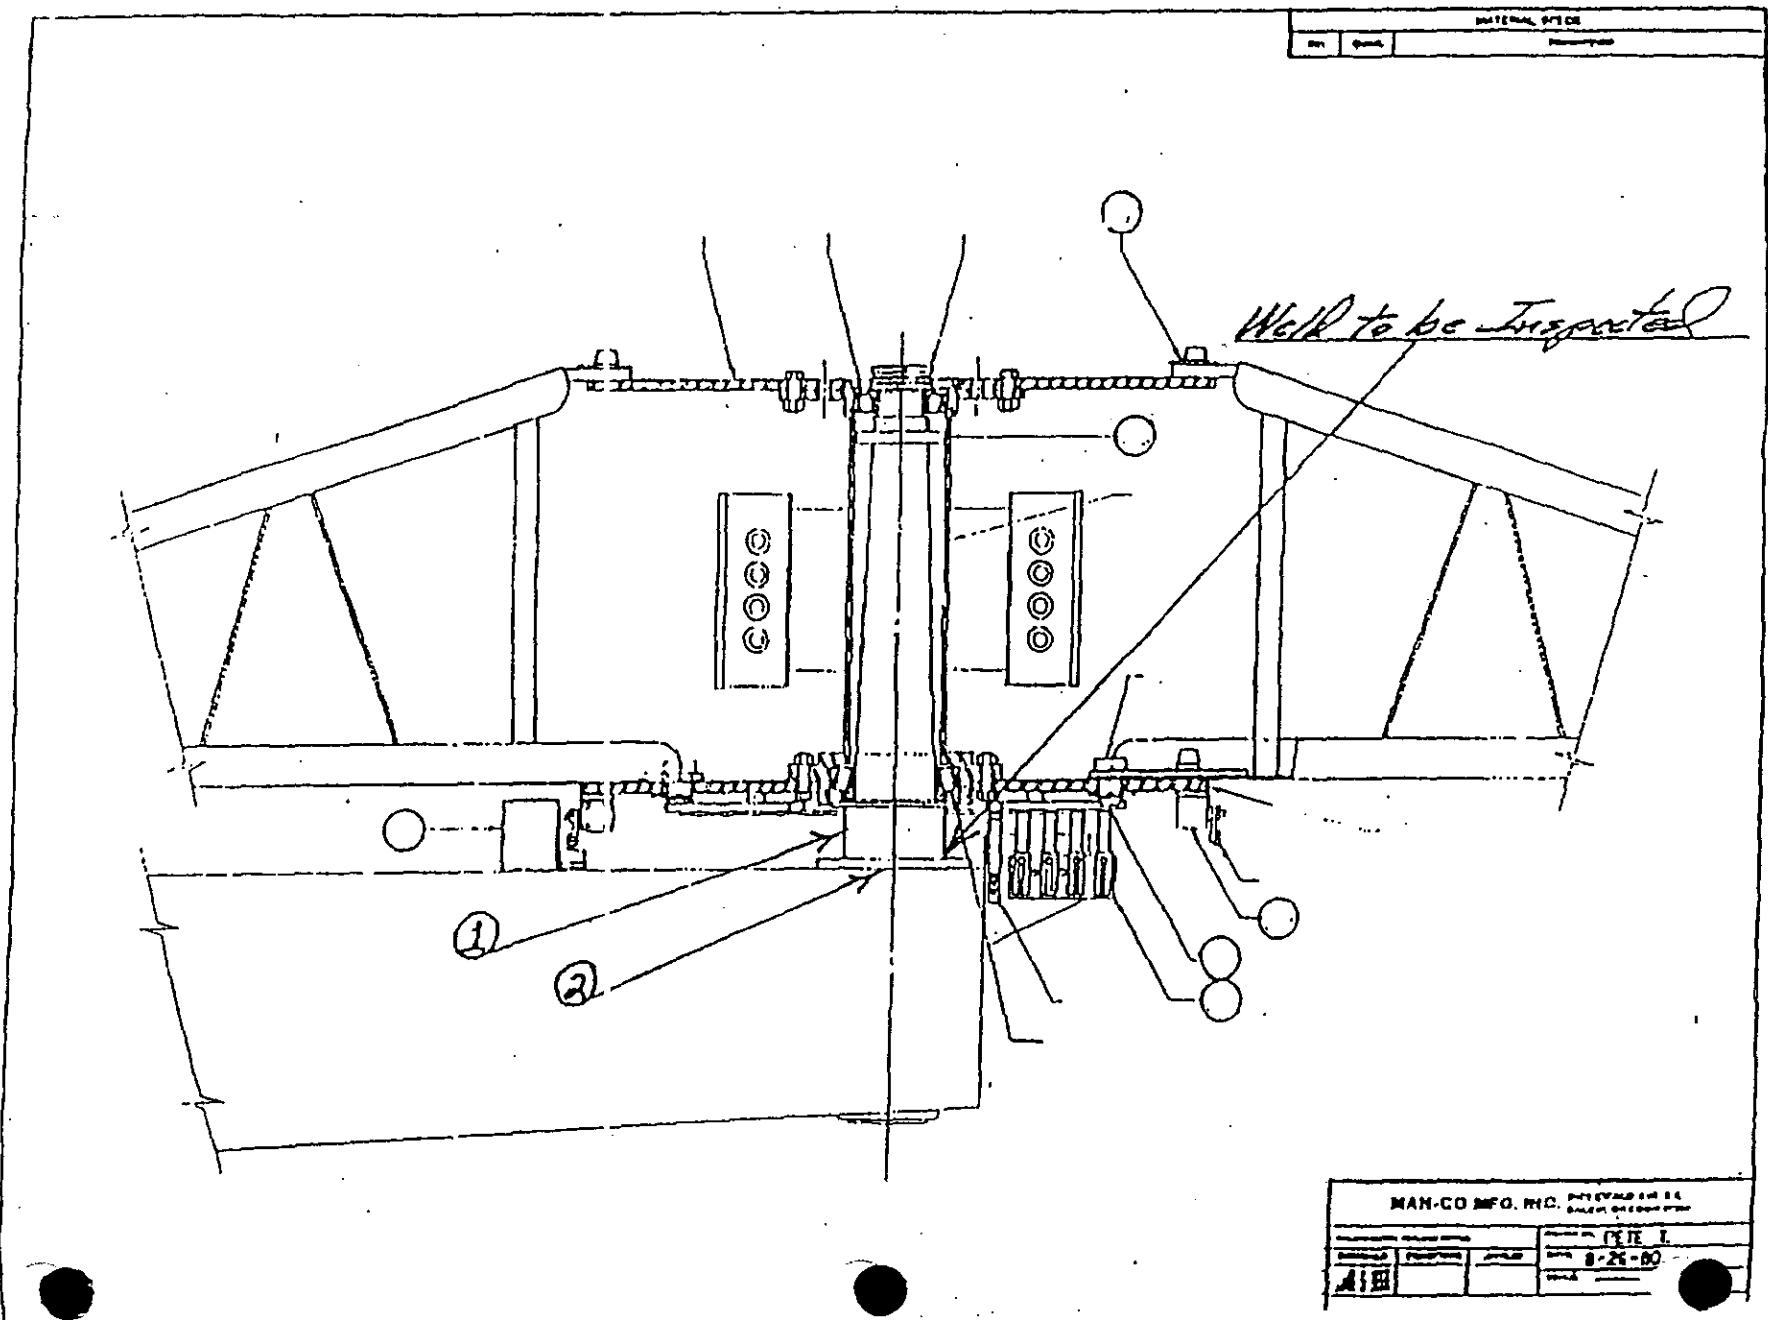
In early June 1993, a Round-Up ride experienced a failure of a weld located on the shrink collar on the main center spindle (two drawings are attached for reference). This is the first known occasion for this style of shaft to fail since the manufacturer's Bulletin requiring replacement of an earlier system.

The weld should be visually inspected immediately and periodically thereafter.

In doing so, the power for the ride needs to be turned off, and the brush holder located at the end of the main boom removed. Once this is completed, the weld that ties the (1) shrink collar to the (2) steel plate needs to be cleaned and inspected. See the first of the drawings for areas marked (1) and (2). Should a visual indication be found, the ride needs to be closed and the K&K Insurance Group, Loss Control Division, notified immediately (219-455-5709).
