Maurer Rides GmbH
Frankfurter Ring 193
80807 München

Service Bulletin 001/09

Ride: Sky Loop
Component: Seat Locking Device

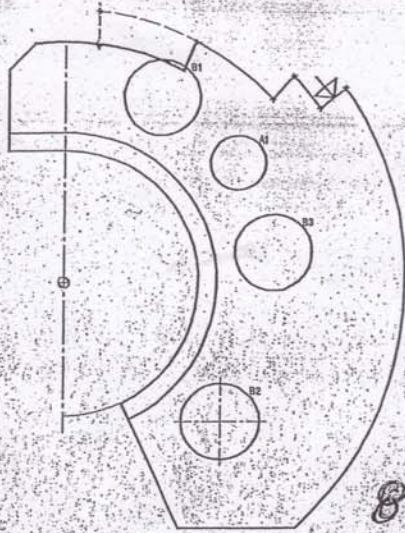
85164 alt
old

Due to a new development for our X-Car vehicle we have determined that gear segments of the mechanical locking device on vehicles that have been equipped with the so-called "Big Boy Seat" have to be replaced.

The reason for this procedure is that with the present partitioning, the opening on the security bar is too big for children, should there be a simultaneous breakdown of the hydraulic locking device.

We have made a new construction for this gear segment and have adjusted it respectively. It is absolutely essential that the gear segments with the article No. 85167 are replaced with the new gear segments with the article No. 808827 that we have sent you free of charge.

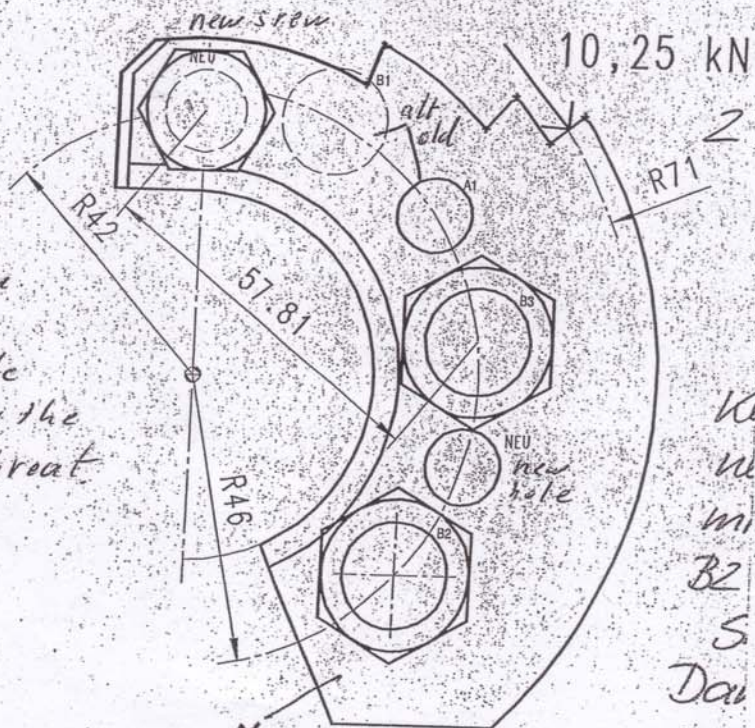
New
808827
new

Die neue konstruktive Lösung ist in Bild 3 dargestellt.

Neue Zahnplatte als
Bohrschablone verwenden

Use ~~the~~ segment as plate
to drill the new holes for the
pin and the additional throat.
