## SERVICE BULLETIN

To  
Fax  
Company  
Subject: MaxFlight Safety Service Bulletin 2008-001  
Sent: 4/13/08 at 8:30:00 PM

Units Affected: All MaxFlight Simulators [VR2000, VR2002, VR2500 and MT3000]

Purpose: To ensure security of both Pitch and Roll Encoders

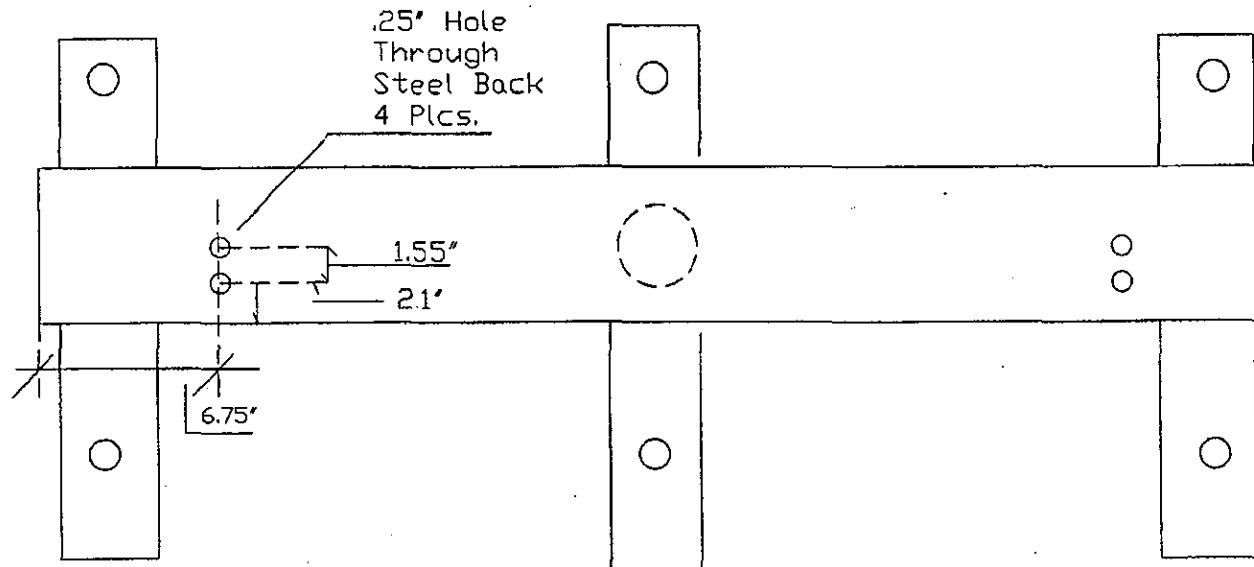
Old Aluminium Seat Backs are no longer authorized and should have been replaced with steel back mount system along with roll hub retention system.
