Important Service Advisory

**Redpoint™ and Auto-Belay Descenders
Part Numbers 10024873 and 10021806**

January 4, 2002

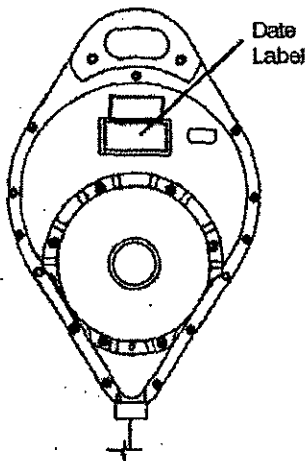
Due to the results of our investigation, all affected Redpoint and Auto-Belay Descenders must be returned for replacement of the carabiner. The ISC UK KH251 carabiner will be replaced with a carabiner of a slightly different design. **Descenders manufactured or serviced after December 1, 2001 are not affected by this Advisory.** The date of manufacture and last factory service date can be found on the back of the Redpoint and Auto Belay Descenders (See Diagram below). Contact MSA Rose Service and Repair at 1-888-737-7339 to schedule your return arrangements.

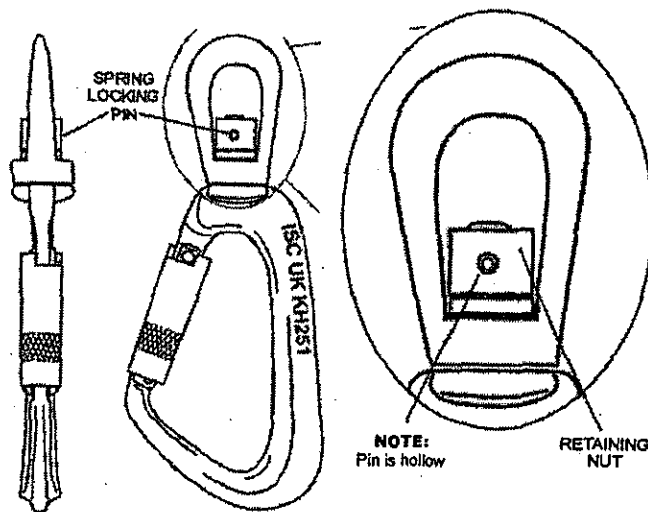
MSA has recently completed an investigation of a report of a failure of the carabiner attached to a Redpoint Descender. This carabiner is identified by the manufacturer's marking "ISC UK KH251". Our findings indicate that the swivel eye of the carabiner separated from the carabiner body when the spring-locking pin that secures the retaining nut came out, allowing the retaining nut to loosen.

Check that the spring-locking pin in the swivel eye retaining nut is present and in the correct position. The pin should be below the level of the hole, or level with the hole. Note: Earlier versions of this carabiner have a hole drilled all the way through the nut and therefore the pin needs to be checked from both sides. Please see diagrams 1(a) and 1(b) (below) for correct and incorrect pin locations.

The end of pin is level with or below the surface of the nut.

The pin is missing, or as shown below, the end of the pin sticks out above the surface of the nut.

If the pin is missing or if the end of the pin sticks out of the hole, immediately stop using the descent device and return it to MSA Rose.
