SORIANI srl

Bulletin No: 2004 TF02

SERVICE BULLETIN

Ride Name: Turbo Force and Stratosphere

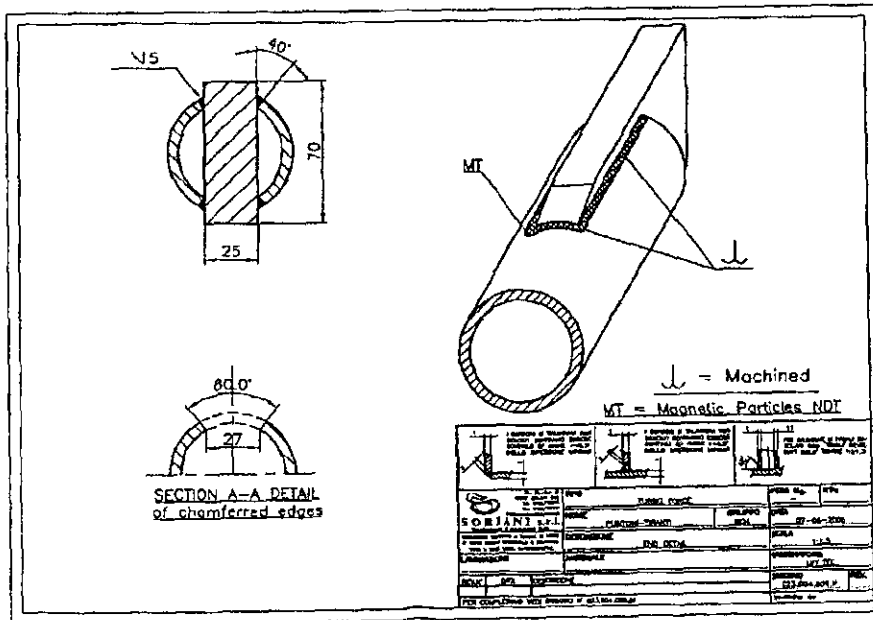
Code	Description and illustration	Symbol
343	Continuous component slotted to accommodate a plate with chamfered or radiused ends, which is welded on. The end welds in the zone not less than 5 x t in width are made in the form of double bevel butt weld with double fillet welds and machined to avoid notch effect.	See detail drawing 023.004.006M below End weld only.

The notch in the pipe to for the 25 mm steel plates must be machined and have a chamfer along its sides and ends to accommodate the weld bead. The steel plate must be welded to the pipe all around, which is recommended by the DIN Standard 15018, on table 31, notch case K3, code 342 and code 343. The slot in the pipe will accommodate a plate with angled ends, which is welded with a single bevel butt weld with fillet weld. The weld is then machined across the end and 125mm back along each side, starting at the end to avoid notch effect. (DIN 15018 is the reference standard for the design and calculation of the Turbo Force). After welding and machining the weld is to be inspected by magnetic particle. See following diagram and drawing:

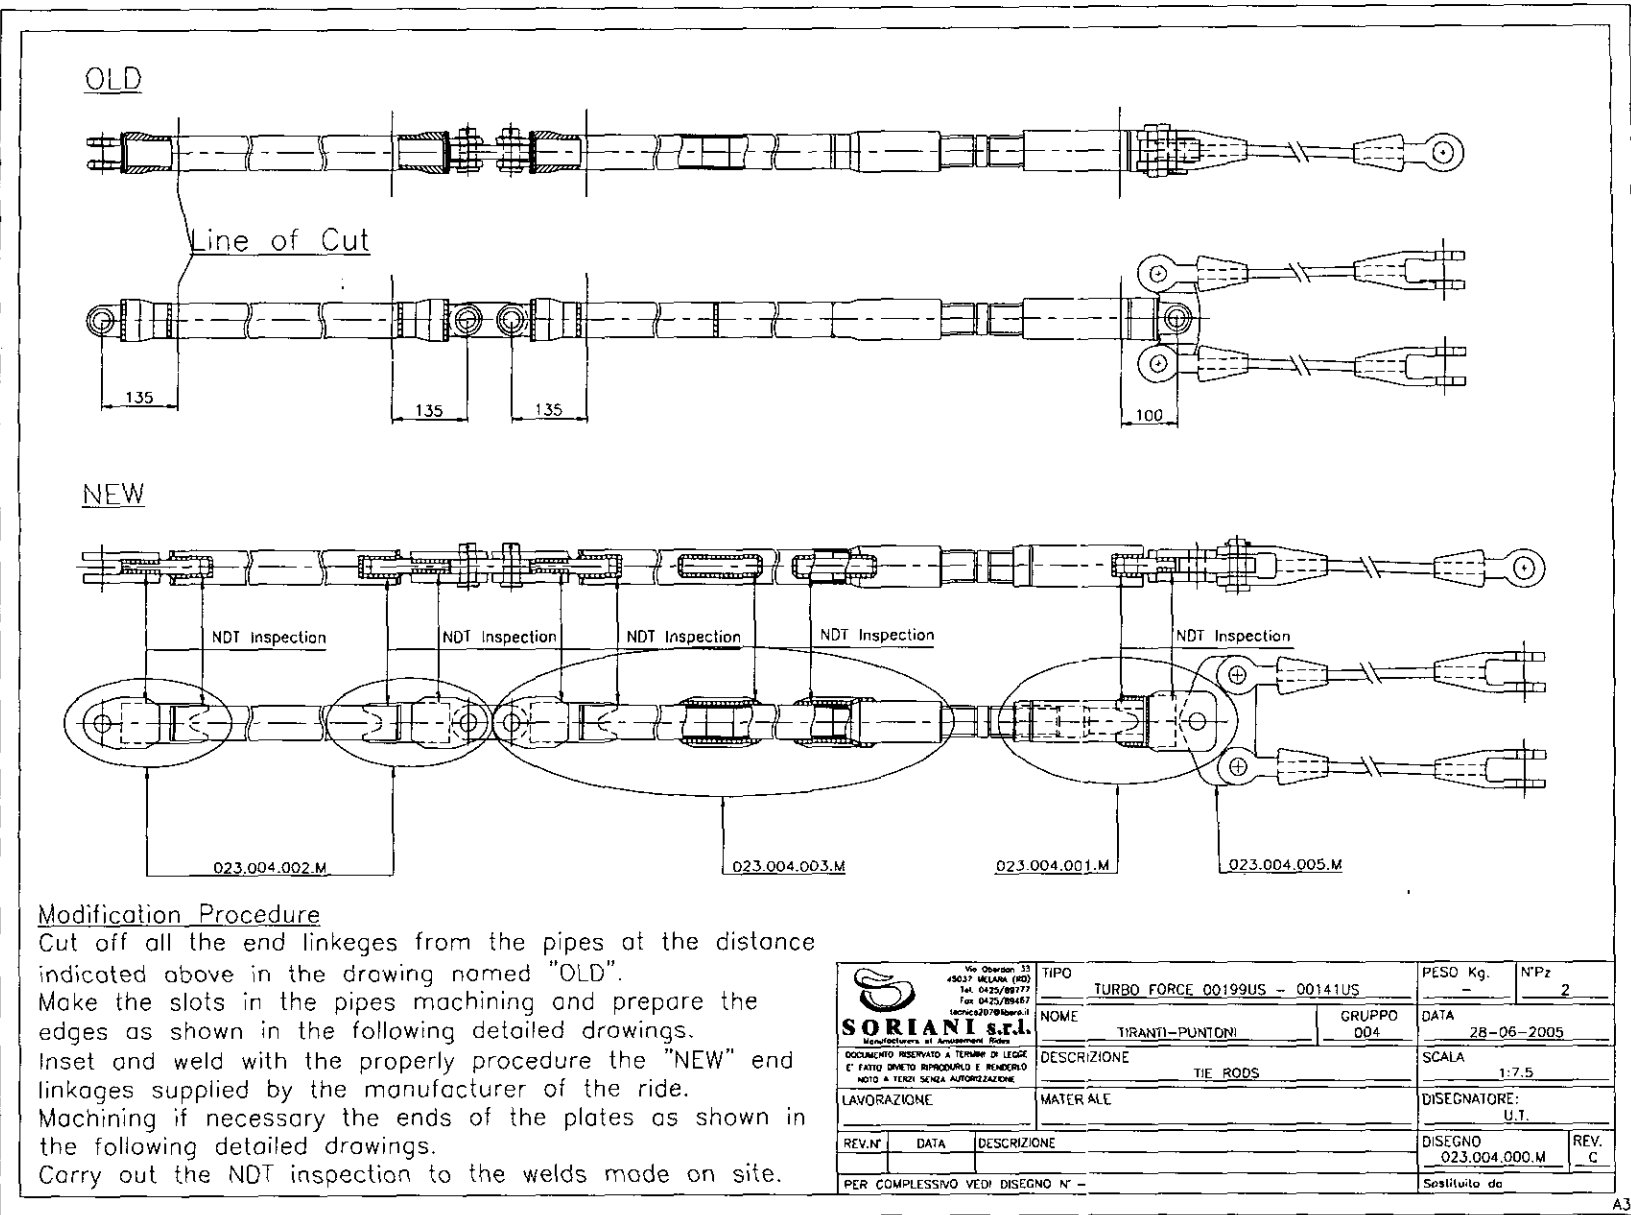
The NDT inspection should be conducted at all five positions listed in this drawing.
