**REVERCHON, S.A. INDUSTRIES, FRANCE
"HIMALAYA"
April 22, 1998**

AMUSEMENT RIDE SAFETY ALERT

Subject : Repair of « HIMALAYA » amusement ride

CPSC, Reverchon Industries Announce Repair Program for Himalaya Amusement Rides

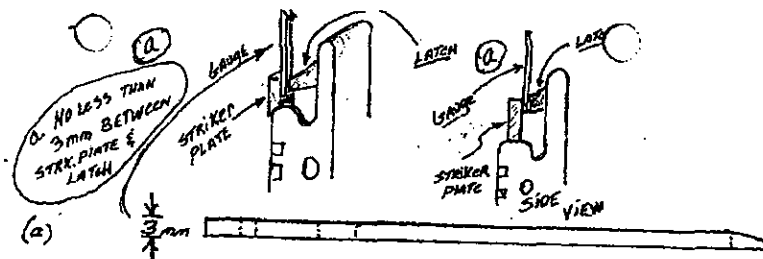
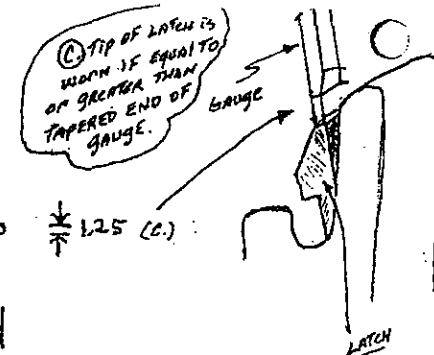
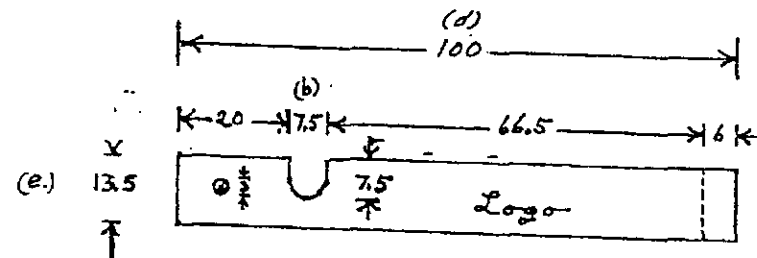
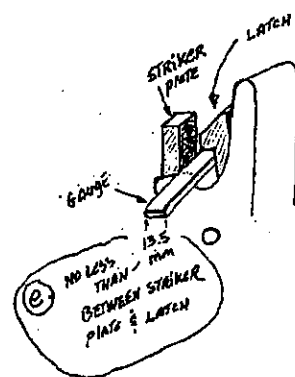
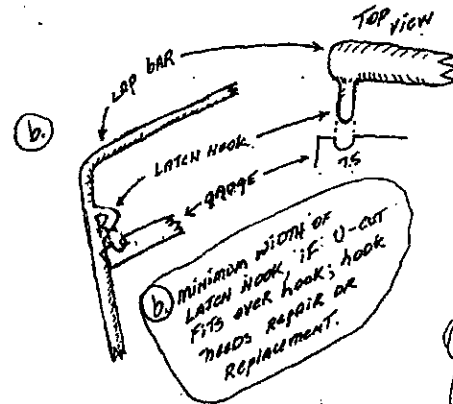
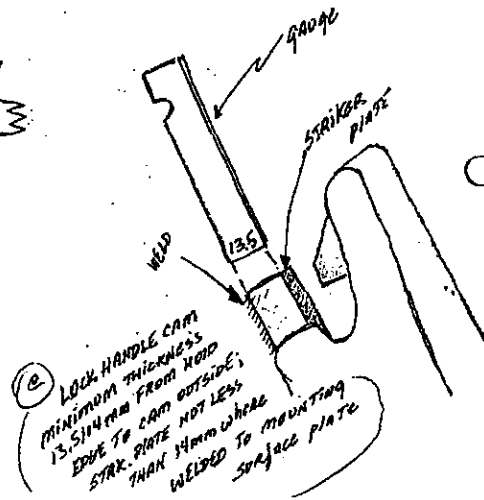
99.06 Reverchon ^{Himalaya} Gauge

- (a) Thickness - 3 mm Length between latch and striker plate, if length is less than 3 mm, latch needs repair or replacement.
- (b) U-cut - 7,5 mm Minimum width of latch hook; if U-cut slides over hook, the hook will need repair or replacement (latch hook thickness latch hook - original thickness 10 mm)
- (c) Tapered End - 1.25 mm Tip is worn if latch tip is equal to or greater than tapered end thickness.
- (d) Length - 100 mm Straight-edge for flatness measure
- (e) Width - 13,5 mm Lock handle cam minimum thickness measure 13.5/14 mm from hold edge to cam outside; striker plate not less than 14 mm where welded to mounting surface plate.

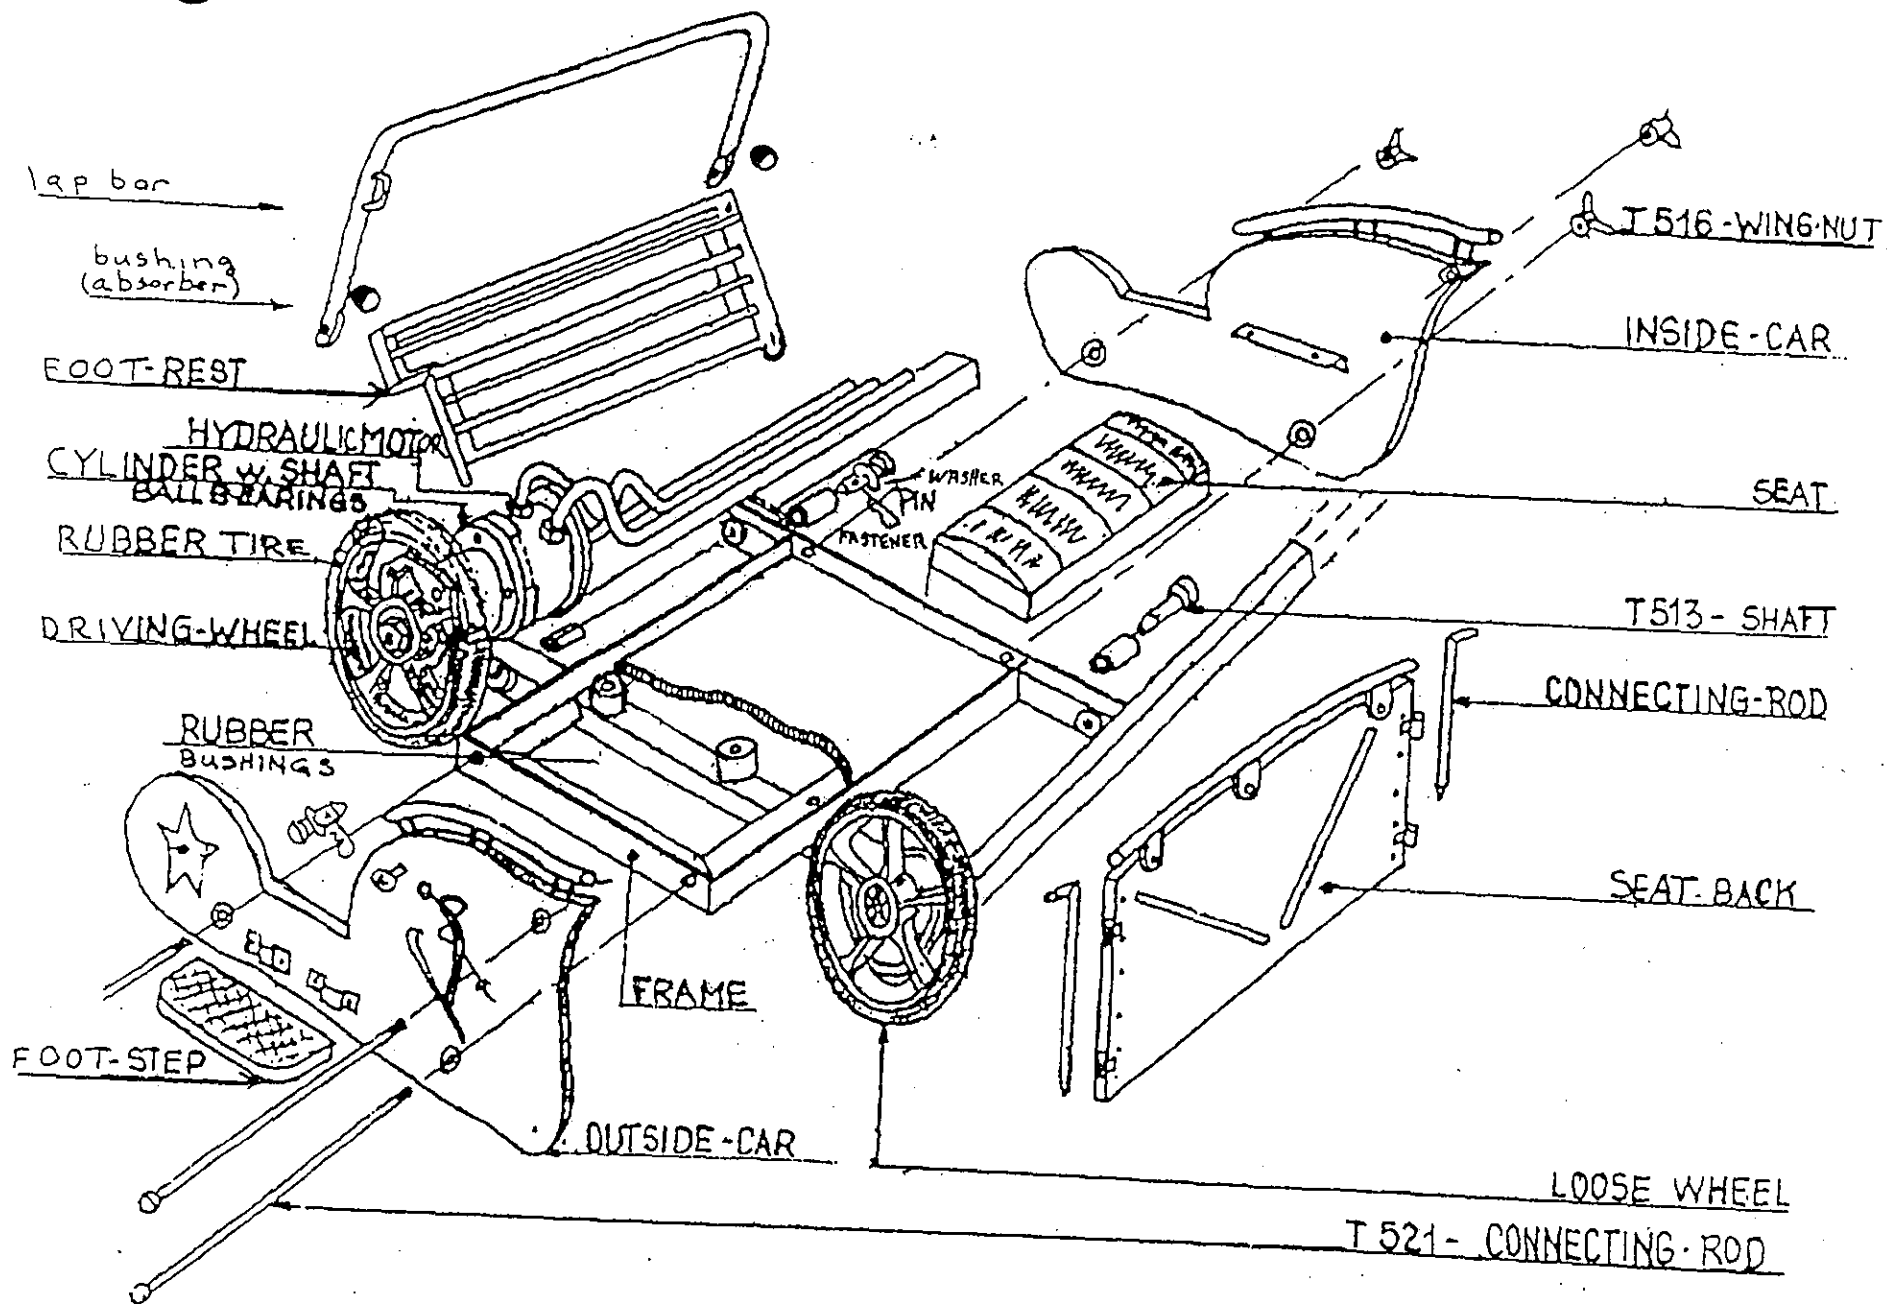
1. Stainless steel cotter pins or R-keys, with hardened washers (with a hole diameter that closely fits the car's lower lap bar pin) are to be used as fasteners for car lap bars. These stainless steel fasteners are non-magnetic and can be checked with a magnet. The stronger stainless steel cotter pins have been used on amusement rides where there is a concern of removal by a patron. A 304, 316 or 18-8 stainless steel alloy cotter pin could be more difficult to dislodge than a wired R-Key. Alternately, "rue" pins and "circular cotter pins" are also appropriate fasteners. A hardened washer that closely fits the lower lap bar pin that is placed between the stronger fasteners and lower lap bar should reduce fastener shearing. The lower lap bar fasteners require inspection, maintenance, and replacement as necessary. [SEE ATTACHED DRAWING]

8. Inspect rubber bushings (absorbers), both on the lap bar latching system and under each car, for bulging, cracking, wear, and deterioration that affects the bushings purpose and effectiveness. Replace bushing if indicated. [SEE ATTACHED DRAWING]

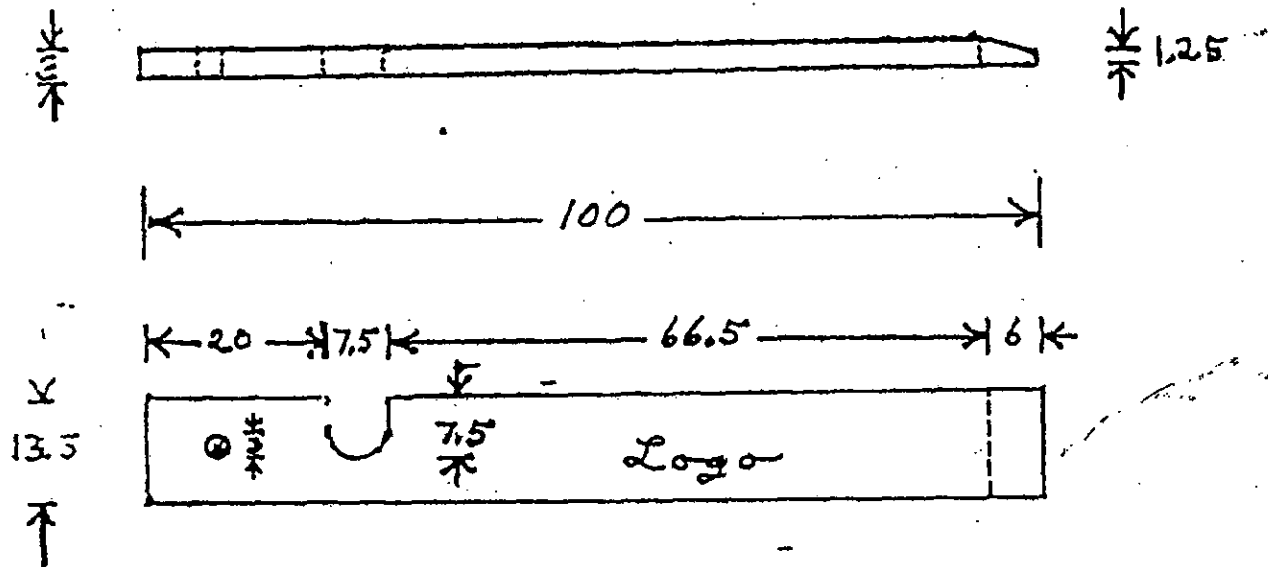
Use of Lap Bar Latch Tolerance Gauge for Reverchon HIMALAYA

- (a) Thickness - 3 mm Length between latch and striker plate, if length is less than 3 mm, latch needs repair or replacement.
- (b) U-cut - 7,5 mm Minimum width of latch hook; if U-cut slides over hook, the hook will need repair or replacement (latch hook thickness latch hook - original thickness 10 mm)
- (c) Tapered End - 1.25 mm Tip is worn if latch tip is equal to or greater than tapered end thickness.
- (d) Length - 100 mm Straight-edge for flatness measure
- (e) Width - 13,5 mm Lock handle cam minimum thickness measure 13.5/14 mm from hold edge to cam outside; striker plate not less than 14 mm where welded to mounting surface plate.
