# Tivoli MFG Ltd.

## Service Bulletin

Bulletin No: SOSR001

Ride Type: Spin Out  
Date: September 8, 1998

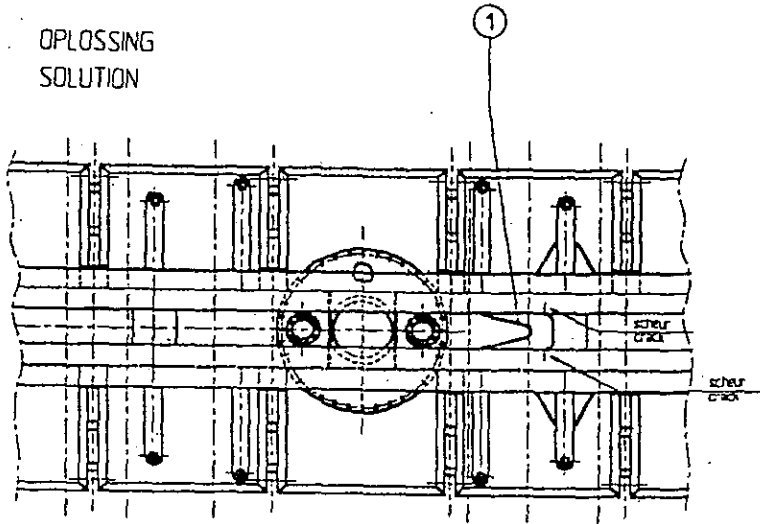
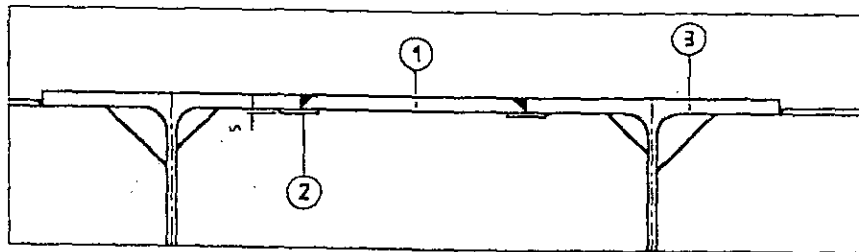
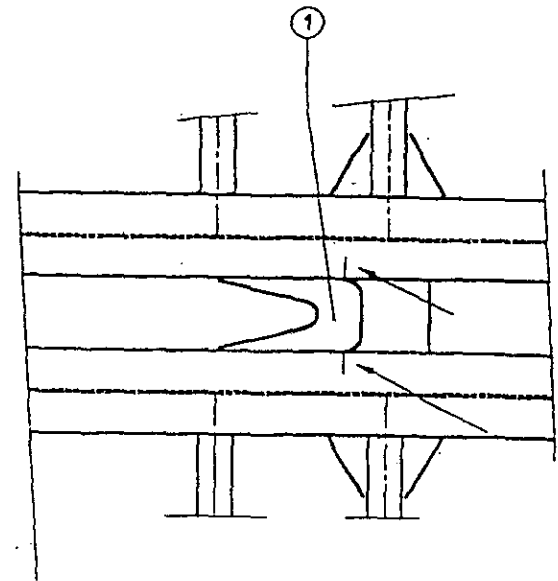
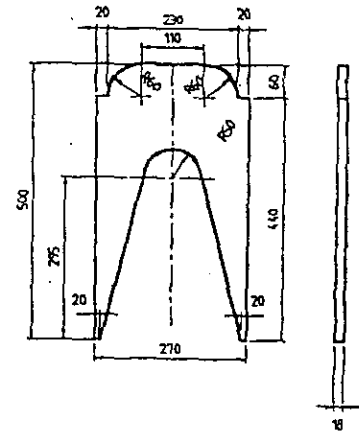
OPLOSSING  
 SOLUTION

It has come to the attention of **Tivoli Mfg. Ltd.** from the original designers of the Spin Out, **KMG Europe BV**, that there has been cases where cracks have been detected on the center I beam of the rotating base frame as described in the accompanying drawings.

- 1 LAS STRIP POS. 2 ONDER DE CHASSIS BALKEN POS. 3  
 WELD PLATE POS. 2 UNDER THE CHASSIS BEAMS POS. 3
- 2 LAS PLAAT POS 1 IN DE TRAILER  
 WELD PLATE POS. 1 IN THE TRAILER
- 3 REPAREER DE SCHEUR. DOOR DE SCHEUR UIT TE SLIJPEN EN DICT TE LASSEN  
 REPAIR THE CRACK . BY GRINDING OUT THE CRACK AND WELD THE HOLE.

1. Locate end of crack and drill a 1/4" hole through beam where crack ends.
2. Grind and clean out crack to about 1/8" of bottom of beam.
3. Weld up ground out crack and grind of weld flush with I beam.
4. Install gusset plate as described in attached drawings and weld in place.

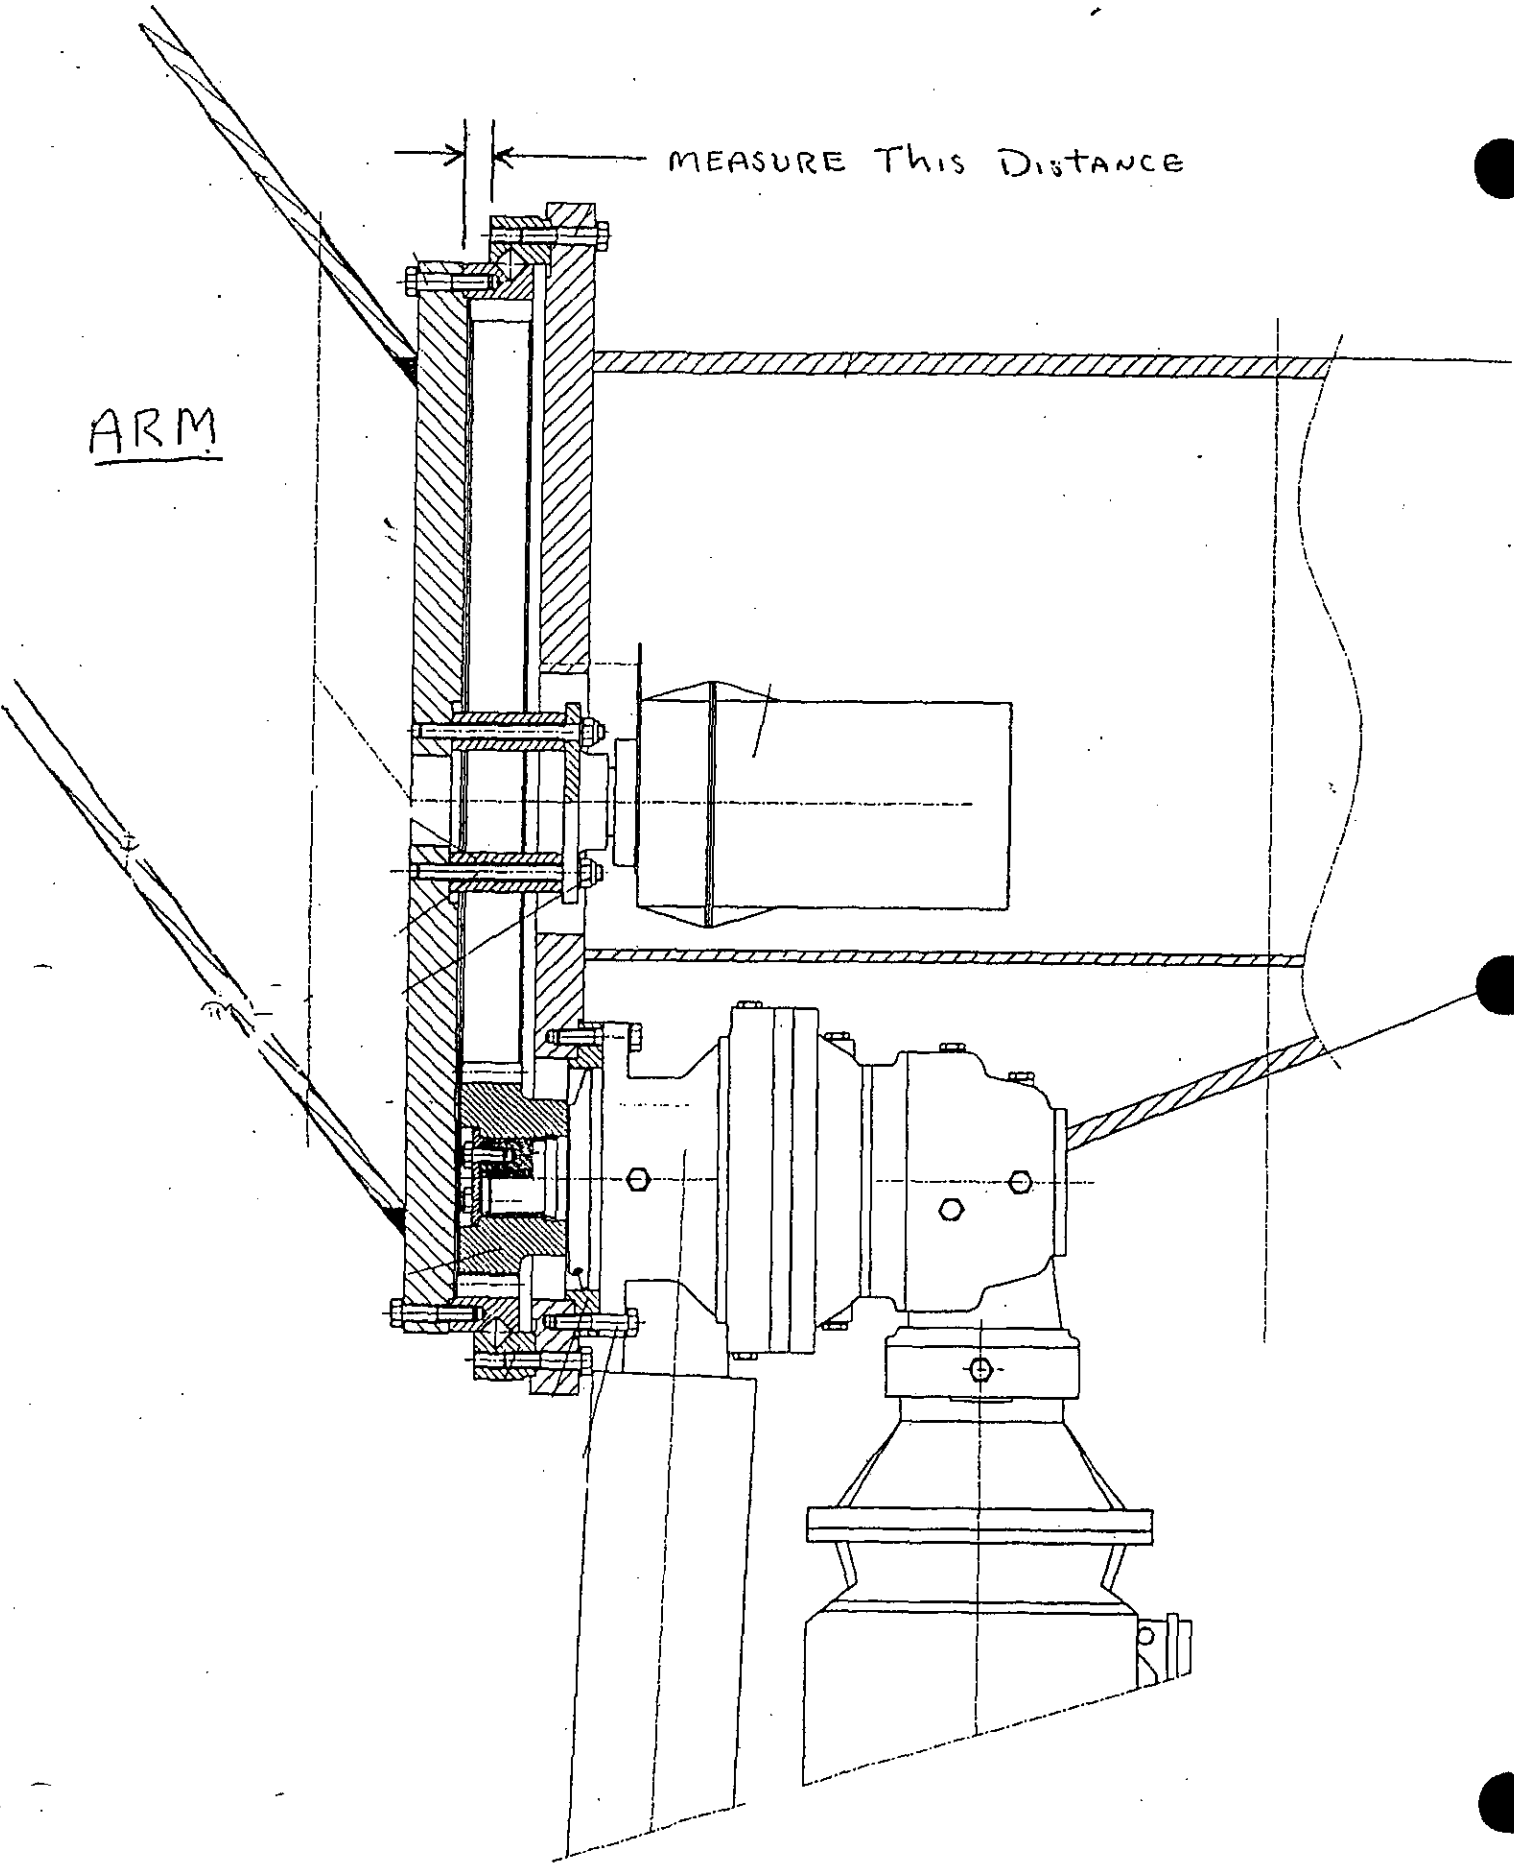
Measure the distance as described on page 2 at the 12:00 O'Clock position of the arm slewing ring and record measurement in ride log book. Check this measurement on a monthly bases. If the measurement increases over 1/8" the bearing is wearing to a point that it must be replaced.

If the bearing is starting to wear metal filings will be noticeable in the grease around the seal. Inspect this on a weekly bases.

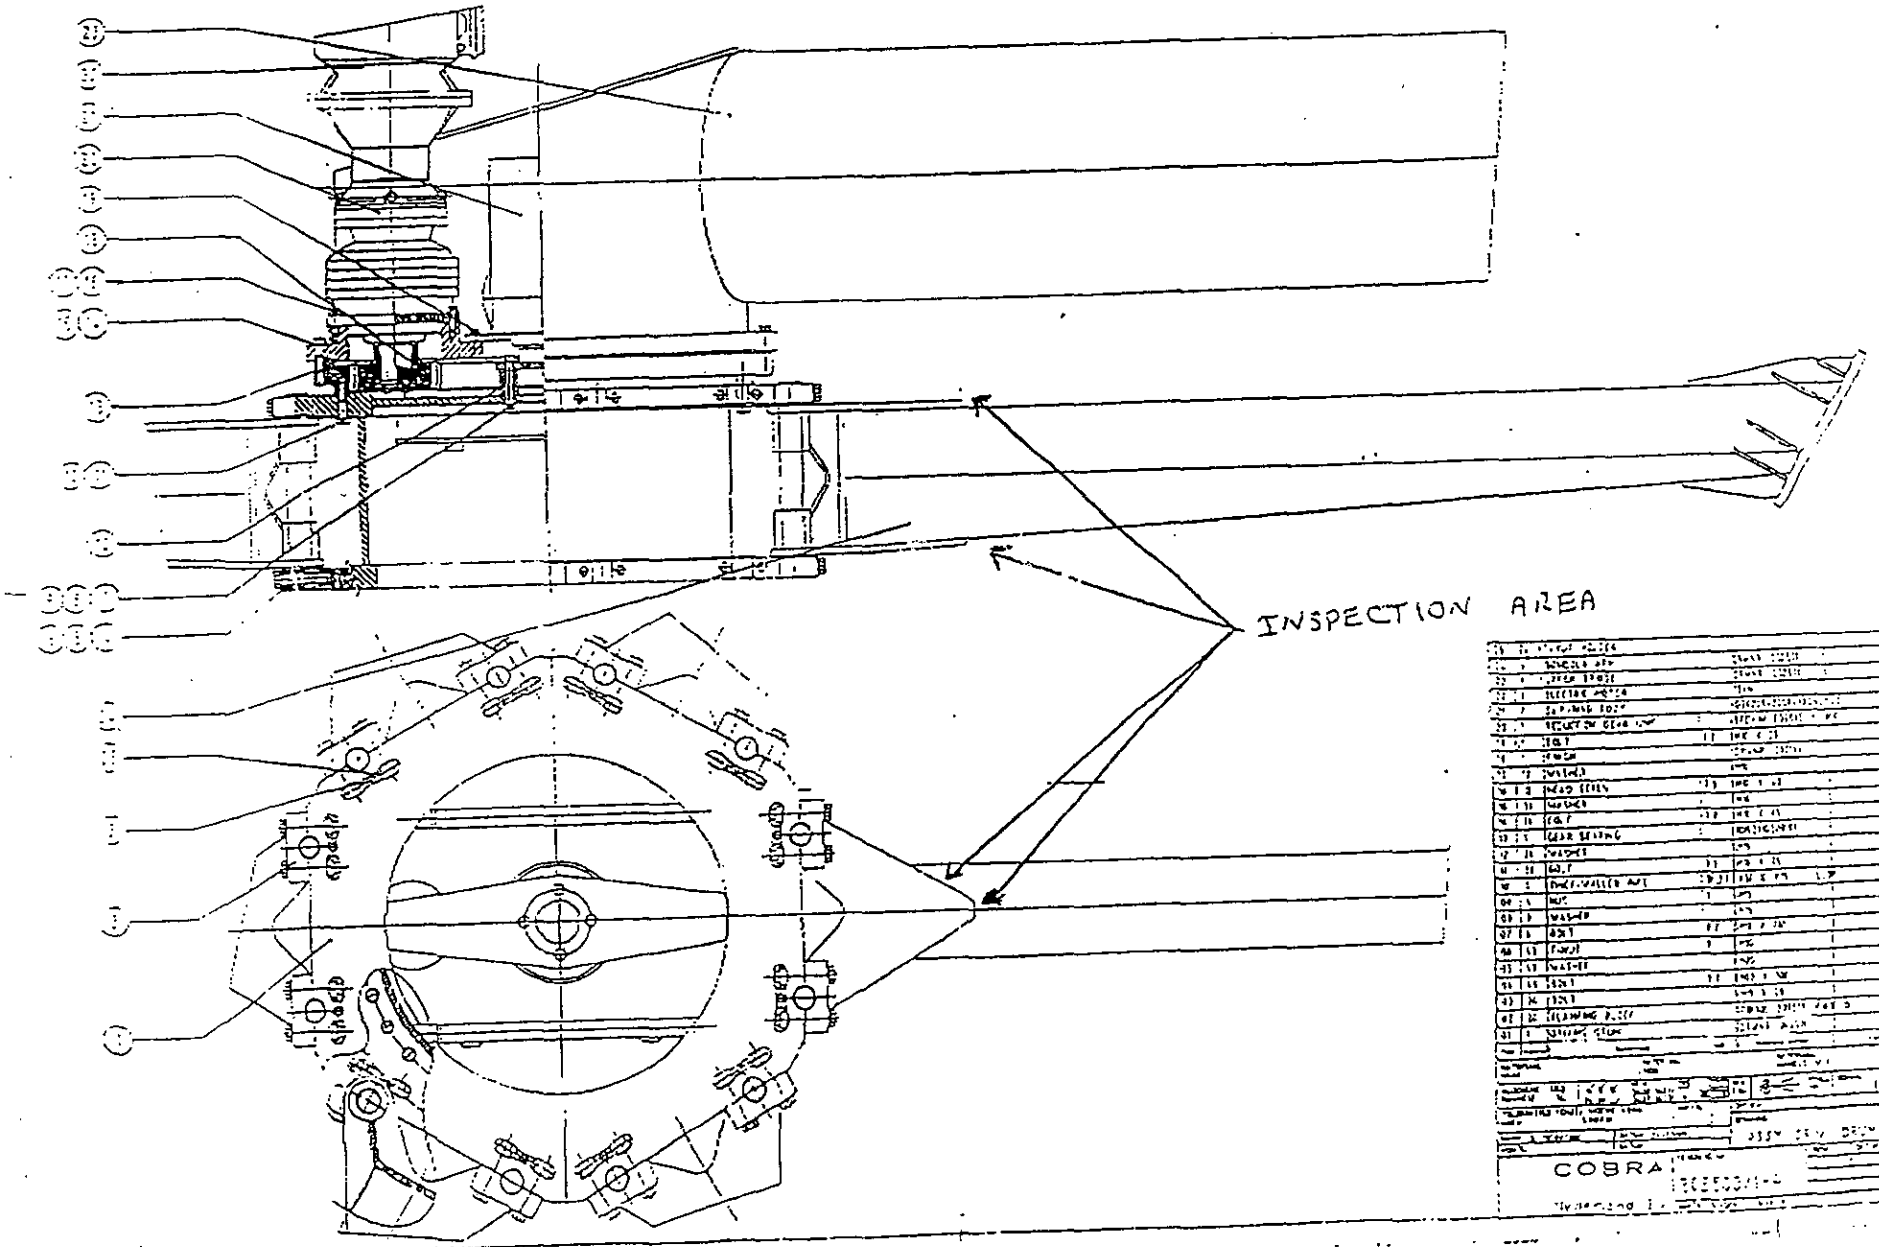
INSPECTION AREA

It has come to the attention of **Tivoli Mfg. Ltd.** from the original designers of the Spin Out, **KMG Europe BV**, that there has been cases where cracks have been detected on the sweep arms (see attached drawings) of Spin Out rides operating in Europe.

Repair procedure: Drill 1/4" though hole at each end of crack. grind out crack  
approximately 3mm deep and weld up crack using 7018 low  
hydrogen welding rod.

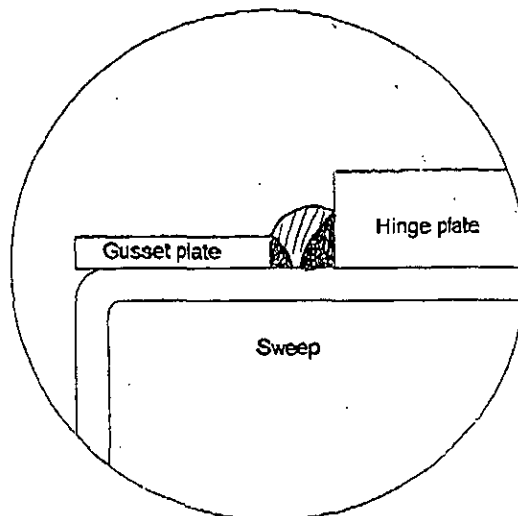
During routine inspection of a Spin Out Sweep, it was found that the upper and lower "H" gussets were not welded to the triangular hinge plate properly. Tivoli Mfg. Ltd requires that the gusset plate be welded completely to the hinge plate. This may require up to 4 welding passes where the gusset plate does not meet up to the hinge plate. Please review the safety bulletin SOSA010 and confirm that the gussets have been installed correctly. Below is an example of proper welding of the gusset plate to the hinge plate where there is a gap between plates.
