REQUIRED INSPECTION NOTICE

DATE: JULY 31, 1998
RIDE: DRAGON WAGON
SUBJECT: ROD END COUPLER THREADS
REQUIRED COMPLIANCE: MANDATORY
COMPLETION DATE: IMMEDIATELY

DATE: JULY 31, 1998
RIDE: DRAGON WAGON
SUBJECT: ROD END COUPLER GREASE ZERK HOLES
COMPLIANCE: MANDATORY
COMPLETION DATE: IMMEDIATELY

SUBJECT: Wisdom's Dragon Wagon/Go Gator/Scooper Jet/Clatterpillar/Minor Mike

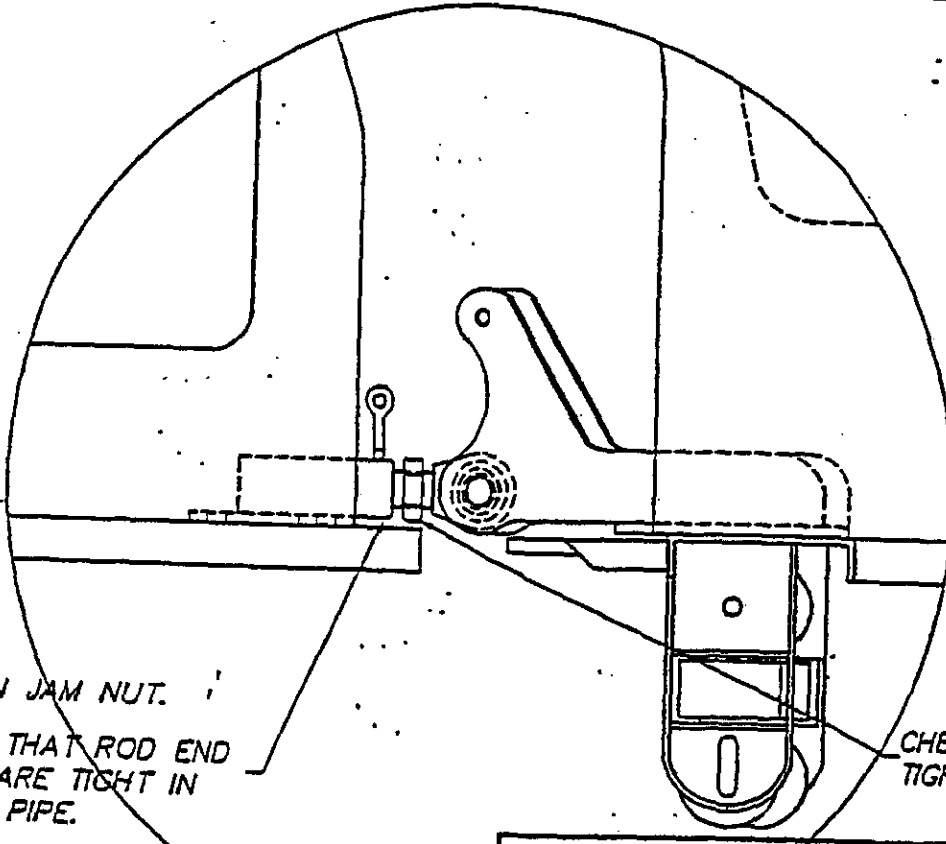
One coaster has experienced wear on the threads on the rod end connecting the cars together. The wear is caused by the lock nut loosening and allowing the rod end to work back and forth in the coupler mount. To prevent the possibility of the rod end pulling out of the mount, check the threads in all rod end couplers for wear and replace any that are worn.

1. LOOSEN JAM NUT.
2. CHECK THAT ROD END THREADS ARE TIGHT IN MOUNTING PIPE.
3. TIGHTEN JAM NUT.

CHECK JAM NUT FOR TIGHTNESS DAILY.

1. Loosen jam nut on rod end.
2. Raise and lower the front of the car that the rod end is attached to.
3. Look for looseness or movement of the thread end inside the coupling mount as the front of the car is raised and lowered.
4. If no looseness is observed retighten the rod end.
5. If the threads are loose remove the rod end and replace.
6. Retighten the rod end.

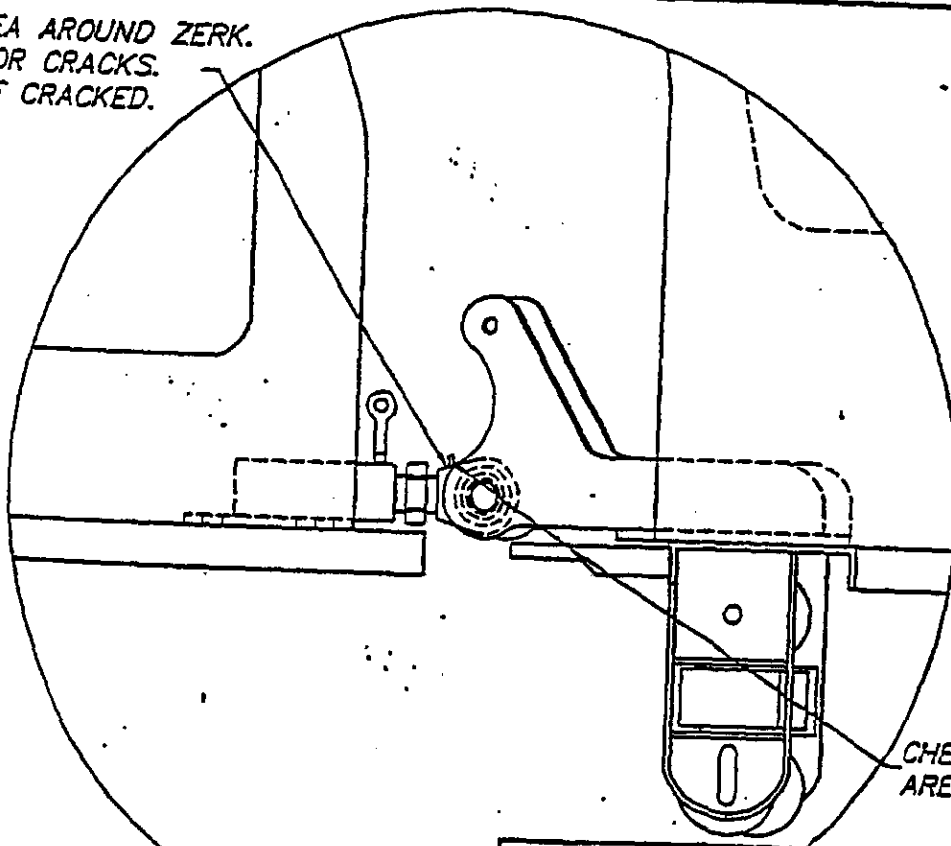
One coaster has has one rod end crack at the grease zerk hole. Inspect the rod end, between the cars for cracking in the grease zerk area.

CLEAN AREA AROUND ZERK.
INSPECT FOR CRACKS.
REPLACE IF CRACKED.

CHECK GREASE ZERK
AREA FOR CRACKS.

1. Thoroughly clean the area around the grease zerk.
2. Inspect the area around the ground zerk for cracks.
3. If there is a question about cracking use a dye penetrant kit to check for cracks.
4. If no cracks are found include a check of the grease zerk area in the daily inspection of the ride.
5. If the rod end is cracked replace the rod end.

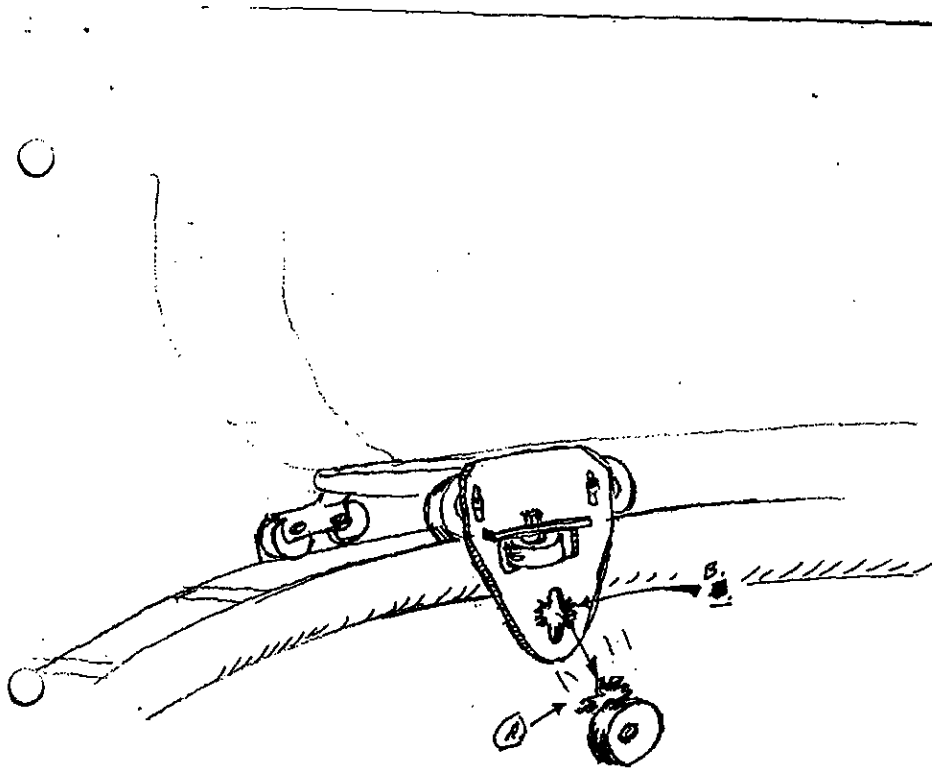
Carlos Corvo inspected Crown's Dragon Wagon and found the bottom wheel had broken loose, and came completely through the adjustment slot, due to metal fatigue/incorrect bolt size/incorrect nut/incorrect washer or combination of all four. (See diagram)

Removing the bottom wheels from the remaining tubs Carlos found seven out of the remaining eight had "v" shaped cracks (see diagram) emanating from the adjustment slot, and one of the seven was almost ready to fail.

Until we hear further from Wisdom we will require the operators remove the bottom wheel, clean the area of grease and dirt, so that we can more closely visually inspect for cracks. There is an oversized washer that, we believe, is to be used on this wheel. If an undersized nut/bolt or washer is used it may exacerbate the situation.
