# REQUIRED INSPECTION NOTICE

**DATE:** JULY 31, 1998  
**RIDE:** ONE TRUCK HIMALAYA  
**SUBJECT:** ROD END COUPLER THREADS  
**COMPLIANCE:** MANDATORY  
**COMPLETION DATE:** IMMEDIATELY

**DATE:** DECEMBER 18, 1998  
**RIDE:** ONE TRUCK HIMALAYA  
**SUBJECT:** MASTER SWEEP INSPECTION (4 SWEEPS)  
**COMPLIANCE:** MANDATORY  
**COMPLETION DATE:** IMMEDIATELY

# **SAFETY BULLETIN**

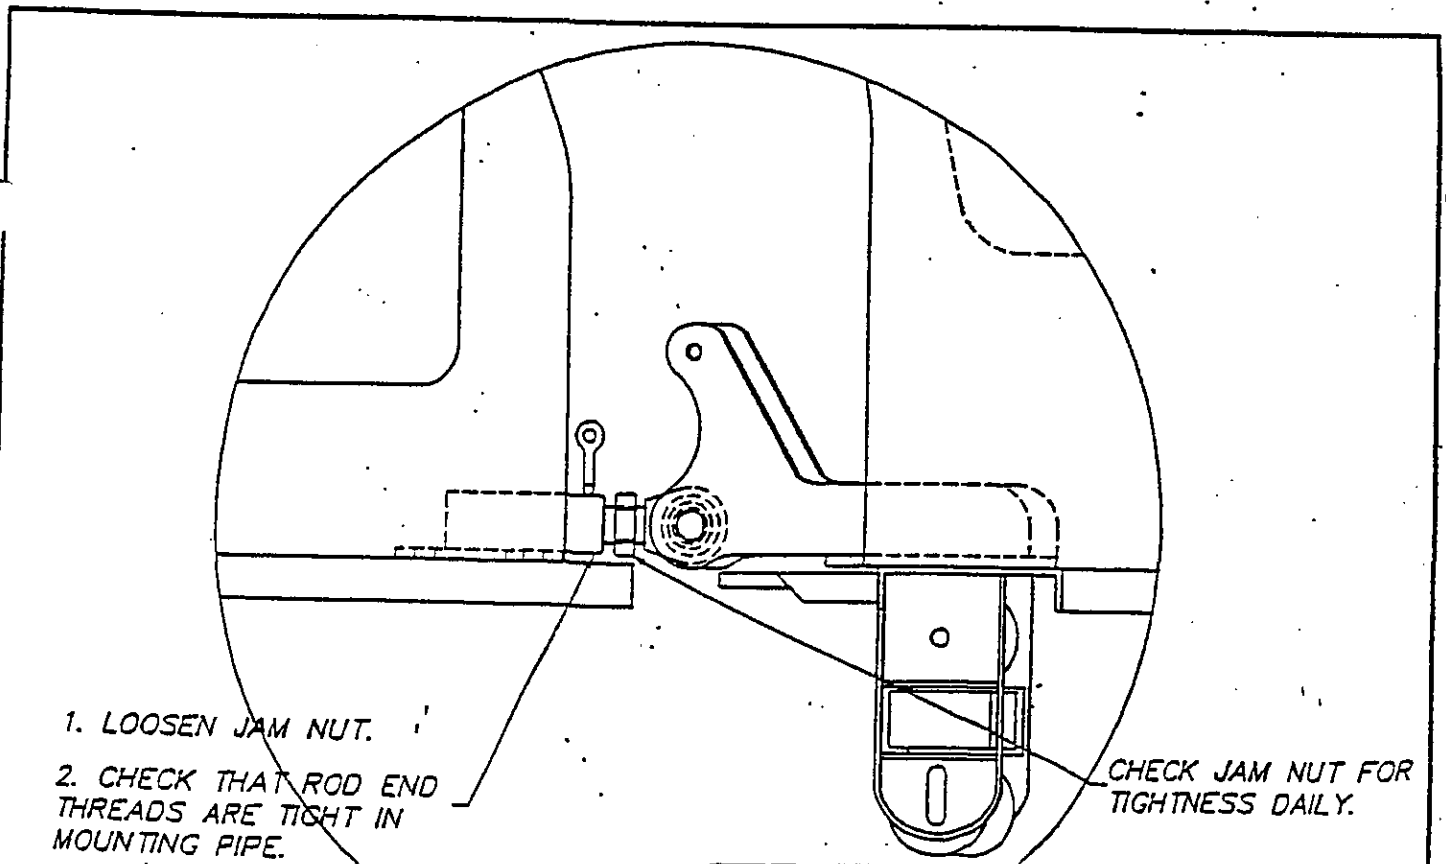
One coaster has experienced wear on the threads on the rod end connecting the cars together. The same connection is used on the Himalaya. The wear is caused by the lock nut loosening and allowing the rod end to work back and forth in the coupler mount. To prevent the possibility of the rod end pulling out of the mount, check the threads in all rod end couplers for wear and replace any that are worn.

1. LOOSEN JAM NUT.
2. CHECK THAT ROD END THREADS ARE TIGHT IN MOUNTING PIPE.
3. TIGHTEN JAM NUT.

CHECK JAM NUT FOR TIGHTNESS DAILY.

1. Loosen jam nut on rod end.
2. Raise and lower the front of the car that the rod end is attached to.
3. Look for looseness or movement of the thread end inside the coupling mount as the front of the car is raised and lowered.
4. If no looseness is observed retighten the rod end.
5. If the threads are loose remove the rod end and replace.
6. Retighten the rod end.

1. Block up front of car.
2. Remove connecting pin.
3. Push car ahead to allow access to rod end.
4. Loosen lock nut.
5. Unscrew rod end from coupler.
6. Screw lock nut from original rod end onto new rod end.

7. Screw new rod end into front of car.
8. Tighten lock nut.
9. Reconnect cars together with pin and R-key.
10. Check that the lock nut is tight.
11. Remove blocks and check track for objects on the track that can stop the ride.
12. Test run ride.
13. Check that the jam nut is tight daily.

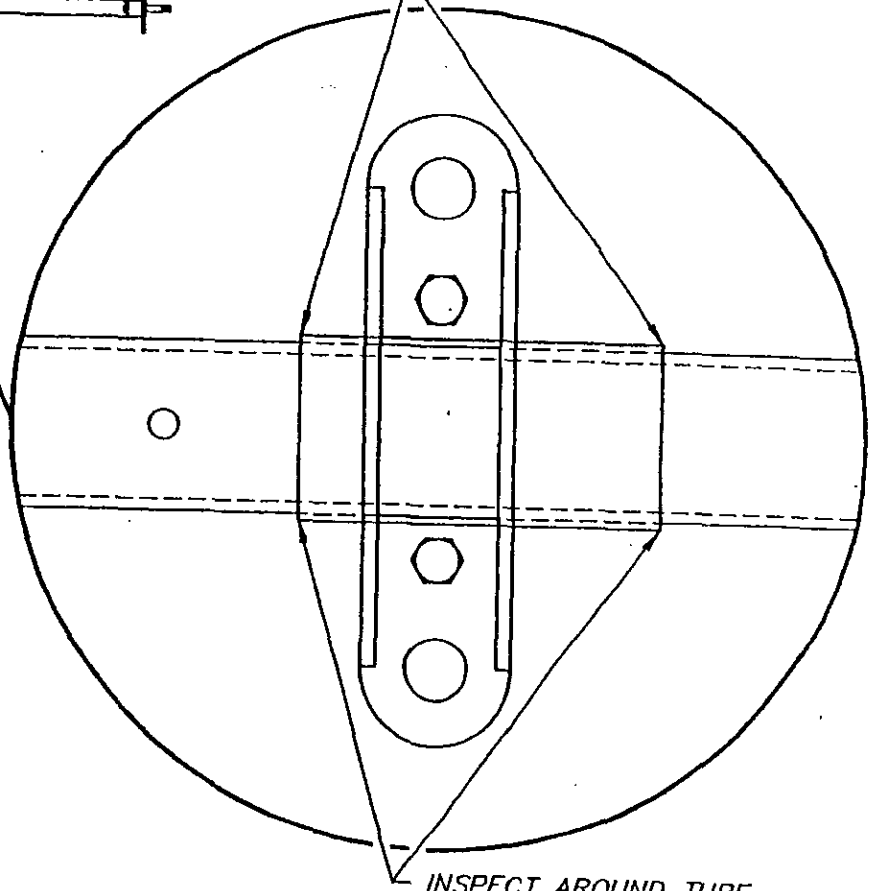
One Himalaya has experienced cracking on the master sweep where the diagonal rods pivot the end of the sleeve. Review the drawing on the reverse side and inspect for cracking around the tube at the end of the sleeve. If cracks are indicated contact Wisdom Industries at 800-634-6097 for repair or replacement of the sweep.

INSPECT AROUND TUBE

INSPECT MAIN SWEEP TUBE FOR CRACKS.  
 CLEAN OFF GREASE & DIRT BEFORE INSPECTING.  
 IF CRACKS ARE FOUND, DO NOT OPERATE  
 THE RIDE UNTIL CONTACTING WISDOM INDUSTRIES  
 AT (800) 634-6097 FOR REPAIR OR REPLACEMENT  
 INSTRUCTIONS.  
 USE VISUAL INSPECTION FOLLOWED BY MAGNA FLUX.

1. Clean area on each master sweep where indicated on the drawing.
2. Visually inspect around the circumference for cracks.
3. Follow the visual inspection with magnaflux.
4. If cracks are found contact Wisdom Industries before operating the ride for instructions on repair or replacement of the sweep.
5. Repeat for the other 3 master sweeps.

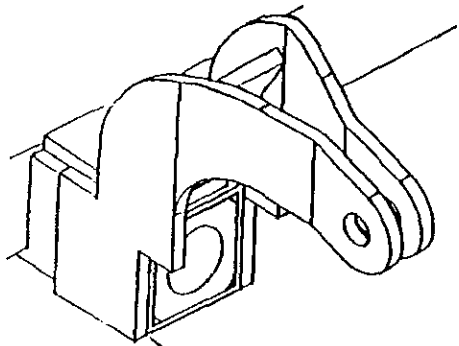
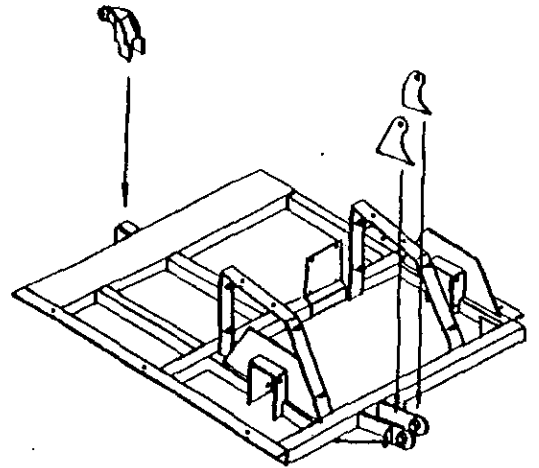
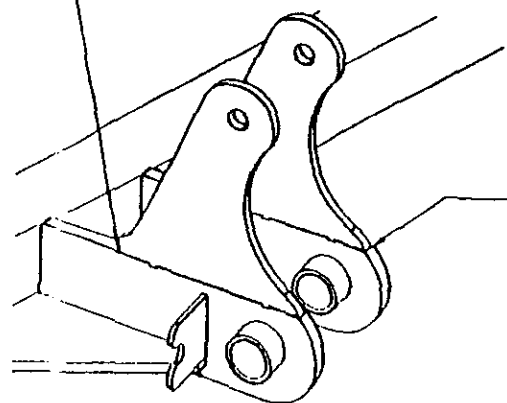
<b>WISDOM INDUSTRIES</b> Merino, CO 80741	
SCALE: 3/4" = 1'-0"	APPROVED BY:		
DATE: 04/06/99		DRAWN BY: CKW	
DESCRIPTION		REVISED	
<b>CAR HITCH SERVICE BULLETIN</b>			
EQUIPMENT:		DRAWING NUMBER	
<b>HIMALAYA</b>		<b>BH 099</b>

Until the safety plates are installed, check the jam nut between the cars daily for tightness. If a jam nut is found to be loose. Remove the rod end and check the threads for wear. Replace the rod end if the threads are worn on the rod ends.

Install the safety plates and couplers between the cars according to the drawing shown on the reverse. Contact Wisdom Industries for a set of plates to install.

NOTE 1: BE SURE BOTTOM OF BRACKET IS PARALLEL WITH TUBING TO ACHIEVE CORRECT HOLE HEIGHT.

NOTE 2: ALIGN FRONT CORNERS BEFORE WELDING.

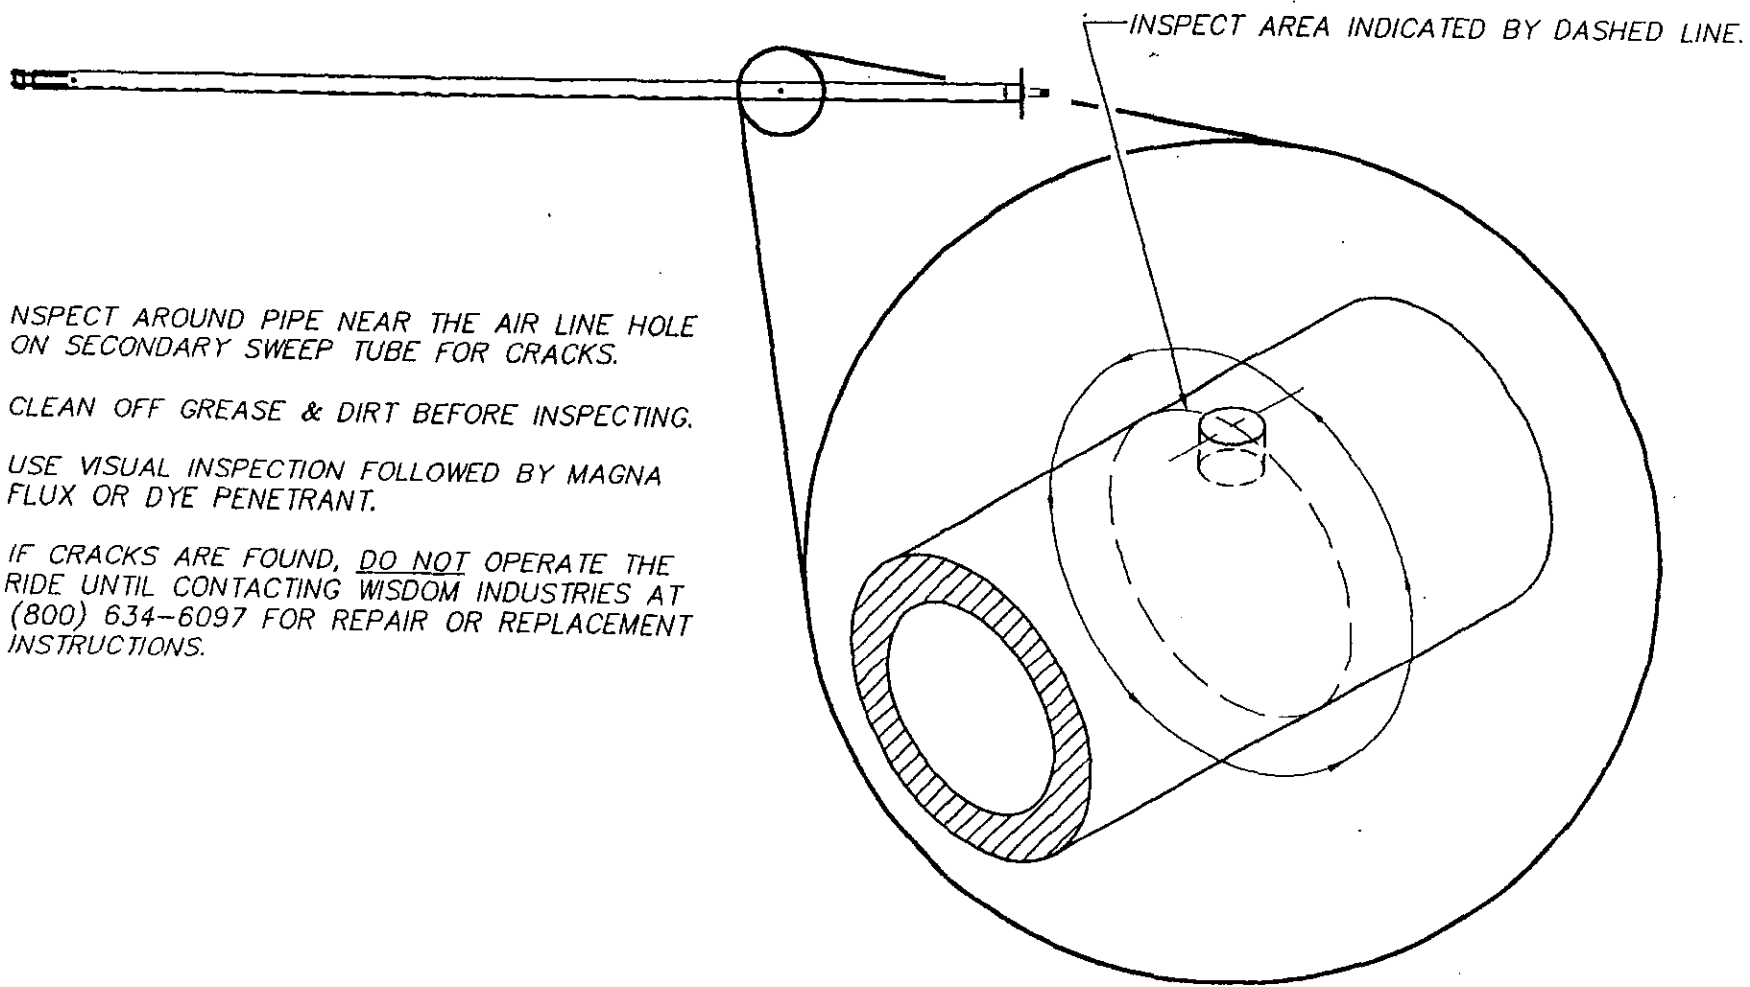
One Himalaya has experienced cracking on the secondary sweeps where the air line hole is drilled near the cars. Review the drawing on the reverse side and inspect for cracking around the airline hole. If cracks are indicated contact Wisdom Industries at 800-634-6097 for repair or replacement of the sweep.

INSPECT AROUND PIPE NEAR THE AIR LINE HOLE ON SECONDARY SWEEP TUBE FOR CRACKS.

1. Clean area on each secondary sweep where the air line exits the pipe ( see drawing).
2. Visually inspect around the circumference of the pipe at the air line hole for cracks.
3. Follow the visual inspection with magnaflex or dye penetrant.
4. If cracks are found contact Wisdom Industries before operating the ride for instructions on repair or replacement of the sweep.
5. Repeat for the other 17 secondary sweeps.

CLEAN OFF GREASE & DIRT BEFORE INSPECTING.

USE VISUAL INSPECTION FOLLOWED BY MAGNA FLUX OR DYE PENETRANT.

IF CRACKS ARE FOUND, DO NOT OPERATE THE RIDE UNTIL CONTACTING WISDOM INDUSTRIES AT (800) 634-6097 FOR REPAIR OR REPLACEMENT INSTRUCTIONS.

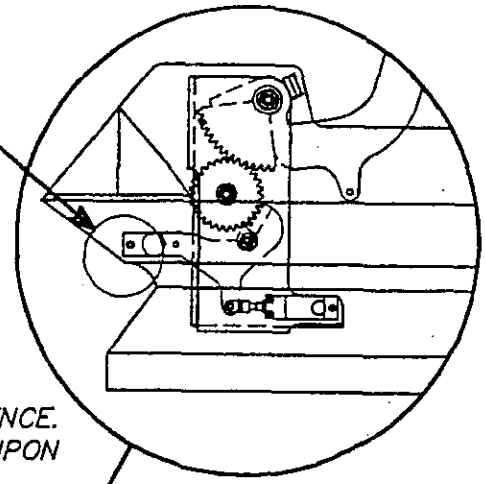
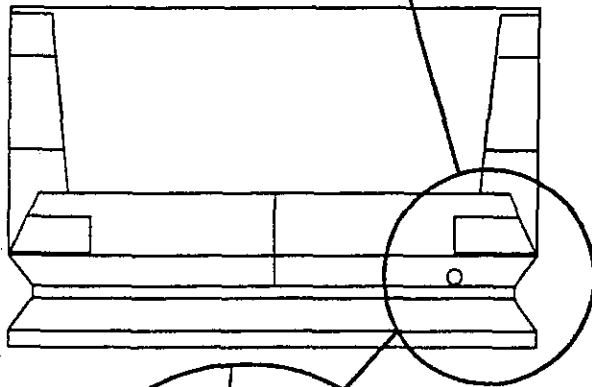
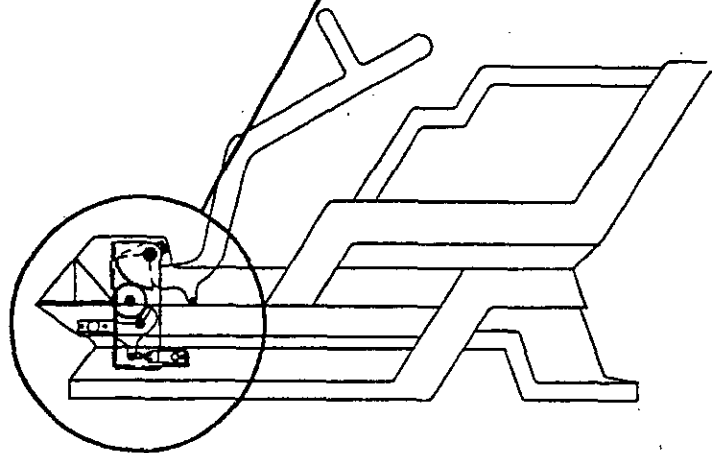
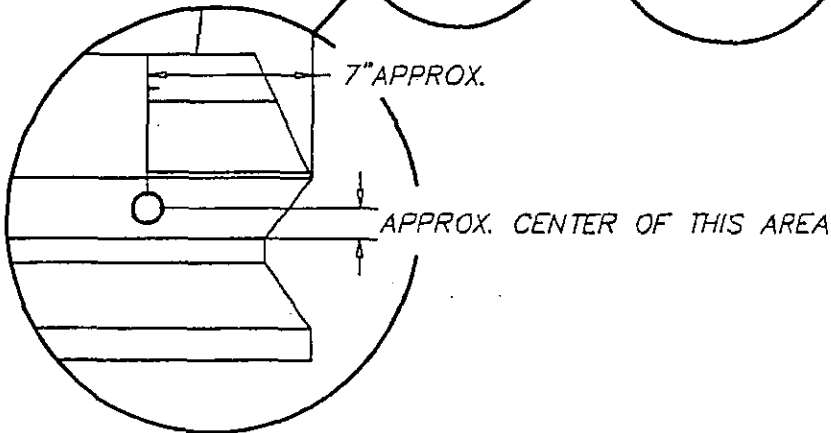
HANDLEBAR SOLUTION

IT HAS COME TO OUR ATTENTION THAT ON A FEW OF THE MID-SIZED HIMALAYA'S THE INSIDE HANDLEBAR LOCKING MECHANISM MAY BE HITTING THE FIBERGLASS BODY OF THE CAR. THIS MAY NOT ALLOW THE HANDLE BAR TO LATCH PROPERLY.

- 1. Review the enclosed drawing to locate a 1 ¼ hole to be cut in the fiberglass.**
- 2. Check that hole is in the correct location to keep the lock dog from hitting the car body.**
- 3. Perform latch check to see that the inside lock dog engages completely.**
- 4. Perform the same operation on the remaining 21 cars.**

INSPECT YOUR HANDLEBARS, AND IF THIS PROBLEM EXISTS DRILL AN 1-1/4" TO 1-1/2" HOLE, USING A HOLE SAW, IN THE BODY OF THE CAR AT THE LOCATION OF THE INTERFERENCE. THIS CAN BE DONE EASILY FROM THE OUT SIDE OF THE CAR UPON SET UP OR TEARDOWN OF THE RIDE.
