**WISDOM  
INDUSTRIES, Ltd.**

# **SERVICE BULLETIN**

**DATE: NOVEMBER 1, 2005**  
**RIDE: LASER SHIP**  
**SUBJECT: SWEEP INSPECTION  
PROCEDURE**  
**COMPLIANCE DATE: IMMEDIATE**

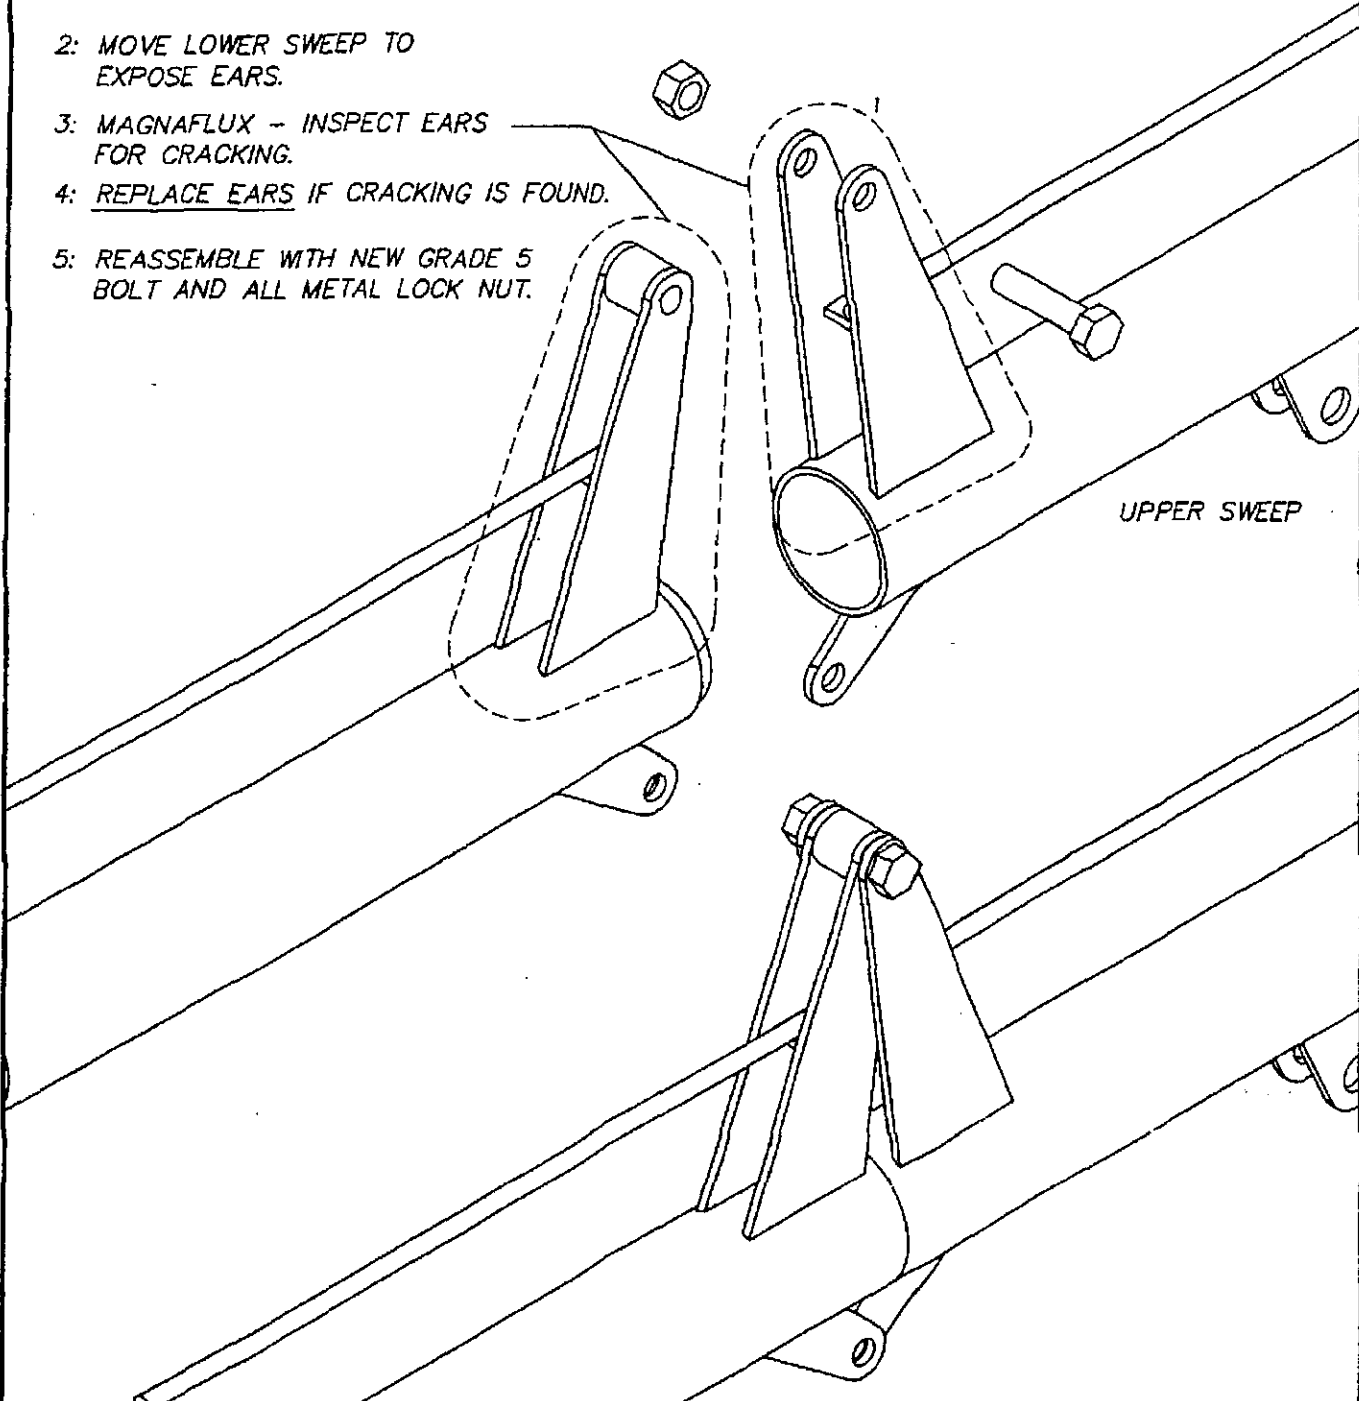
UPPER SWEEP

- **THERE HAS BEEN ONE INSTANCE OF A SWEEP MIDDLE HINGE EAR FAILING DUE TO CORROSION.**
  1. **Inspect the ears shown in the attached drawing using magnetic flux testing for cracks at the hinge point and at the weldment to the sweep tube.**
  2. **If cracking is indicated at the pipe to ear weldment "V" the crack.**
  3. **Weld with 7018 Low Hydrogen rod.**
  4. **If cracking is indicated at the hinge point the ear must be replaced.**
  5. **Weld new ear with 7018 Low Hydrogen Rod.**

- 1: REMOVE BOLT AND NUT.
- 2: MOVE LOWER SWEEP TO EXPOSE EARS.
- 3: MAGNAFLUX - INSPECT EARS FOR CRACKING.
- 4: REPLACE EARS IF CRACKING IS FOUND.
- 5: REASSEMBLE WITH NEW GRADE 5 BOLT AND ALL METAL LOCK NUT.
