WISDOM INDUSTRIES, INC.

# REQUIRED INSPECTION NOTICE

DATE: AUGUST 1994  
RIDE: SIZZLER  
SUBJECT: INSPECTION OF SEAT MOUNTING BOLTS

SEAT INSPECTION HOLE LOCATIONS

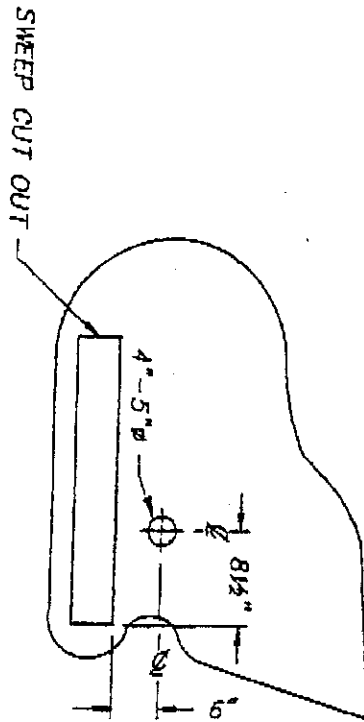
**LEFT SIDE OF SEAT**

1. Remove seat liner OR cut a hole in the left side of the car body using a hole saw. Review the enclosed drawing for the location of the hole. Using a minimum of a 3" hole saw up to 5" diameter.
3. Locate the hole, drill the hole through the fiberglass and inspect the two mounting bolts. If you would like a cover for this hole. Contact us and we will provide inspection covers for these holes.
4. Check the bolts for looseness, missing bolts or sheared bolts and replace with grade 5-7/16" fine thread bolts and Loctite if needed.

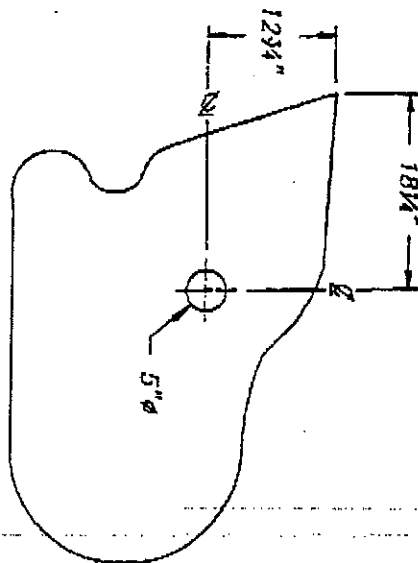
**RIGHT SIDE OF SEAT**

IF RIGHT SIDE INSPECTION HOLE IS DESIRED,  
 NOTE: 1 LEVEL TRAILER.  
 2 USE LEVEL FROM BACK CORNER OF SEAT  
 TO MARK CENTER LOCATION.
