**WISDOM  
INDUSTRIES, Ltd.**

# **SAFETY BULLETIN**

**RIDE: TORNADO**

**SUBJECT: LIFT ARM REINFORCEMENT**

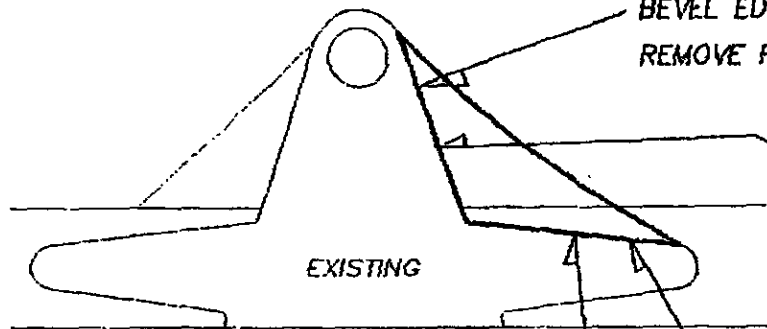
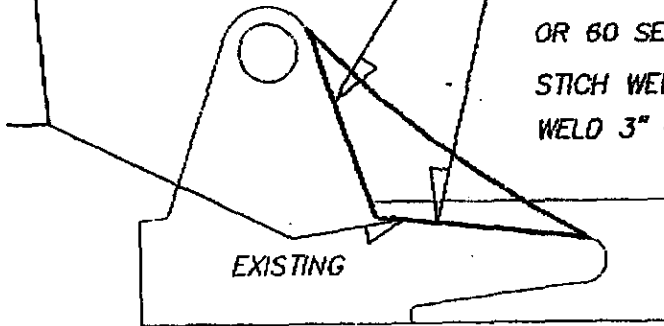
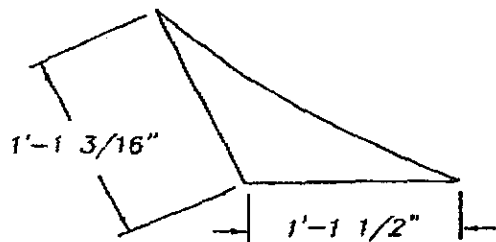
CYLR SHAFT MTG PLATE GUSSET

RELIEVE PLATE IN AREA OF EXISTING WELDS TO ACHIVE GOOD FIT.

BEVEL EDGES OF BOTH PLATES AND REMOVE PAINT WHERE NEEDED.

BEVEL EDGE OF GUSSET AND EDGE OF EXISTING PLATE.  
REMOVE PAINT FROM AREA TO BE WELDED.

WELD WITH 7018 ROD OR 60 SERIES WIRE.  
VERTICAL UP, FULL PENITRATION.

WELD HORIZONTAL USING 7018 ROD  
OR 60 SERIES WIRE. FULL PENITRATION.

STICH WELD BACK SIDE TO TUBE.  
WELD 3" --SKIP 3" ON WELDS TO TUBE.

- 1. Install 4 reinforcing gussets on the Tornado lift arm.**
- 2. Clean area where plates are to be installed.**
- 3. Inspect arm for cracks.**
- 4. "V" any cracks.**
- 5. Weld cracks with 7018 low hydrogen rod.**
- 6. Weld reinforcing gussets to side plates.**
- 7. Inspect welds for cracks.**
- 8. Prime and paint new metal.**

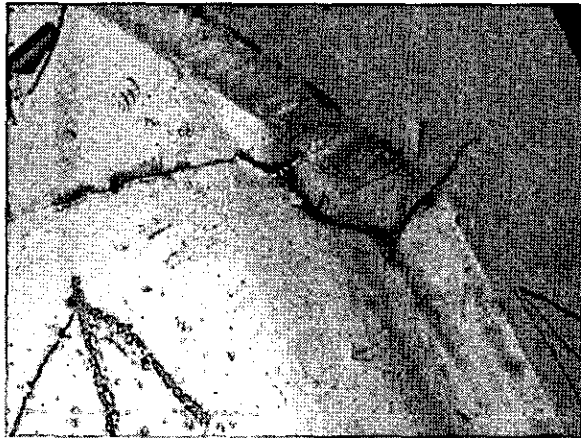
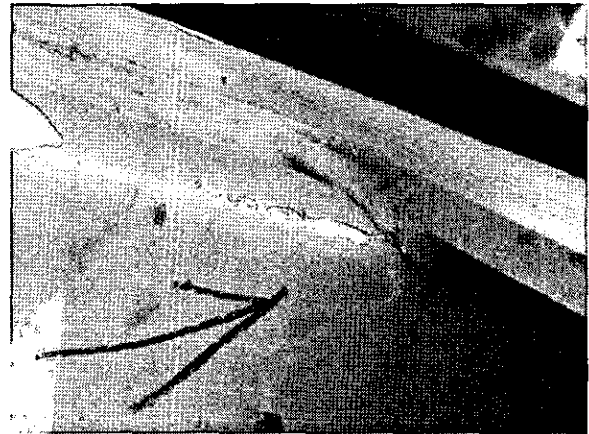
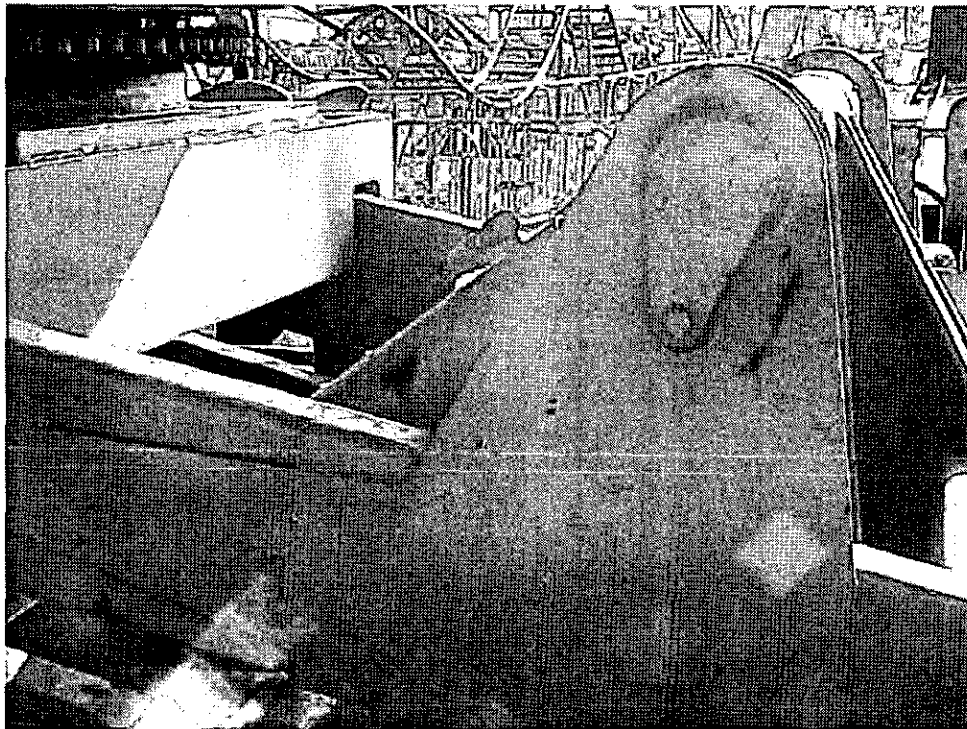
This is to serve as a "heads-up" message. Last week two of my Inspectors were doing setup inspections. While doing the Tornado, they discovered cracks on the main center lift arms of the ride. These cracks are located on the inside of the main lift arm gusset plates. These cracks may be seen by standing on the fender of the trailer looking down at the support arm gussets. The manufacturer has a re-enforcement gusset kit available, but no bulletins have been issued for this problem/repair.

It may be a good idea to check this area out on any Tornado you may have in your jurisdiction. Here are three photos of the crack found:

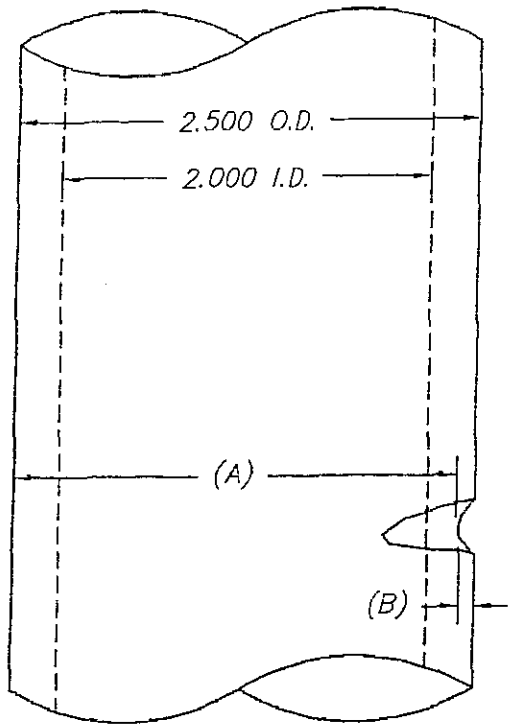
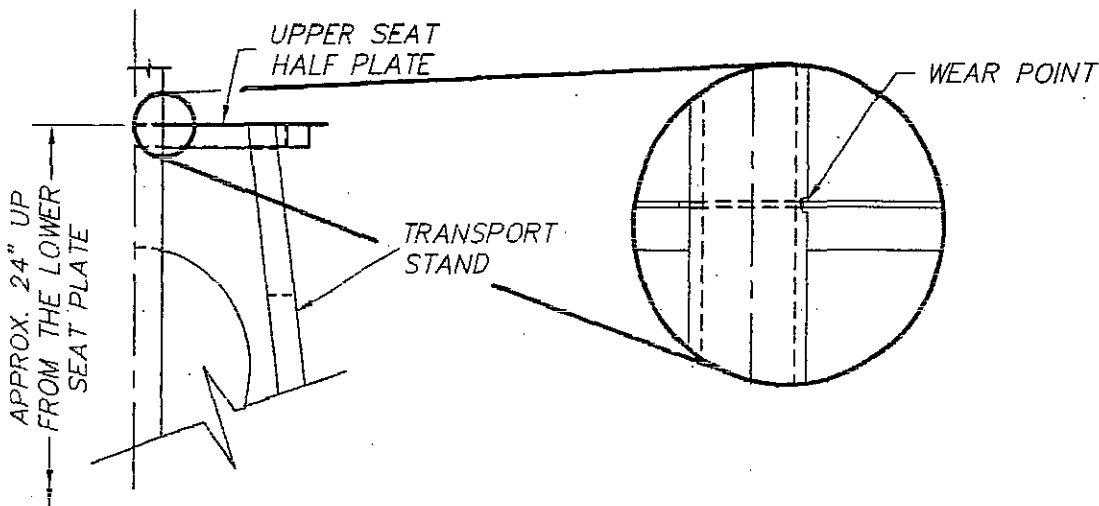
<b>WISDOM INDUSTRIES</b> Merino, CO 80741		APPROVED BY:	
DESCRIPTION <b>WEAR FACTOR ON SEAT CENTER POLE</b>		SCALE: <b>FULL</b>	DATE: <b>02/24/04</b>
EQUIPMENT: <b>TORNADO</b>		DRAWN BY: <b>JJR</b>	DRAWING NUMBER: <b>8T 070</b>

DURING TRANSPORTATION THE UPPER SEAT HALF IS MOVING SIDEWAYS AND WEARING ON THE MAIN SEAT PIPE. THIS WEAR CAN CAUSE A WEAKENING OF THE SEAT PIPE AND THE POTENTIAL OF FAILURE AND INJURY.

1. MEASURE ACROSS THE CENTER POLE AT THE DEEPEST PART OF THE GROOVE (A). IF THE WIDTH IS LESS THAN 2.438" AT THE NARROWEST POINT, THE CAR WILL HAVE TO BE RED TAGGED AND THE CENTER POLE REPLACED.
2. MEASURE FROM THE SURFACE TO THE DEEPEST WEAR AREA (B). IF THIS DEPTH IS MORE THAN 0.062" THE CENTER POLE MUST BE REPLACED.
3. IF THESE DIMENSIONS ARE WITHIN 0.02" OF REJECTION. MAKE A RECORD OF THIS AND REMEASUREMENT EVERY WEEK.
4. ONCE THE CENTER POLE IS AT THE POINT OF REJECTION THAT CAR MUST BE RED TAGGED. IF CRACKING OF THE PIPE IS SHOWING THE RIDE MUST BE SHUT DOWN UNTIL THE CENTER POLE IS REPLACED.

**DAILY INSPECT ALL POLES SHOWING WEAR FOR CRACKING IS REQUIRED**

- 1) Inspect seat pipes ( approximately 6" below the spin wheel) for wear in the pipe. (Review attached drawing)
- 2) Measure the depth of wear.
- 3) If the depth of wear is greater than .062 inch, the pipe must be replaced. (See Drawing)
- 4) Install Trim Lock around the inside of the upper seat half that is causing wear on the pipes.
- 5) You may need to enlarge the hole in the upper seat half to reduce the chance that wear will occur. If hole is enlarged, sand edges smooth and install trimlock.
  - **NOTE:** Keep the transport turnbuckles tight to prevent wear from occurring.
- 6) Contact Wisdom Industries, Ltd. for replacement procedure at (800) 634-6097 if you have any questions.

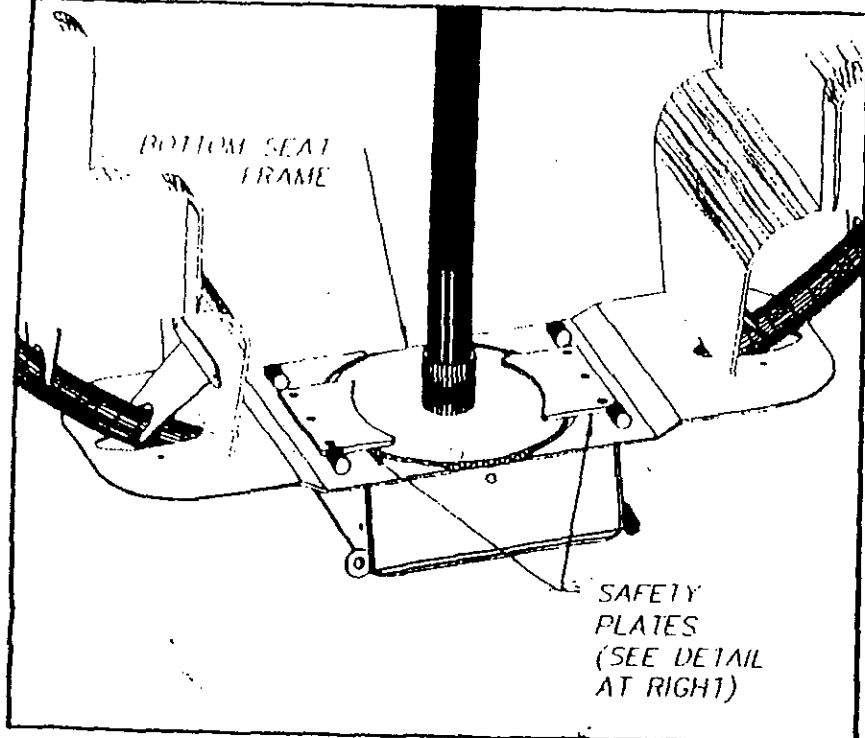
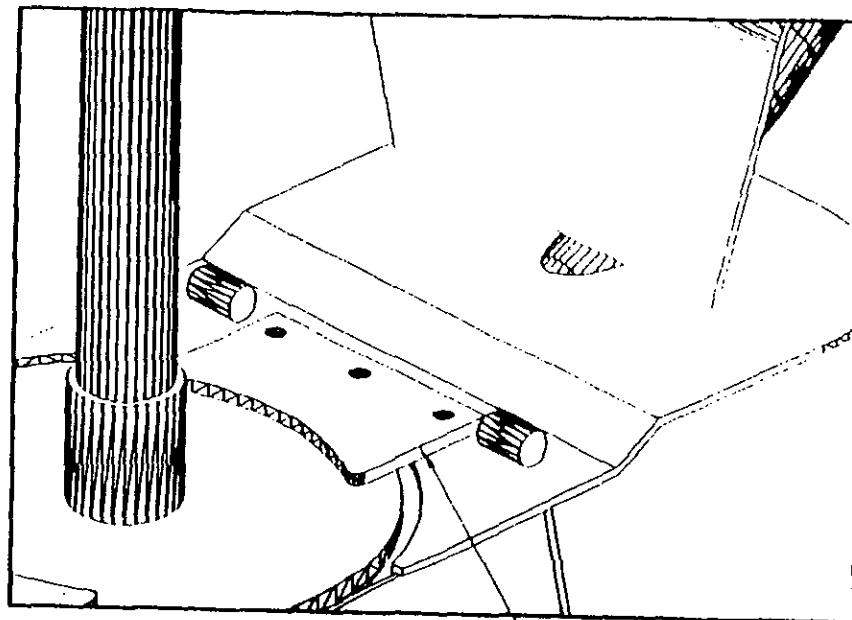
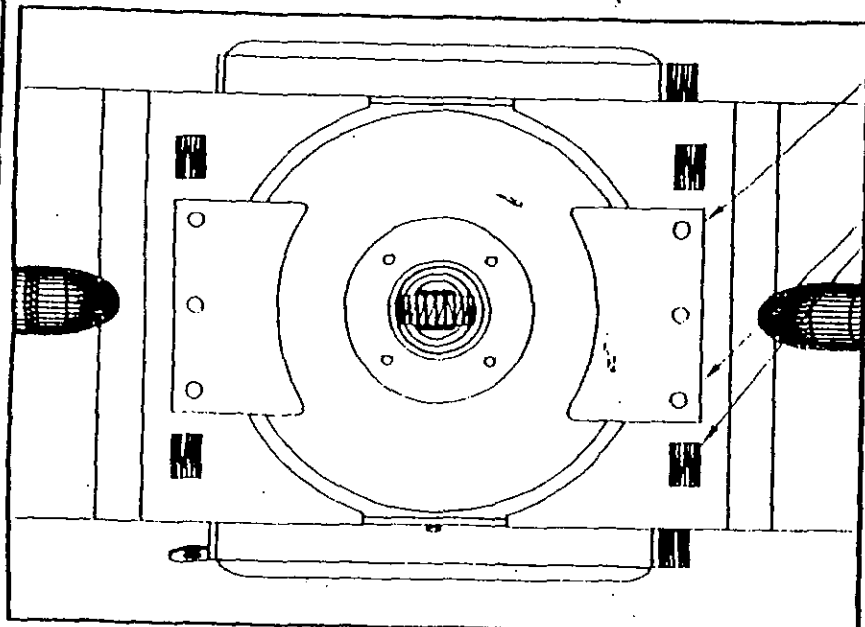
<b>WISDOM INDUSTRIES</b> Merino, CO 80741		
SCALE: NONE	APPROVED BY:	DRAWN BY: JGK
DATE: 10-13-97		REVISED
DESCRIPTION		
SAFETY PLATE INSTALLATION		
EQUIPMENT:	DRAWING NUMBER	
TORNADO	31-04

**DATE:** OCTOBER 1997  
**RIDE:** TORNADO  
**SUBJECT:** Tornado Seat Safety Plate  
**COMPLIANCE:** Due to the possibility of a wheel bearing failure causing the spindle nut to unscrew, install the safety plates and new greaseable dust cap before further operation.

NOTE: THIS EDGE MUST NOT PROTRUDE PAST THE SIDE OF THE STOPS.

LINE-UP BACK OF SAFETY PLATES WITH OUTSIDE EDGE OF STOPS AND DRILL THROUGH BOTTOM SEAT FRAME PLATE. BOLT SAFETY PLATES TO BOTTOM PLATE USING THREE 1/2" GRADE 5 BOLTS AND LOCK NUTS.

3. Review the attached drawing for locating the safety plates. Two plates per car.
4. Drill three 1/2 inch holes for each plate. 6 for each car.

**Note:** Make sure the edge of the plate does not protrude past the seat locator bosses. If the plate is too far out, the upper seat half will not lower fully into position.

5. Bolt the safety plates to the lower seat frame with six 1/2 inch, grade 5 bolts and lock nuts.
6. Check that the seat brake airline will not catch on the safety plates while the seat is turning. Pull up the extra air line to the top of the seat pipe.
7. Remove the C-clamp and lower the upper seat half into position.
8. Check that the upper seat half lowers fully onto the lower seat assembly.
9. Reinstall the two seat hold down pins and R-clip.
10. Remove the wheel dust cover from under the seat assembly.
11. Install the new wheel dust cover.
12. Grease the wheel using the zerk in the new dust cover.
13. Repeat the above procedure for the remaining cars.

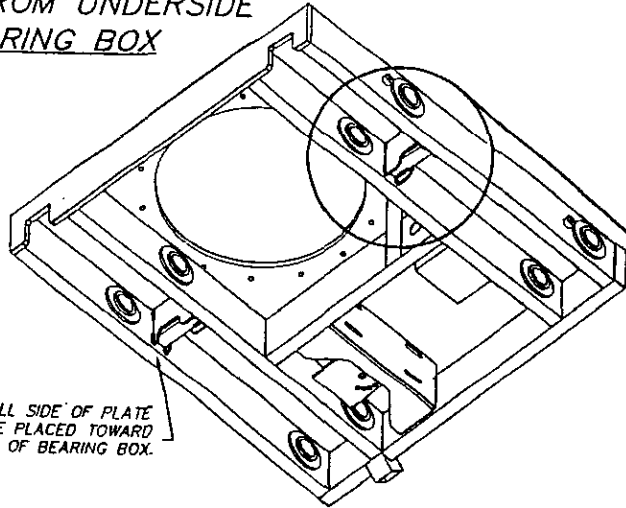
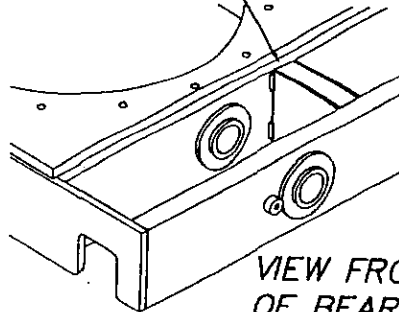
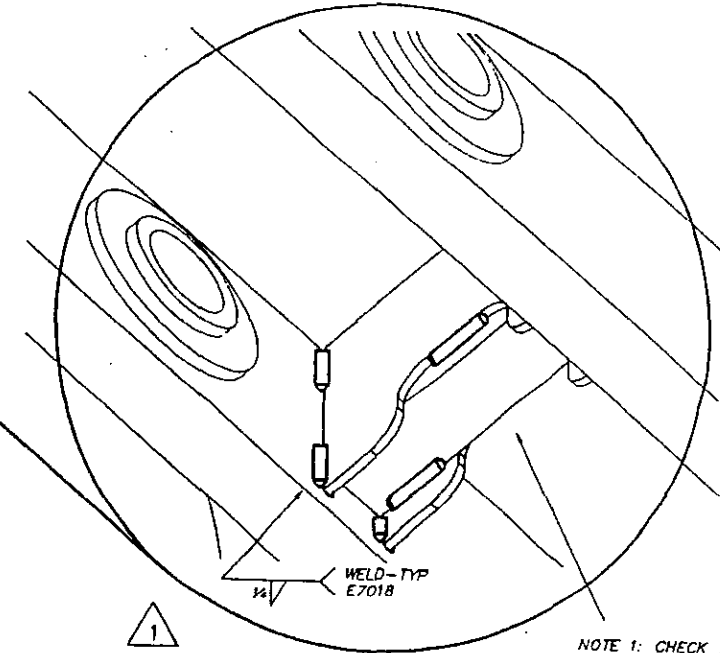
REVISED	
DESCRIPTION: SERVICE BULLETIN			
EQUIPMENT: TORNADO		DRAWING NUMBER: BT 3055B

NOTE 3: SMALL SIDE OF PLATE  
MUST BE PLACED TOWARD  
THE OUTSIDE OF BEARING BOX.

NOTE 4: TOP OF PLATES MUST BE  
FLUSH WITH TOP OF BEARING BOX.

NOTE 1: CHECK THAT  
CROSS TUBE DOES NOT  
REST ON LIFTING ARM IN  
THE DOWN POSITION. IF  
IT DOES, ADD SHIMS TO  
RAISE OFF OF LIFT ARM.

NOTE 2: NOTCH IS OFFSET  
TO CLEAR LIFT ARM.  
WATCH DURING  
INSTALLATION

- 1) Inspect the frame near the 2 x 6 cross tube for cracks.  
(See Drawing)
- 2) If cracks are found, grind the affected area and reweld with  
7018 rod and install doubler plates prior to further operation.
- 3) If cracks are not found, inspect area daily for cracks prior to  
operation.
- 4) If your unit does not have doubler plates, install doubler  
plates.
- 5) Contact Wisdom Industries and the plates can be sent out. If  
you have any questions, contact Wisdom Industries, Ltd. at  
(800) 634-6097.

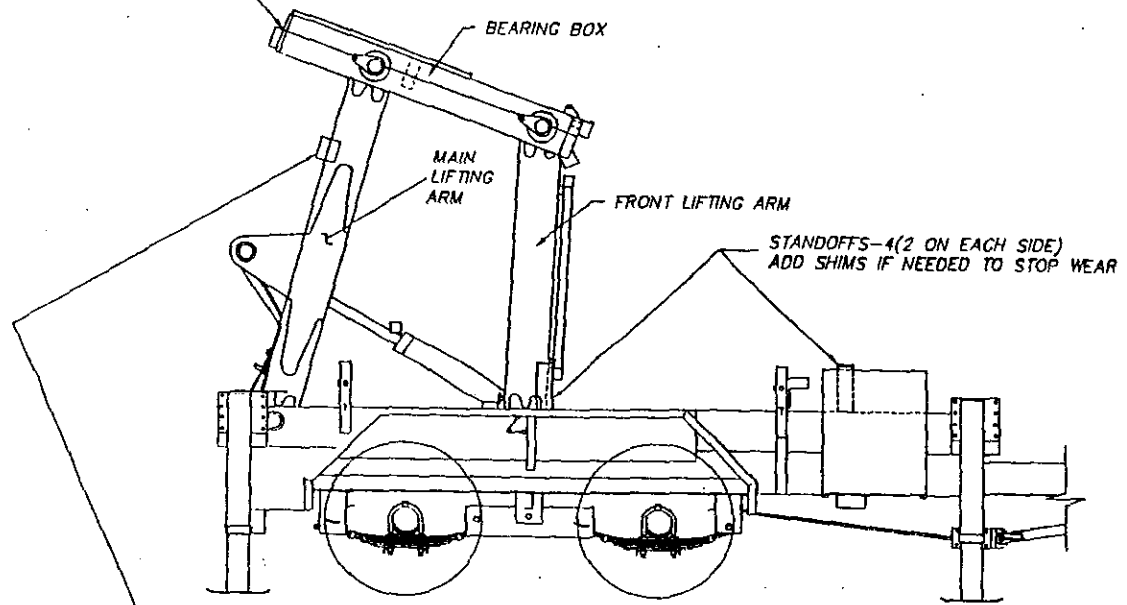
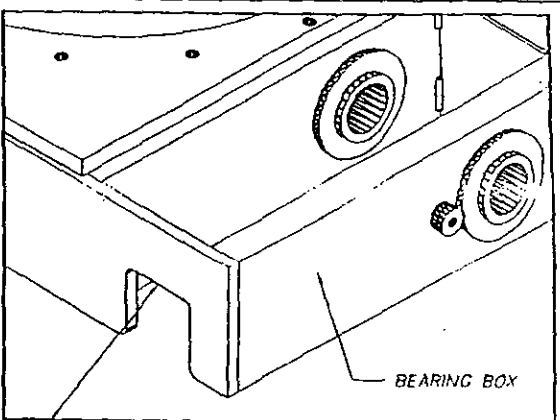
<b>WISDOM INDUSTRIES</b> Merino, CO 80741		
SCALE: 1/4" = 1'-0"	APPROVED BY:	DRAWN BY: JJR
DATE: 05/01/01		REVISED
DESCRIPTION <b>SERVICE BULLETIN</b>		
EQUIPMENT: <b>TORNADO</b>	DRAWING NUMBER <b>BT 230</b>

WEAR POINT FROM  
LIFT FRAME

NOTE: INSPECT TOP AND SIDES OF THE MAIN  
LIFTING ARM AS THEY PASS THROUGH THIS  
OPENING FOR WEAR AND CRACKS ON BOTH ARMS.

- 1) INSPECT TOP EDGE OF LIFTING ARM FOR WEAR FROM LOWER EDGE OF BEARING BOX. IF WEAR IS NOTED INSPECT FOR CRACKS IN TUBE AND CONTACT WISDOM FOR REPAIR PROCEDURE.
- 2) IF WEAR IS NOTED, BLOCK UP STANDOFFS UNTIL THERE IS 1/8" GAP BETWEEN THE ARM AND LIFT FRAME. CONTACT WISDOM INDUSTRIES IF YOU HAVE ANY QUESTIONS.

- 1) Inspect top edge of main lift arm for wear from lower edge of lift frame. (See Drawing)
- 2) If wear is noted block up standoffs until there is a 1/2" gap between the arm and lift frame.
- 3) If the surface of the tube is worn, inspect for cracks in tube and contact Wisdom for repair procedure.
- 4) Contact Wisdom Industries, Ltd. at (800) 634-6097 if you have any questions.
