Bulletin No: 2000 BS1

SERVICE BULLETIN

Ride Manufacturer: Zamperla Inc.	Affected Production Dates: All
Ride Name: Barnstormer	Affected Serial Nos.: All
Model Number: Barnstormer	,
Abstract Of Issue:	
A hazard exists in a guard of the gondolas.	
Reason For Release:	
	nder the guard on each gondola in one corner. A small child's can fit through the opening.
Action To Be Taken:	
	uards as indicated in the attached photo. There is one for the a and one for the right gondola.
Detail Of Issue:	
Attached photo (page 2)

Bulletin No: 2002 BS1

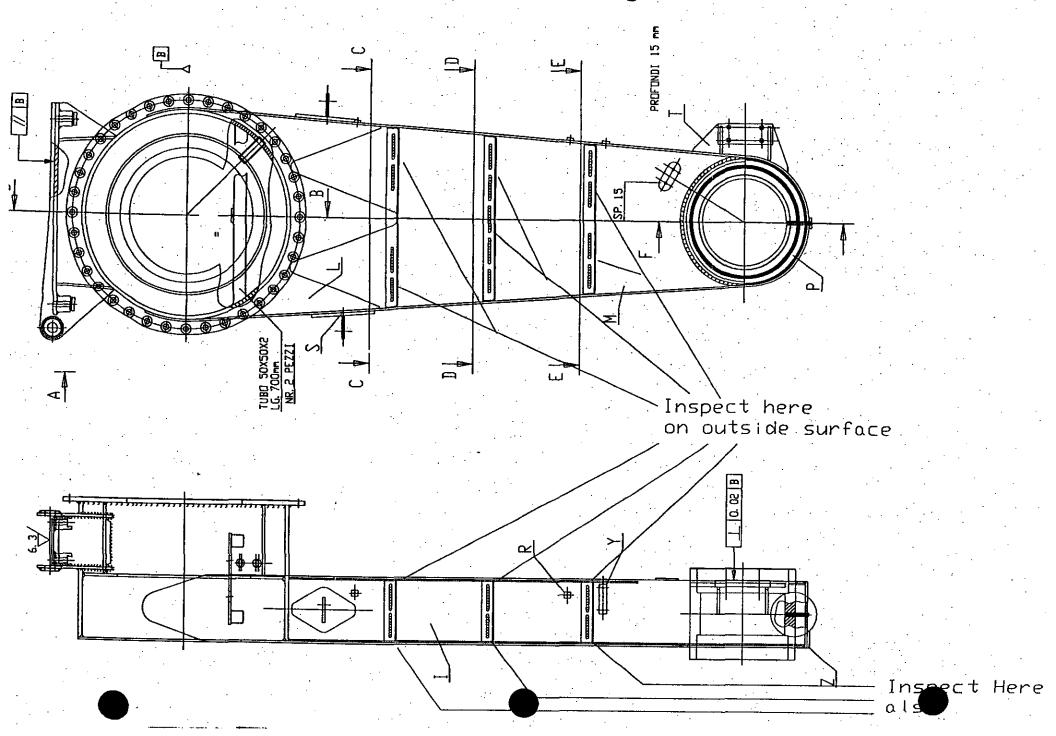
Bulletin 2002 BS1 Page 2 of 2

A crack has been detected in a weld of an internal reinforcing plate of the gondola attaching arm.

Page number 2 "Diagram of the gondola attaching arm".

Visually inspect the side surface of the gondola attaching arms in the area indicated on page 2. If there are any signs of cracked paint contact Zamperla immediately.

Visually inspect the side surface of the gondola attaching arms on a weekly basis. If there is any signs of cracked paint, contact Zamperla immediately.
