# SAFETY ALERT

Ride Manufacturer: Zamperla, Inc.	Affected Production Dates: 11/10/95 to 11/19/97
Ride Name: Lolly Swing	Affected Serial Nos.:
Model Number: Lolly Swing

## SERVICE BULLETIN

TO: ALL AMUSEMENT RIDE SAFETY OFFICIALS  
IMPORTANT  
AMUSEMENT RIDE SAFETY BULLETIN!  
RE: Zamperla "Lolli Swing"  
January 29, 1998

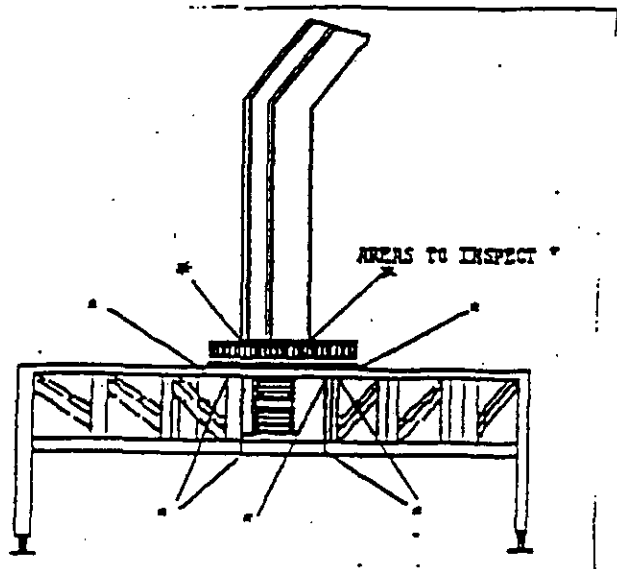
**Detail Of Issue:**  
**Center Column:**  
A daily preoperational visual inspection of the attachment of the center column, including gussets, to the base plate is to be performed. Look for cracking along the welds. Such daily inspections are to be performed until this area has been non-destructively tested using the magnetic particle method by a certified technician. Thereafter, this area is to be visually inspected on a weekly basis.

**Support Frame:**  
Support frame members should be visually inspected weekly where indicated on the accompanying drawing.

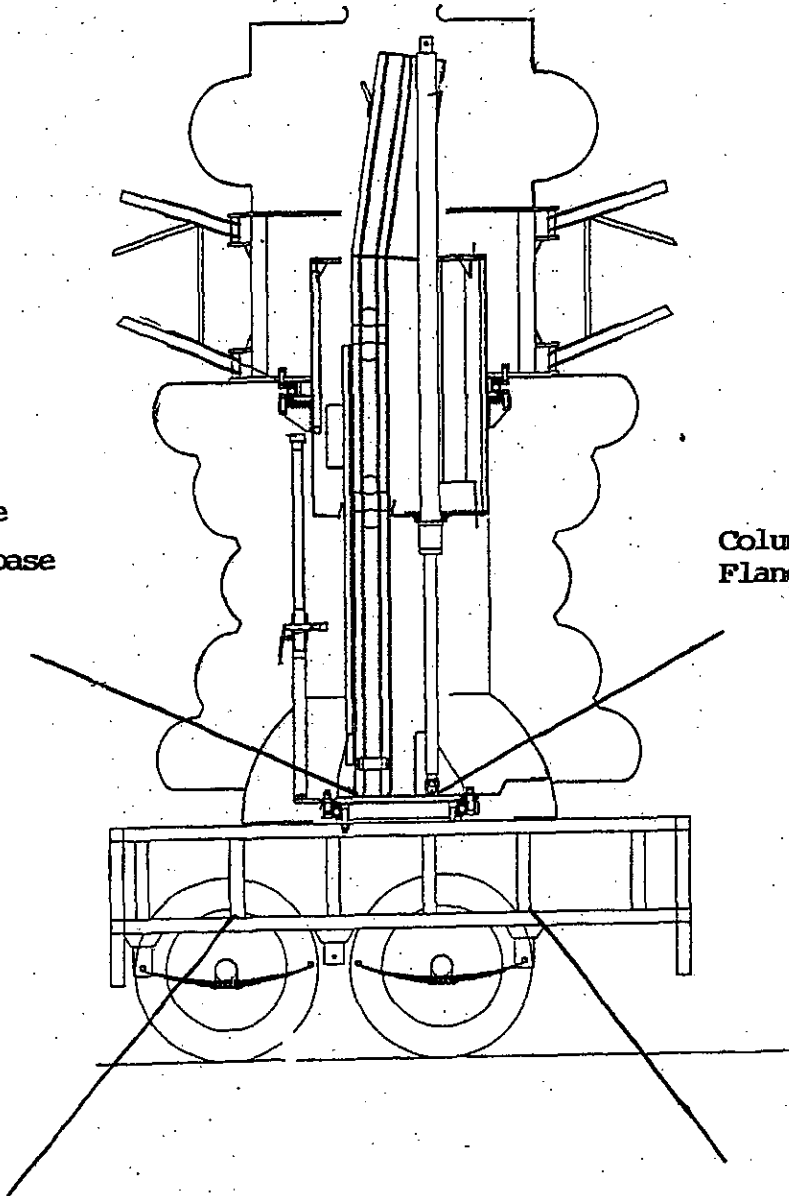
Cracks have been found in the welds located at the center column base plate junction and in the lower center frame structure. See areas indicated on the accompanying diagram.

Inspect the column flange  
joint welds here at the base

Column joint  
Flange welds

Inspect the lower frame welds here

LOWER FRAMES WELDS

Magnetic particle testing by a certified NDT technician

Magnetic particle testing by a certified NDT technician annually.

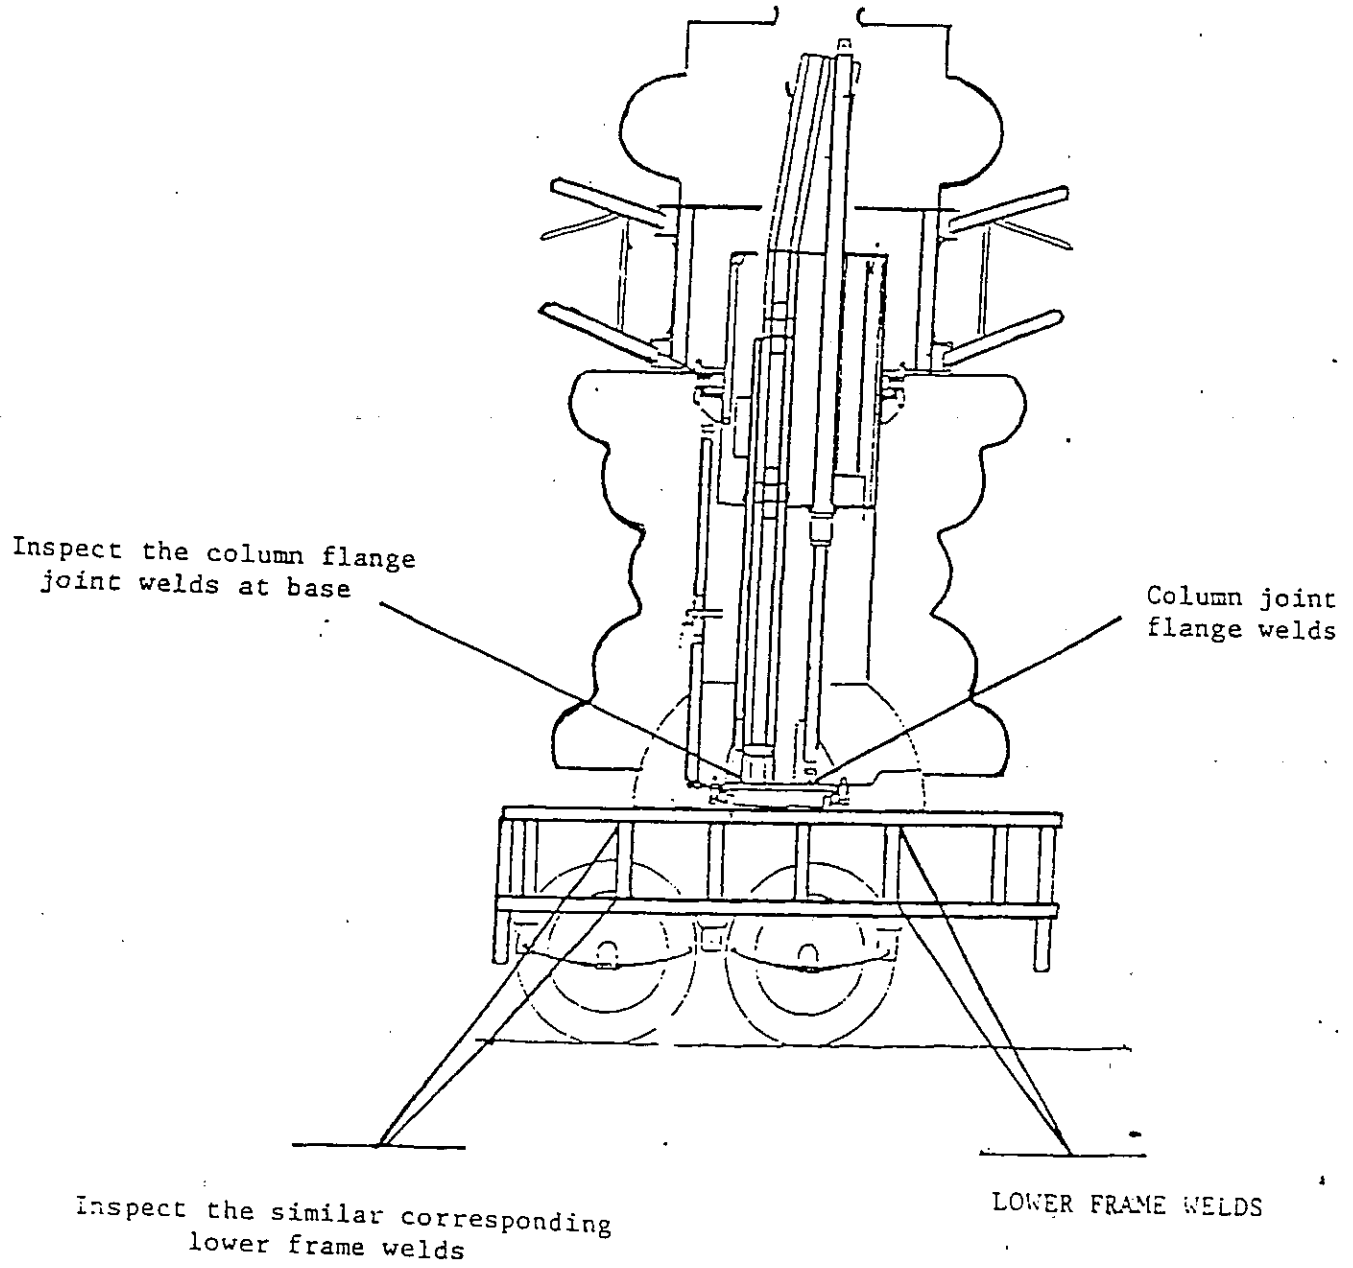
( FIG. 1 )

- Visually examine the center spindle/tower mast for cracking (Fig. 1), especially those areas covered by the fiberglass shroud. The visual inspection should be done during setup, and at takedown (the minimum inspection interval should be weekly, whether or not the ride is transported). Inspection will involve removing the shroud to reveal the areas to be inspected.

- Non-destructively inspect (Magnetic Particle) the critical areas identified by Zamperla, Inc. (Fig 1). Inspection should be done immediately and annually, thereafter. Inspection should be done by an inspector certified in the above technique. Non-destructive inspection may involved removal of paint from those critical areas to be inspected

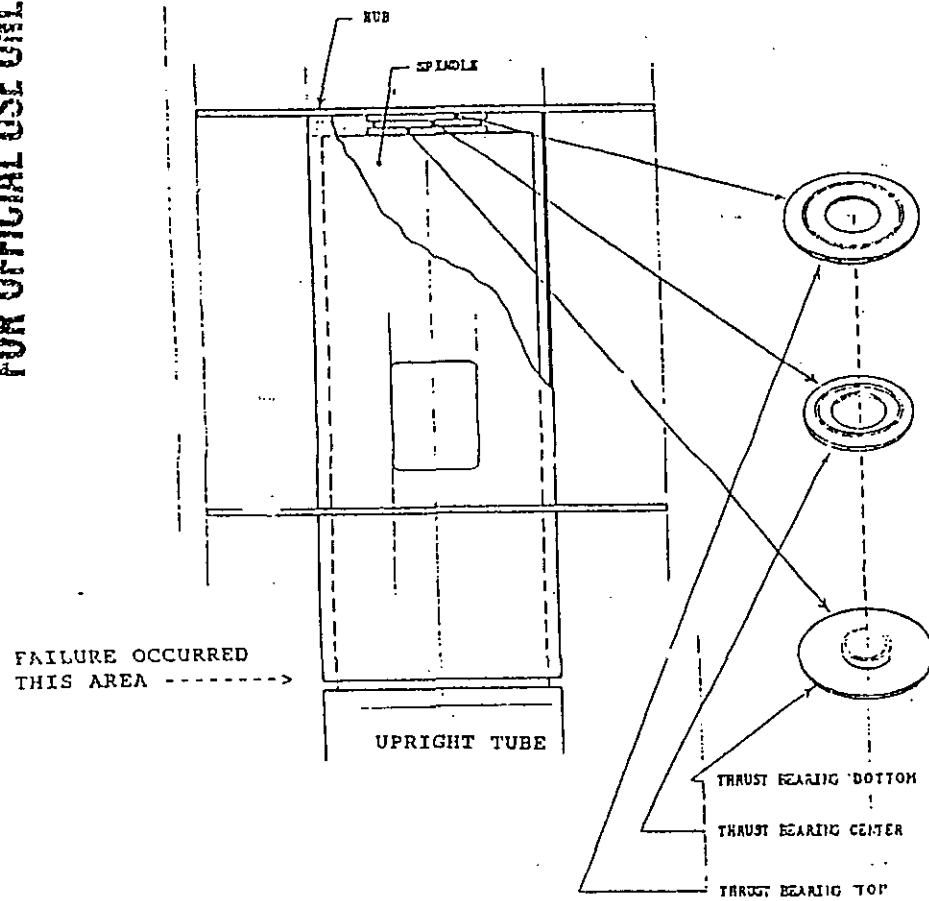
1. Measure the gap between the hub and the upright tube. The gap should be 3/8-inch to 1/2-inch wide. If gap is insufficient, pull hub and upright tube apart. Inspect all surfaces for wear and cracking. Welds on the entire tubes surfaces and structure should be inspected for cracks. Repair as necessary. Non-destructive techniques should be used for crack inspection [See Fig.1].

FIGURE 1 - AREA OF FAILURE

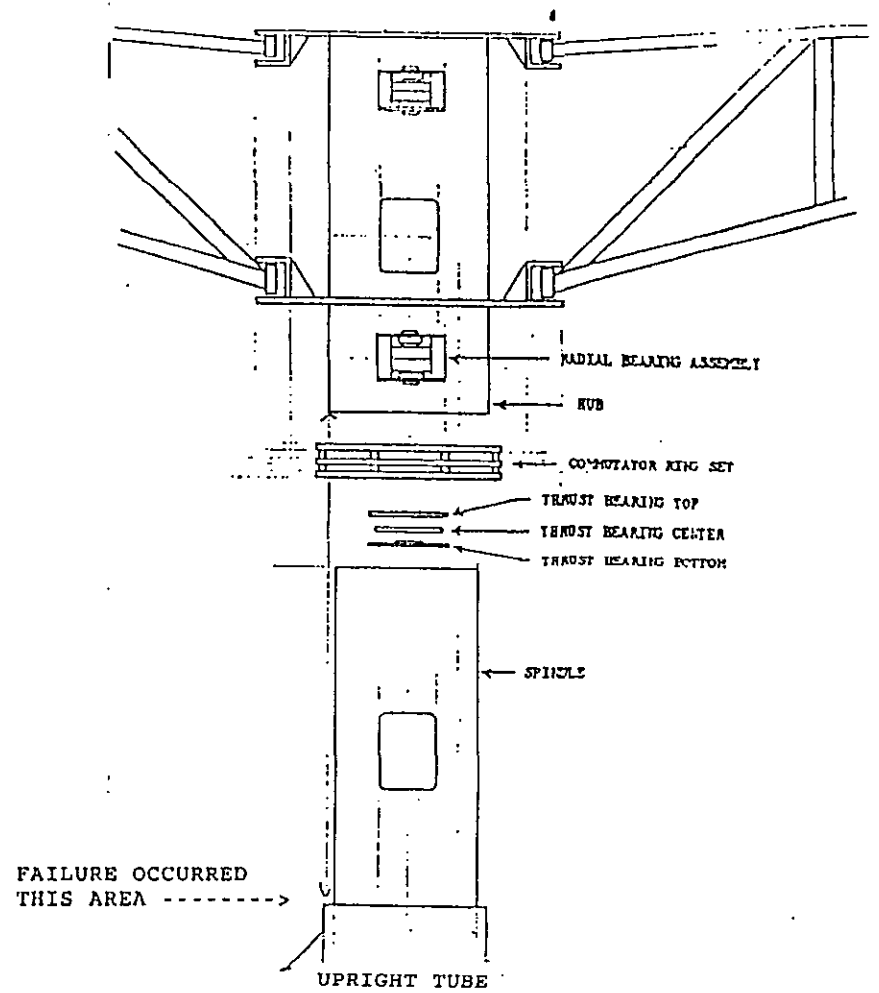
2. Measure spacing of radial bearing rollers and spindle. It should be 0.010-inch. If not, adjust to 0.010-inch [See Fig. 2].
3. Repair is necessary if it appears that the hub has worn into the spindle plate.

FIGURE 2 - CLOSE-UP AND EXPANDED SCHEMATIC OF SUBJECT AREA

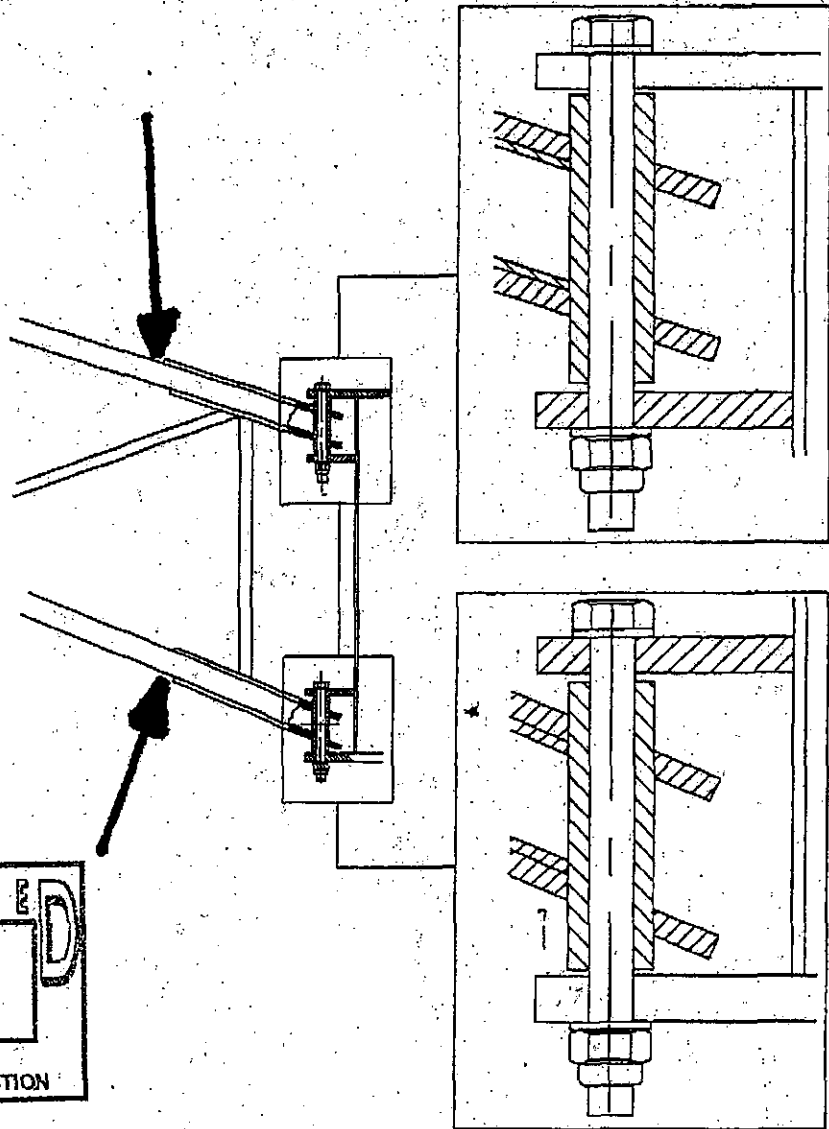
Abstract Of Issue:  
Cracks have been found in the tubing of the sweep arm.

CAPRIATE TRUSSES	Daily	Weekly	Monthly	Quarterly	Six months	Annually
Verificare che i bullone sia chiuso correttamente. Check that the bolt is correctly closed				●

Action To Be Taken:  
Visually inspect the area indicated on the attached diagram. If there is evidence of cracks, shut ride down and contact Zamperia for repair procedure.

Future Action To Be Taken:  
inspect this area on a monthly basis
