Zamperla Inc.

Maintenance Bulletin

RE: Mini-Enterprise Tension Rod Attachment

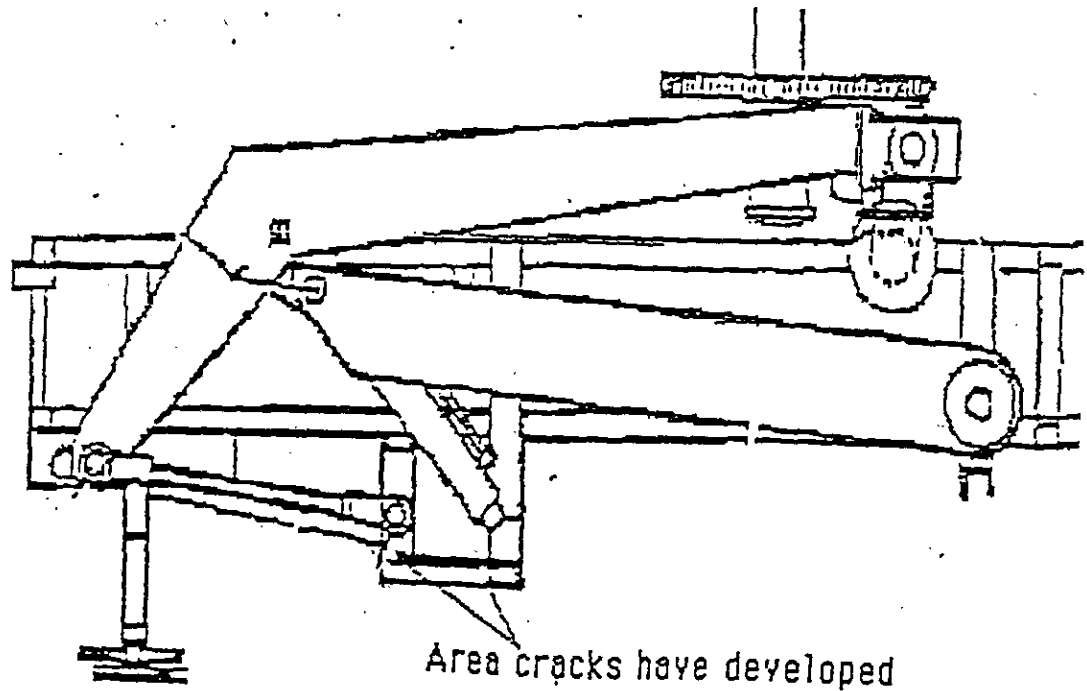
A customer has reported the development of fractures in the structure that attaches the tension rod to the frame on the Mini-Enterprise ride. The cracks developed in the welds, and spread into the parent metal in one area. This ride is approaching 10 years of service. We are advising all Mini-Enterprise owners to visually inspect this area of their ride. Any indications of cracking should be reported to our technical service department and subjected to magnetic particle testing to determine the extent of the damage.
