Zamperla Inc.

ZAMPERLA INC. 49 Fanny Road Parsippany, New Jersey 07054-6545 USA Phone: 973 334 8133 Fax: 973 334 6880	Bulletin No: 2003 MJ01
	Release Date: February 28, 2003
	Effective Date: February 28, 2003
	Supersedes:
	Completion Date: As soon as possible
Page: 1 of 2

SERVICE BULLETIN

Ride Manufacturer: Zamperla Inc.	Affected Production Dates: All Mini Jet Crop Duster rides
Ride Name: Mini Jet Crop Duster	Affected Serial Nos.: 98310, 98320, 98327, 98374, 98395
Model Number: Mini Jet Crop Duster

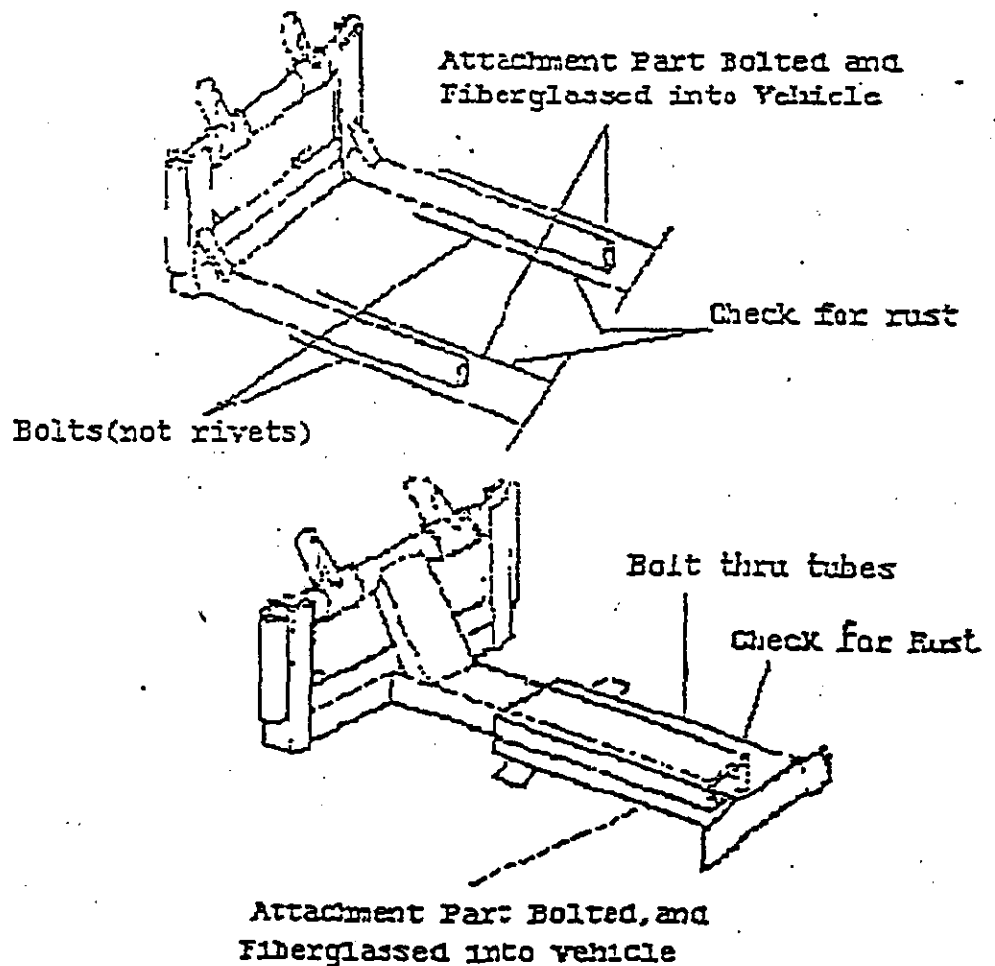
During the fall of 1986 we were alerted by a customer of improper attachment of a vehicle on a Mini-Jet. The Vehicle was riveted to the support frame rather than bolted. A Maintenance Bulletin was issued at that time, and no other incidences have been reported. Of more importance at this time is the issue of the outer tube (fiberglassed and bolted into the vehicle) which the support frame slides into rusting. Inspection of this tube should be performed on a yearly basis. Most vehicles will require the removal of the floor plate to facilitate this inspection. The only approved method of repair is replacement of the tube. Please contact our service department for instructions on how to make this repair, and to order replacement components.
