Bulletin No: 97 SA1
Release Date: 12/8/97
Effective Date: 12/8/97
Supersedes:
Completion Date: Before riding passengers
Page: 1 of 2

SERVICE BULLETIN

Ride Manufacturer: Zamperla Inc.

Ride Name: Samba

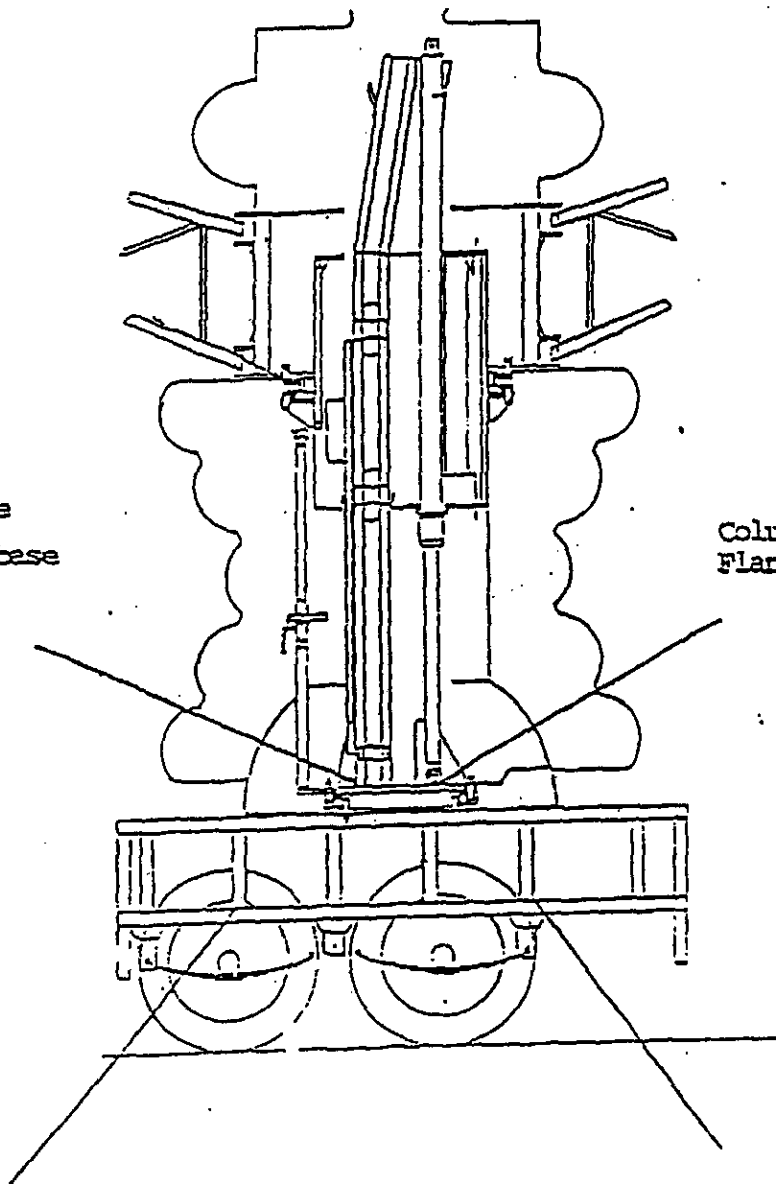
Cracks have been found in the welds located at the center column base plate junction and in the lower center frame structure. See areas indicated on the accompanying diagram.

Inspect the column Flange
joint welds here at the base

Column joint
Flange welds

Inspect the lower frame welds here

LOWER FRAMES WELDS

Magnetic particle testing by a certified NDT technician

Magnetic particle testing by a certified NDT technician annually.

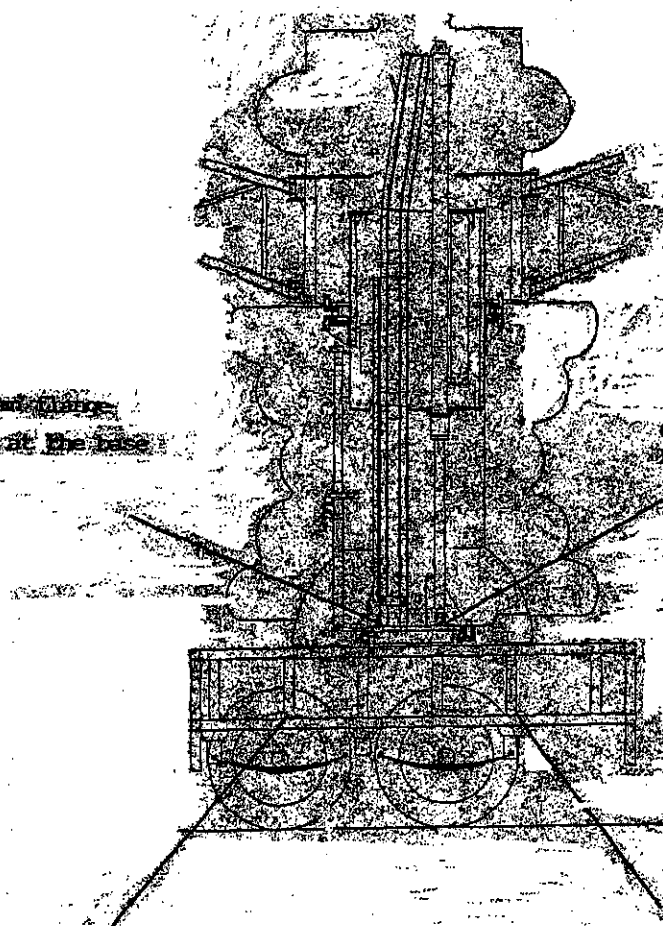
Ride Manufacturer: Zamperla Inc.	Affected Production Dates: N/A
Ride Name: Samba Balloon	Affected Serial Nos.: SB08F302US97, SB08F316US98, SB08F257US95, SB08F121US96, SB08F321US98, SB08F365US98
Model Number: Samba Balloon	
Abstract Of Issue: <p style="text-align: center;">There is a possibility for weld cracks in the upper themeing centerpiece steel structure.</p>	
Reason For Release: <p style="text-align: center;">Cracks have been found on some upper themeing centerpiece steel structures.</p>	
Action To Be Taken: <p style="text-align: center;">Perform a close visual inspection of the steel structure of the upper centerpiece. If cracks are present, weld reinforcements (gussets and/or inserts) in the areas indicated in the following diagram. Use welding procedure AZ-9602 (attached).</p>	
Detail Of Issue: <p style="text-align: center;">Drawing 9CDC001542A (attached).</p>	
Future Action To Be Taken: <p style="text-align: center;">None</p>

Inspect the column flange
joint welds here at the base

Column joint
flange welds

Inspect the lower frame welds here

LOWER FRAME WELDS
