Bulletin No.:	HL19103140
Release Date:	12/3/2019
Effective Date:	IMMEDIATE
Supercedes:	HL19021240
Completion Date:	Opening 2021
	(will vary)
Page:	1 of 4

SERVICE BULLETIN

Ride Manufacturer:	Great Coasters Int., Inc.	Affected Production Dates:	All
Ride Name:	Varies	Affected Serial Nos.:	N/A
Model Number:	All GCII Rides with Millennium Flyer trains

Abstract of Issue:

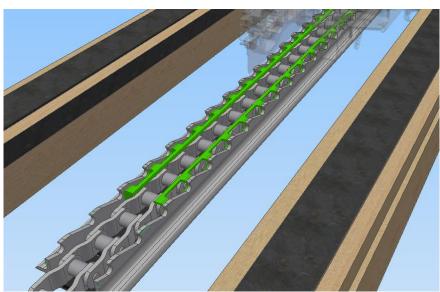
Like the current retainer angles, the new chain retainer is installed via welds to the ARB angle. However, the major difference is that the new design provides continuous coverage along the entire length of the chain trough. Refer to Figures 1 and 2. This reduces the risk of the chain leaving the trough, and directs the broken chain down the trough to gather near the motor base or the lower idler.

Figure 1: Render of new Lift Chain Retainer design

The newly-designed Lift Chain Retainer (1161-2201) must replace the existing chain retainer angles (SP07060442) along the flat portion of the entire lift hill. This requires that the current chain retainer angles be removed before the installation of the new retainer. Please refer to Note 1 on the included installation drawing for more details.

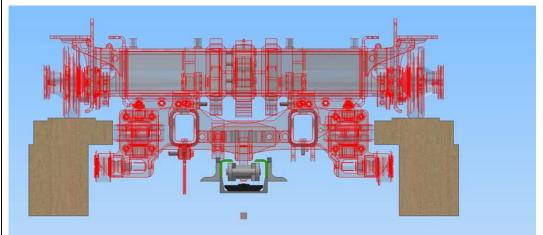
Figure 2: Cross-sectional view of new Lift Chain Retainer design
