## User Inspection Notice – ISC RP074 Zippey

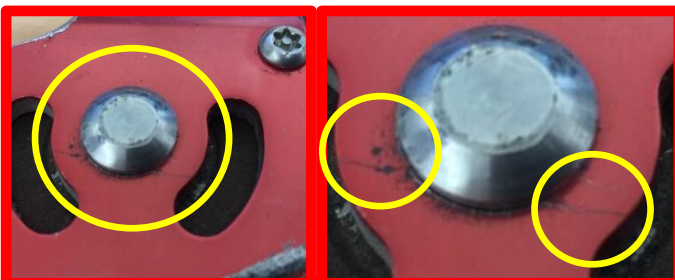
**RETIRE**

If there is evidence of cracks then you **MUST** retire the unit.

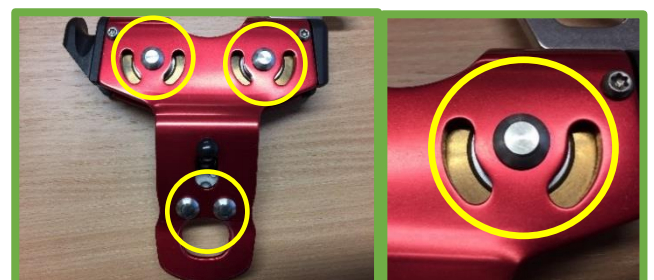
**OK**

Inspect for wear or abnormality, paying particular attention to the area around the rear rivets for cracks. If no cracks are present continue to monitor.
