SERVICE NOTICE

To: All Leitner-Poma fixed grip chair customers 1981 to present.
Re: Bullwheel guide sheave brittle bars (derail switches)

LEITNER-POMA SERVICE BULLETIN

Re: Drive Bullwheel bushing and mounting hardware.

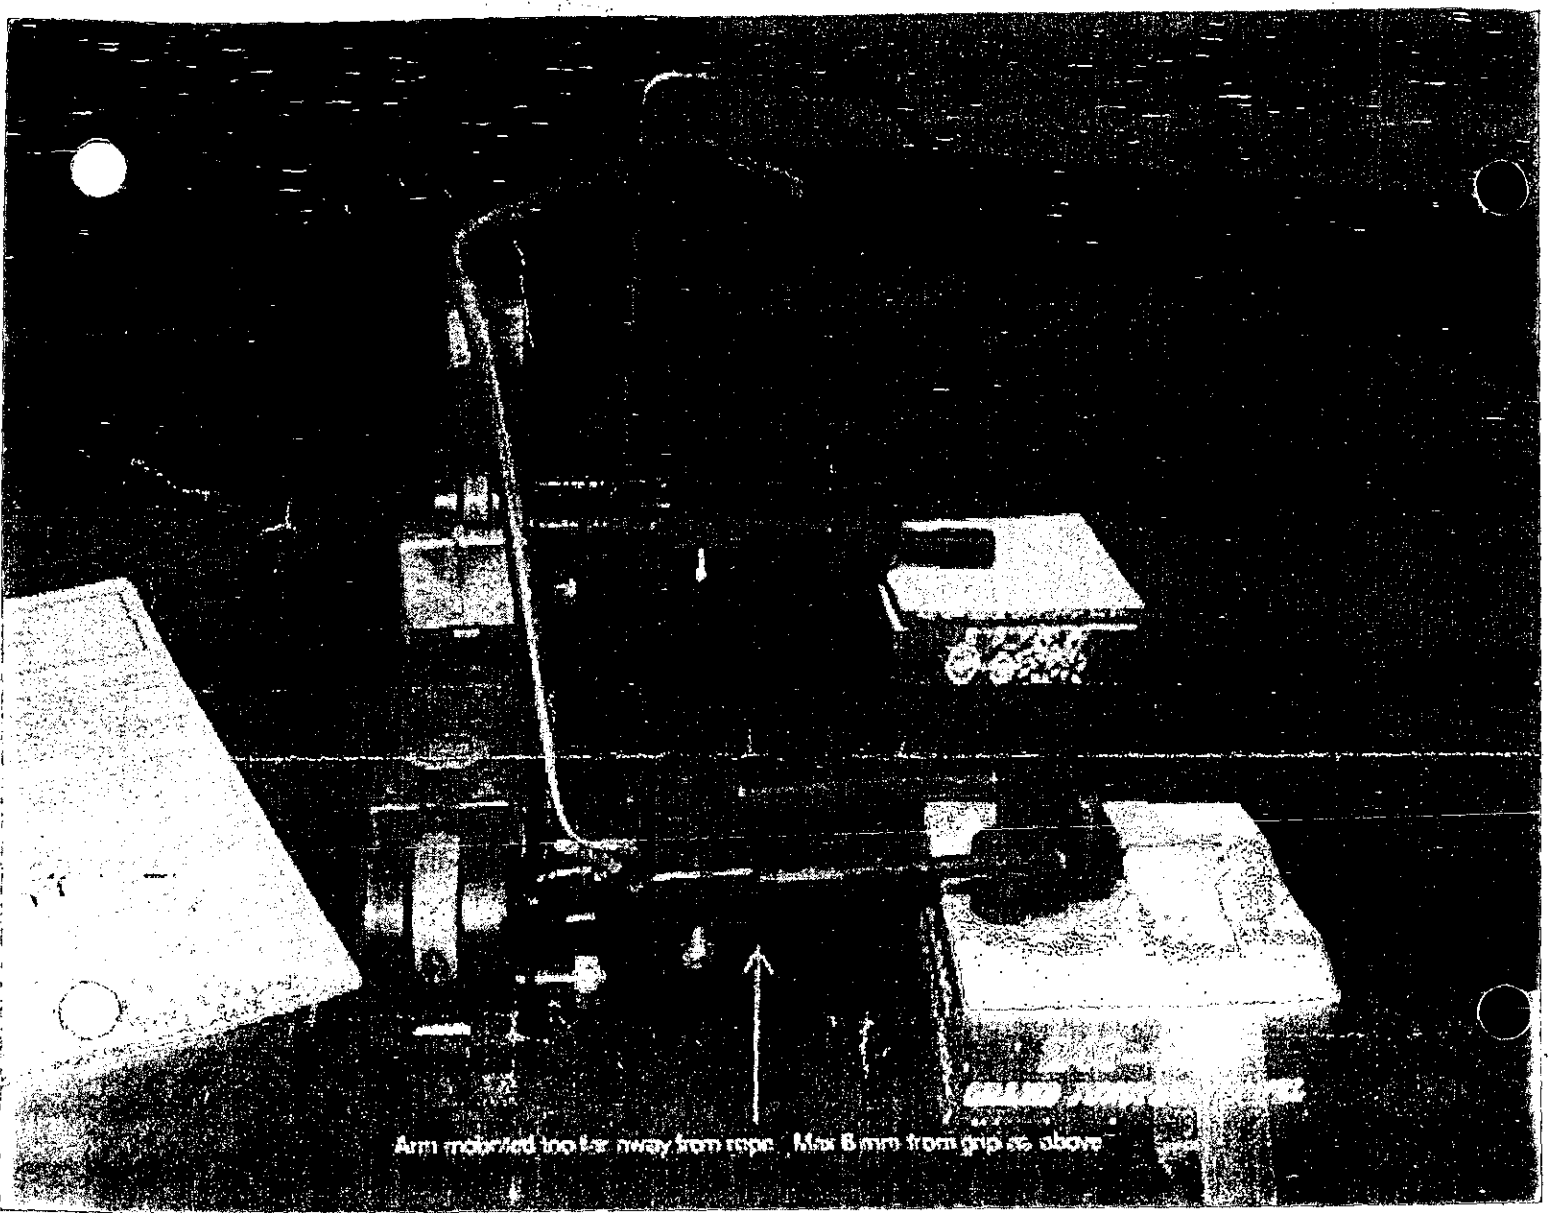
After review, it was determined that the hook was set too close to the mounting block and on the edge of the fracture notches in the brittle bar. This allowed the hook to bend until it contacted the brittle bar mount, reducing the leverage and failing to break the brittle bar.

Accompanying this notice is a picture of the derail switch discussed. One shows the correct position of the hook, (back-ground), the other with the bent hook shows the hook positioned too close to the fracture notches (fore-ground).

Arm retracted too far away from rope. Max 5mm from grip as above

It is very important to verify the correct adjustment of the hook on your guide sheave brittle bars. The hooks should be positioned approximately half way between the fracture notches; the entire switch should then be adjusted in and out so the vertical arm of the hook is 6mm (+ or – 1mm) from the mobile jaw. The switch should then be adjusted vertically so the grip is centered in the opening between the end of the hook and the end of the brittle bar. Some subtle vertical adjustments may be necessary depending on loading or chair positions entering and exiting the bullwheels.

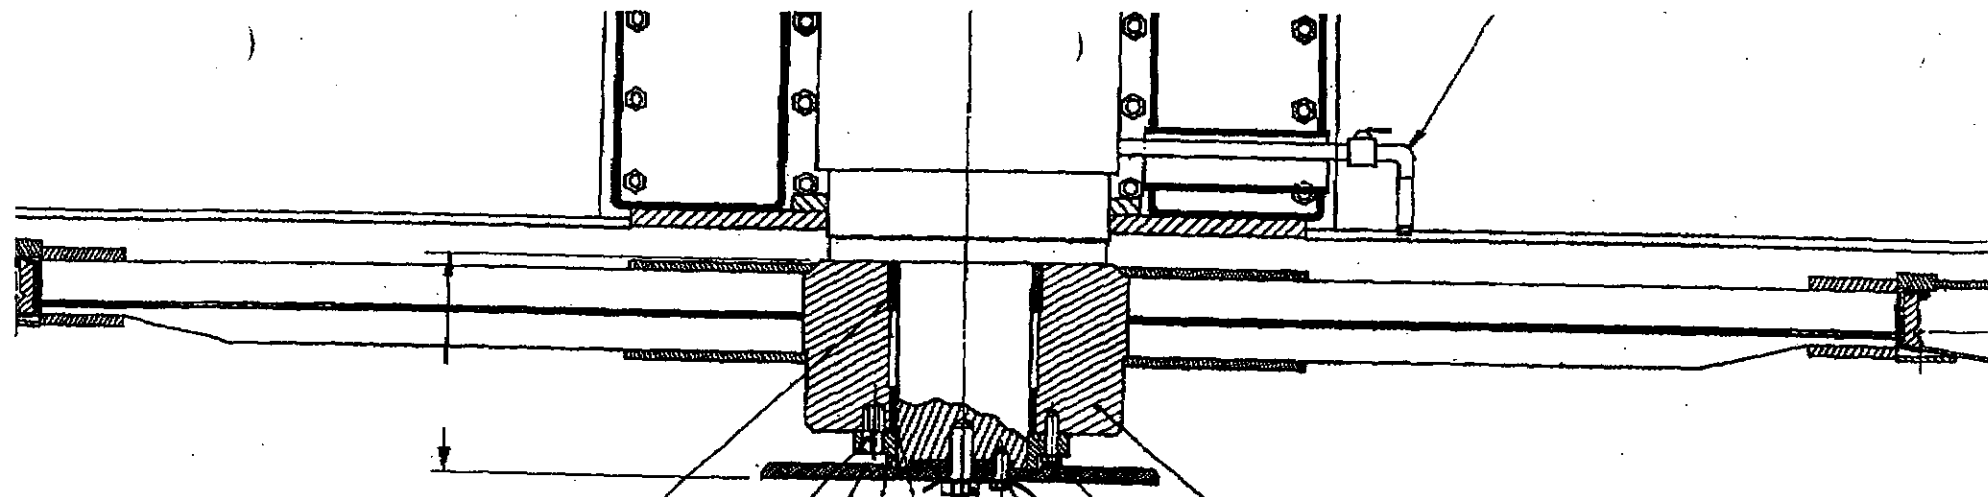
Over the past year we have seen an increase in the number of areas reporting significant wear of the cast iron bushings (I & H on accompanying drawing) in the drive bullwheels. Due to the nature of this mounting it is difficult to determine the extent of the wear without disassembly of the bullwheel. In most cases, the problem did not become apparent until one of the bolts that mount the cable catcher/retaining plate to the shaft was broke. In some cases the wear was discovered when the mounting bolts were found to be loose, or the head of a bolt broke when it was tightened.

Leitner-Poma requests that you check the tightness of the 3-M20 (DD) and the 1-M36 (AA) bolts that mounts the cable catcher/retaining plate (G) to the output shaft. The following procedure for tightening the bolts is recommended.

- Tighten the 3-M20 (DD) bolts to a torque value of 140 ft/lbs.
- Tighten the M36 (AA) bolt to 360 ft/lbs.
- Run the lift for at least 10 revolutions of the bullwheel.
- Repeat this sequence at least 3 times, or until the heads of the bolts no longer turn at the specified torque values.
- After approximately 50 hours of normal operation, check the tightness of the bolts again.

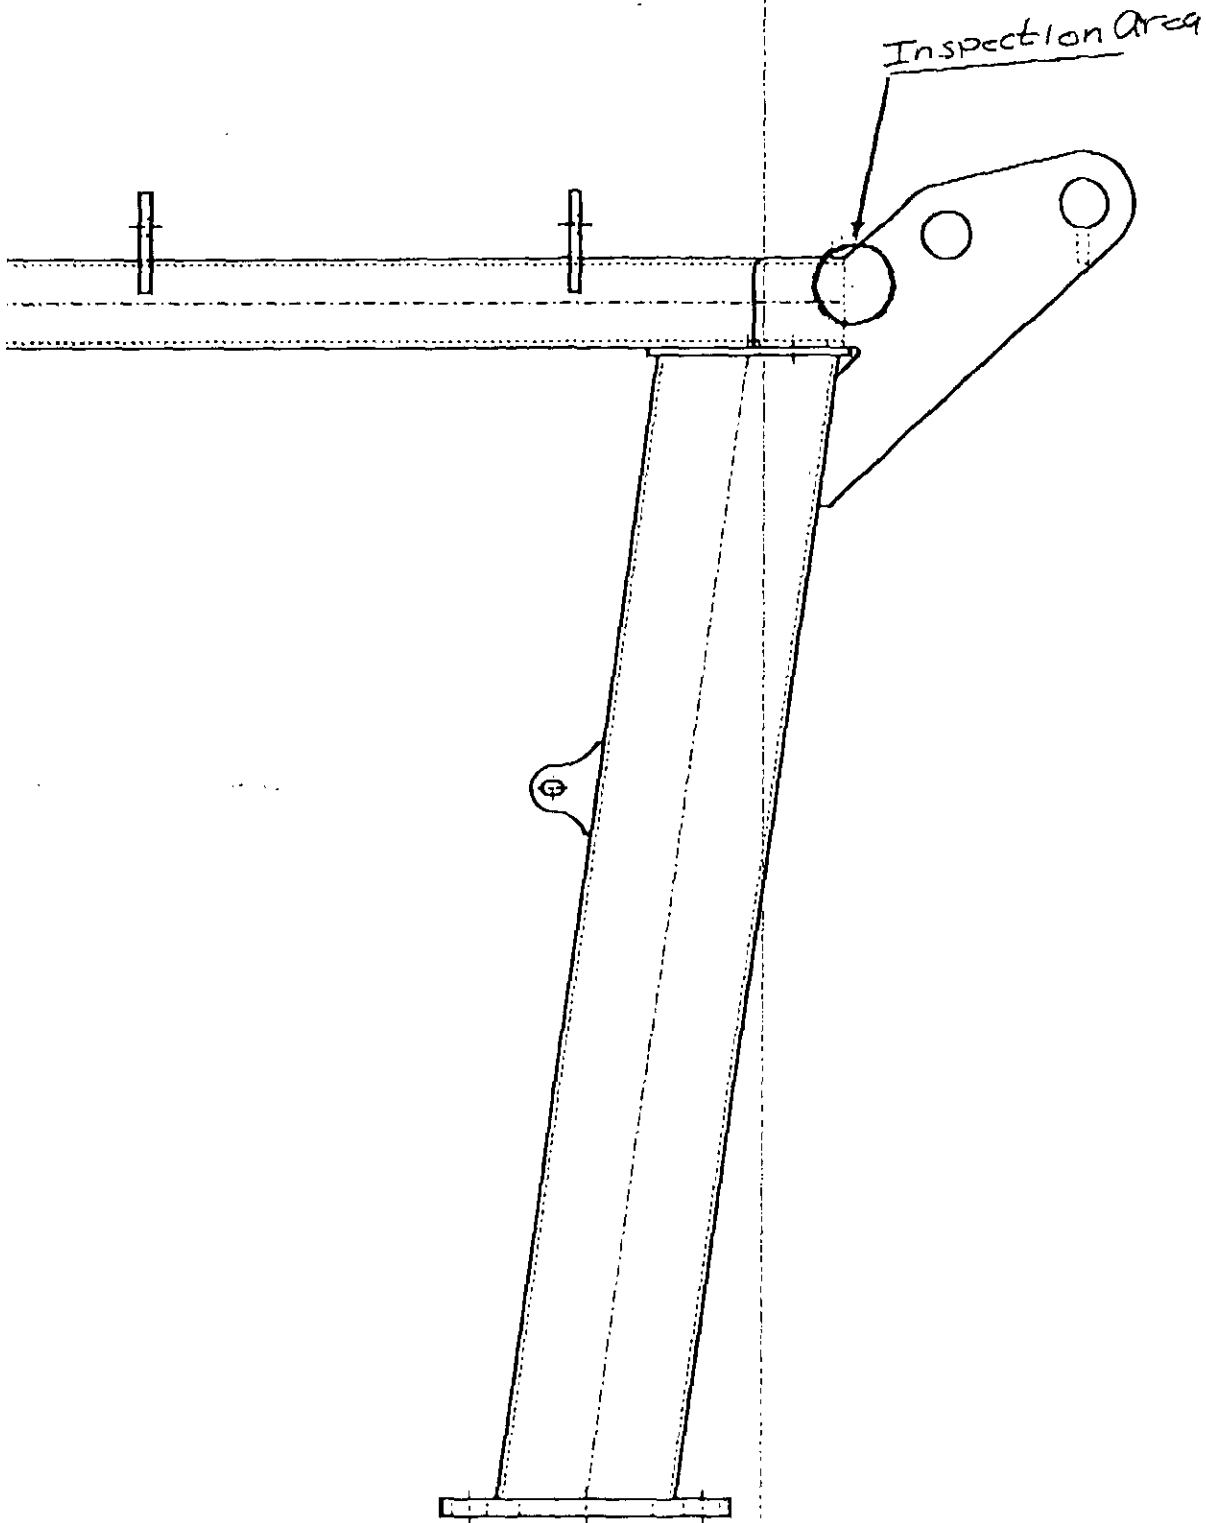
L-POA has been informed of cracks found in the rigging flanges.

L-POA is requesting that you perform a visual inspection of the area noted on the accompanying drawing. This inspection should be performed on 100% of the crossarms of lifts installed in 2001, 2002 and 2003.
