**CHANCE**  
MANUFACTURING CO., INC.

# Service Information

Ride: ZIPPER

Subject: SEAT SAFETY LUG BOLT CHECK

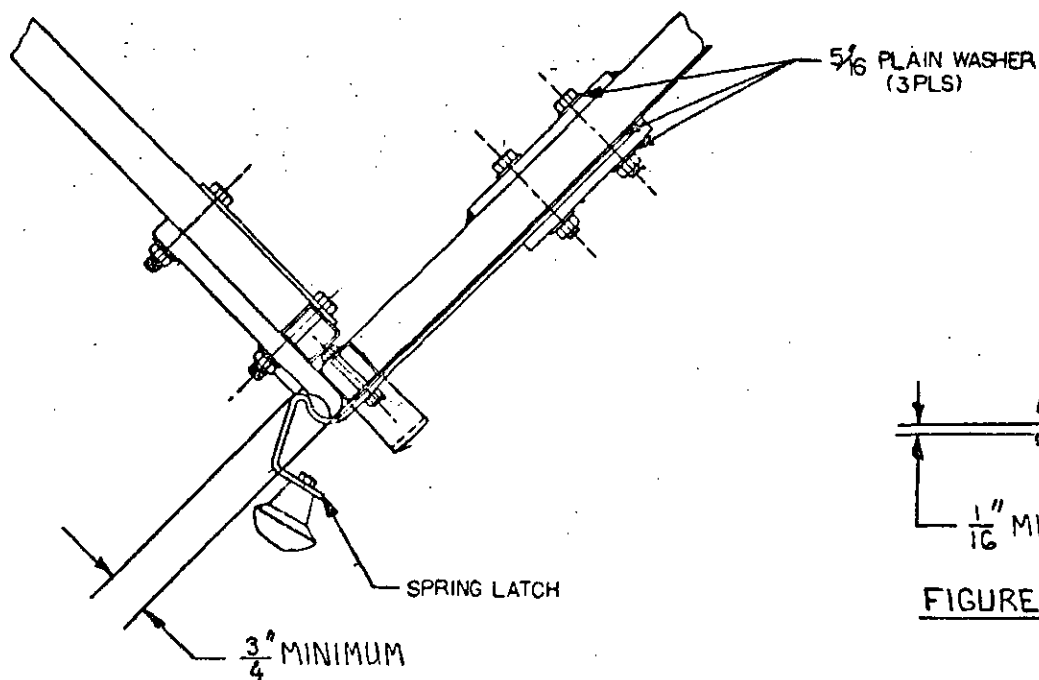
FIGURE B

Ride operators must be instructed to check all spring latches and hairpin latches daily. The spring latch reset must overlap the stricker plate by  $\frac{3}{4}$ ". (FIGURE B) The hair pin must have no more than  $\frac{1}{16}$ " clearance when it is in a relaxed position. (FIGURE C) The hair pin must also have a minimum release point of 8 pounds on a straight pull. A record should be kept of each inspection.

The 390-32497 Spring Latch on each seat must be checked daily. The Spring Latch must be centered on the 305-49420 Striker Plate and should clear the base of the 305-16798 Retainer Clip no more than  $1/16$ " as shown in figure B thus insuring adequate overlap of Spring Latch and Striker Plate and preventing the door from opening unless released by pulling on Spring Latch knob. Spring Latches which clear the base of the Retainer Clip more than  $1/16$  should be replaced immediately and the seat not used until this has been done. (FIGURE B) Do not attempt to straighten or repair the Spring Latch in any way. Each Spring Latch must be replaced on or before the expiration date (month and year) etched at the knob end.

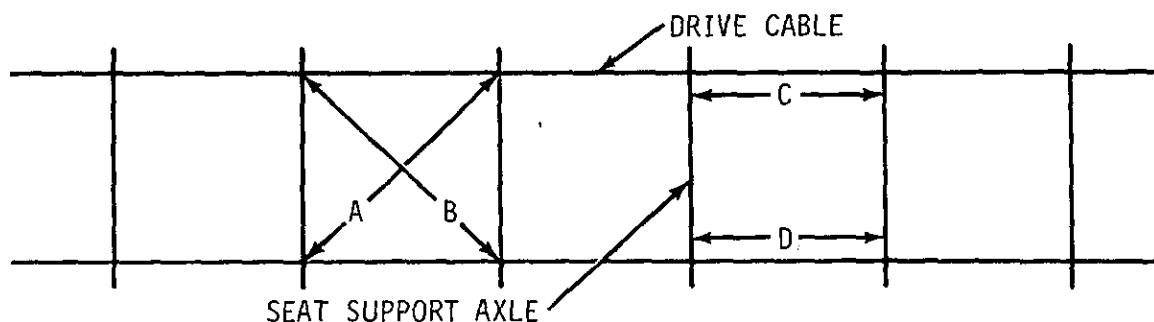
FIGURE A

Cross cables are used to help compensate for a small amount of misalignment in the seat support axles. If the misalignment becomes too severe the cross cables will break. Misalignment of the seat support axles will also result in rapid wear of the seat support axle wheels and binding or breaking of the wheel attaching bolts. Cross cables can also be broken if they are adjusted too tight or if they are twisted.

Check the alignment of the seat support axles to see that they are square with one another. Measure and record the distance diagonally both directions (dimensions A and B) between common points on all of the seat support axles. (See Figure A) Measure and record the distance between all of the axles at common points parallel to the drive cables (dimensions C and D). If the C or D dimensions are not consistent, loosen the necessary U-bolt and move the seat support axle as required. Measurements and adjustments must be performed while the seat support axles are at a straight section of track and all of the cross cables have been removed.

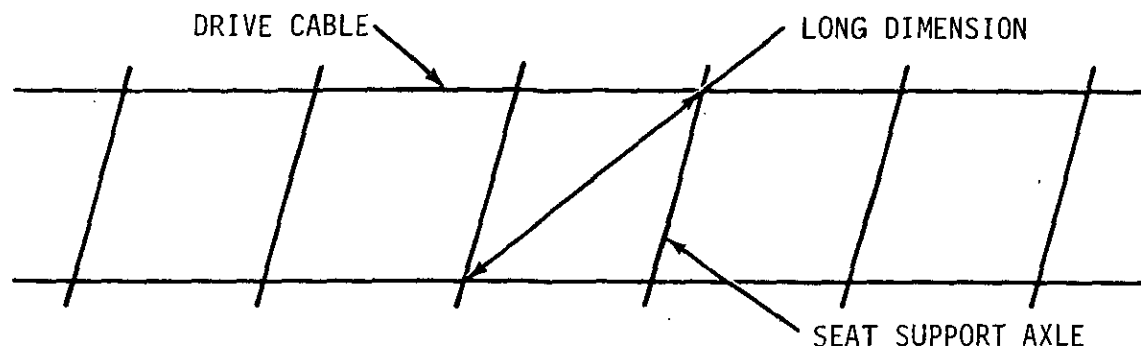
FIGURE B

If one of the drive cables has slipped the A dimensions will differ from the B dimensions, but the C and D dimensions will be the same. To correct this, install one cross rod at dimension A or B which ever is the longest (See Figure B) and tighten the cross rod. "Jog" the drive cables by running the cable drive first one direction and then the other for a few inches. Tighten the cross rod and repeat procedure until the A and B dimensions are the same.

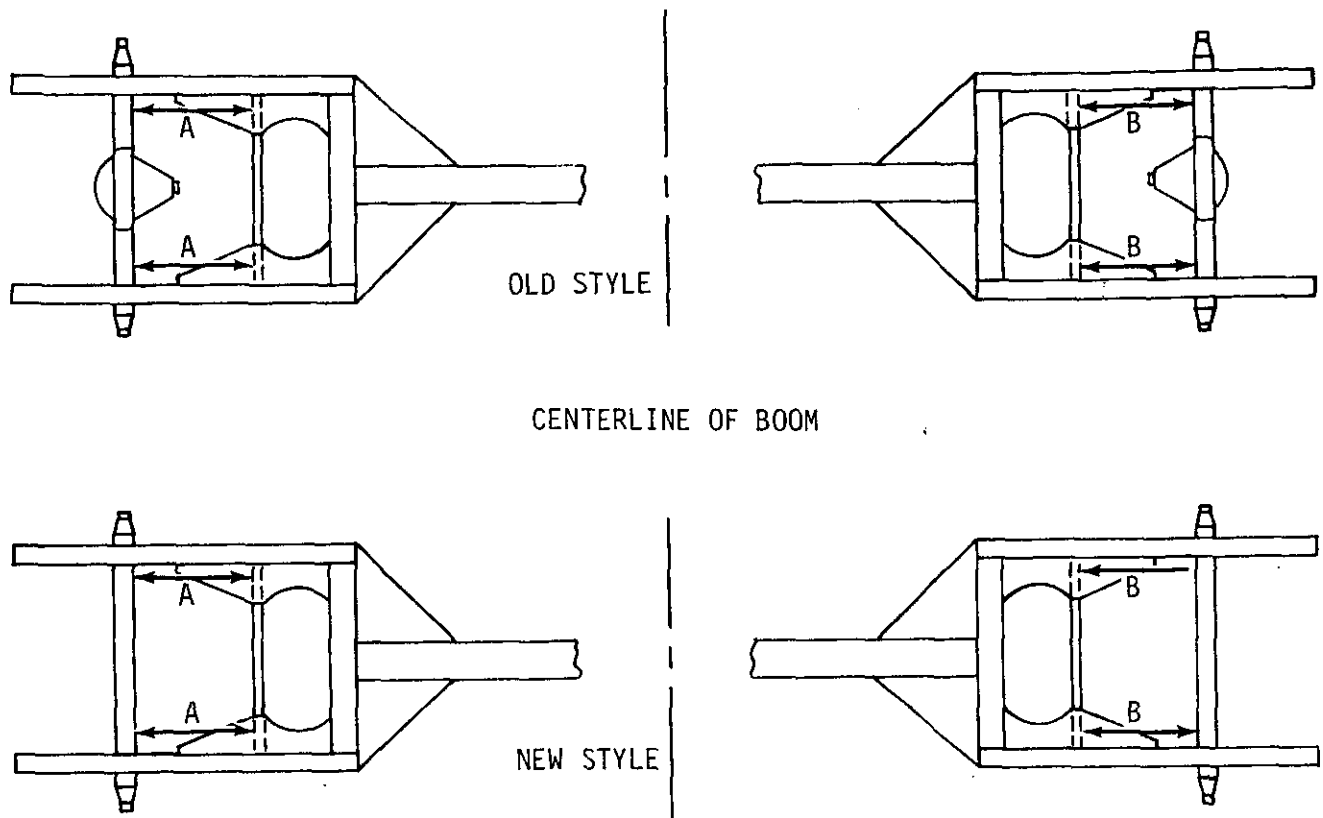
Before adjusting the drive cables, check both sheave drive axles for alignment. Check each axle by measuring from a common point on the differential axle (old models) or the solid shaft axle (new models) to the first cross channel on the boom. (Fig. C ) The two dimensions must be the same on both sides of the same axle. Then compare the dimensions from both axles. There must be no more than one inch difference between the two axles.

BOTH A DIMENSIONS MUST BE THE SAME  
 BOTH B DIMENSIONS MUST BE THE SAME  
 THERE MUST BE NO MORE THAN ONE INCH DIFFERENCE  
 BETWEEN THE A AND B DIMENSIONS

If after checking the adjustment of the drive axles, one of the drive cables appears loose, tighten that cable the minimum amount possible to prevent slippage.

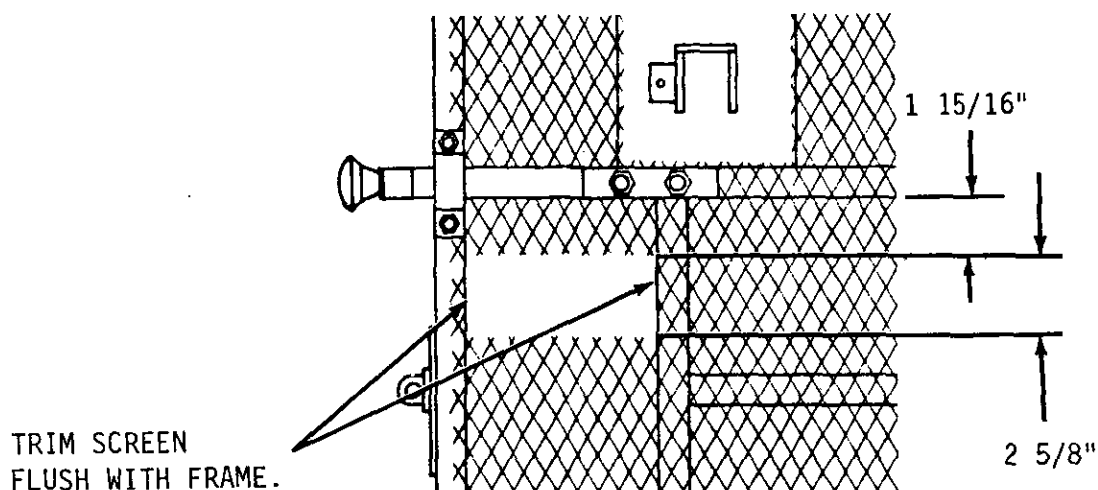
FIGURE A

Remove screening from area shown in FIGURE A.

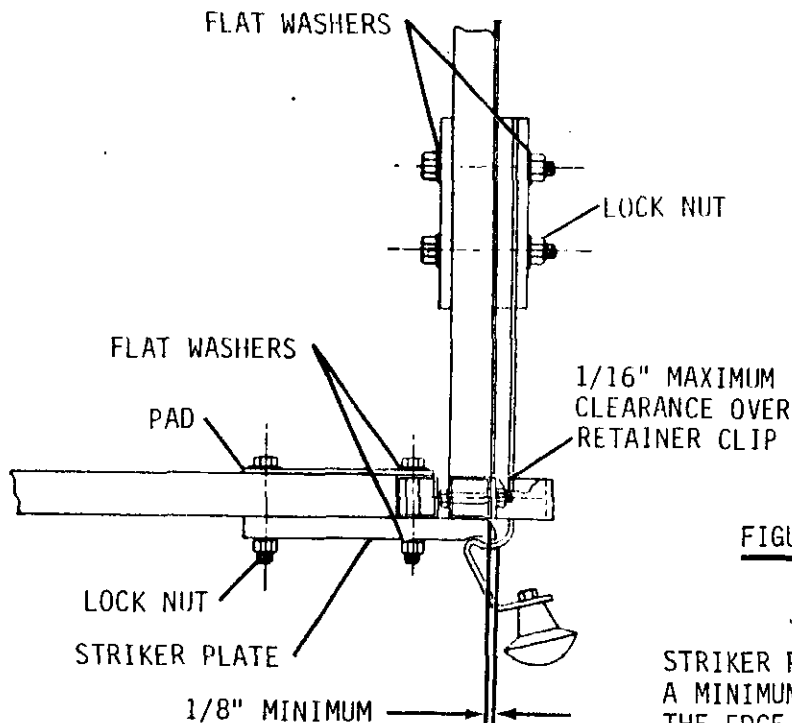
FIGURE F

The 390-32497 Spring Latch must be centered on the 305-49420 Striker Plate and should clear the base of the 305-16798 Retainer Clip no more than 1/16" as shown in Figure F, thus insuring adequate overlap of Spring Latch and Striker Plate and preventing the door from opening unless released by pulling on Spring Latch knob. Spring Latches which clear the base of the Retainer Clip more than 1/16" should be replaced immediately and the seat not used until this has been done. (FIGURE F). Do not attempt to straighten or repair the Spring Latch in any way. Each Spring Latch must be replaced on or before the expiration date (month and year) etched at the knob end. Attaching bolts must be retorqued if found loose.

The 305-16798 Retainer Clip acts as both a centering device to insure that the 390-32497 Latch Spring is centered on the 305-49420 Striker Plate, and a stroke limiting device to prevent over stroking of the Spring Latch. Cap screws must be retorqued if found loose.

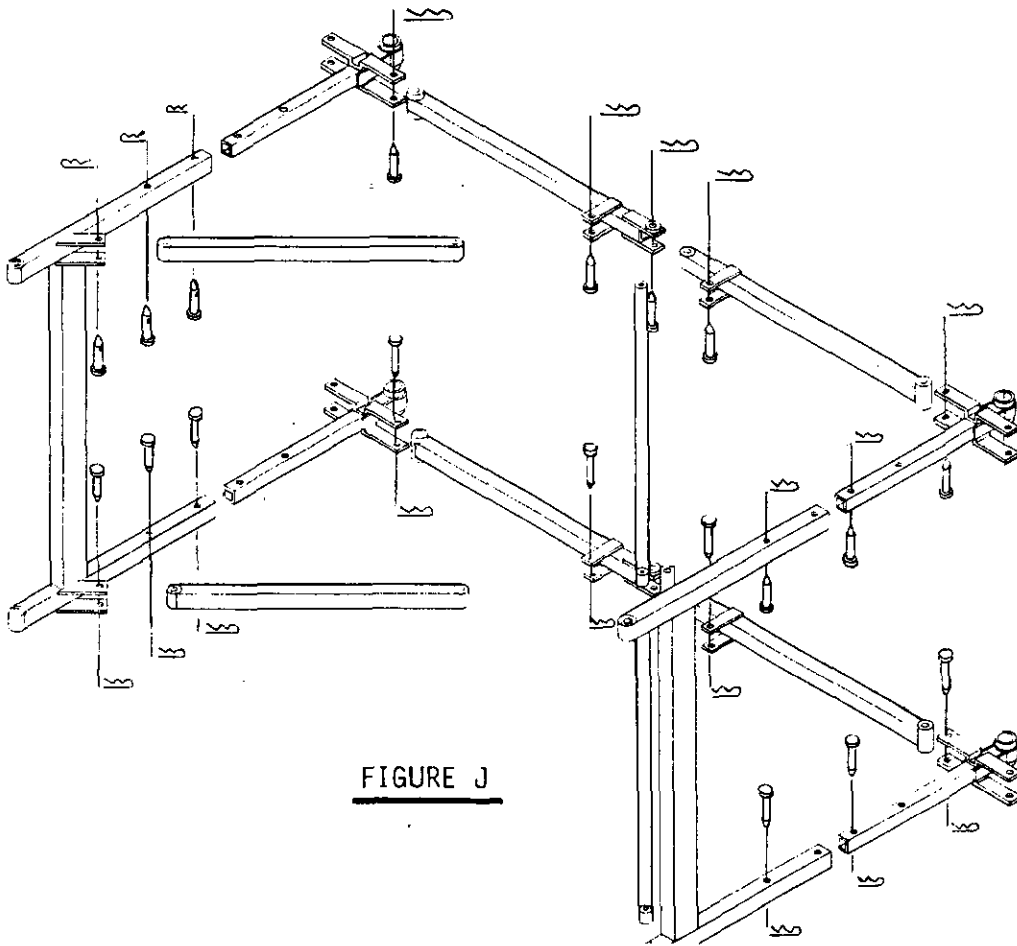
FIGURE J

Inspect all taper pins in seat support frame. Taper pin must always be inserted so that the heads of pins are to the inside of the frame to provide maximum seat clearance.

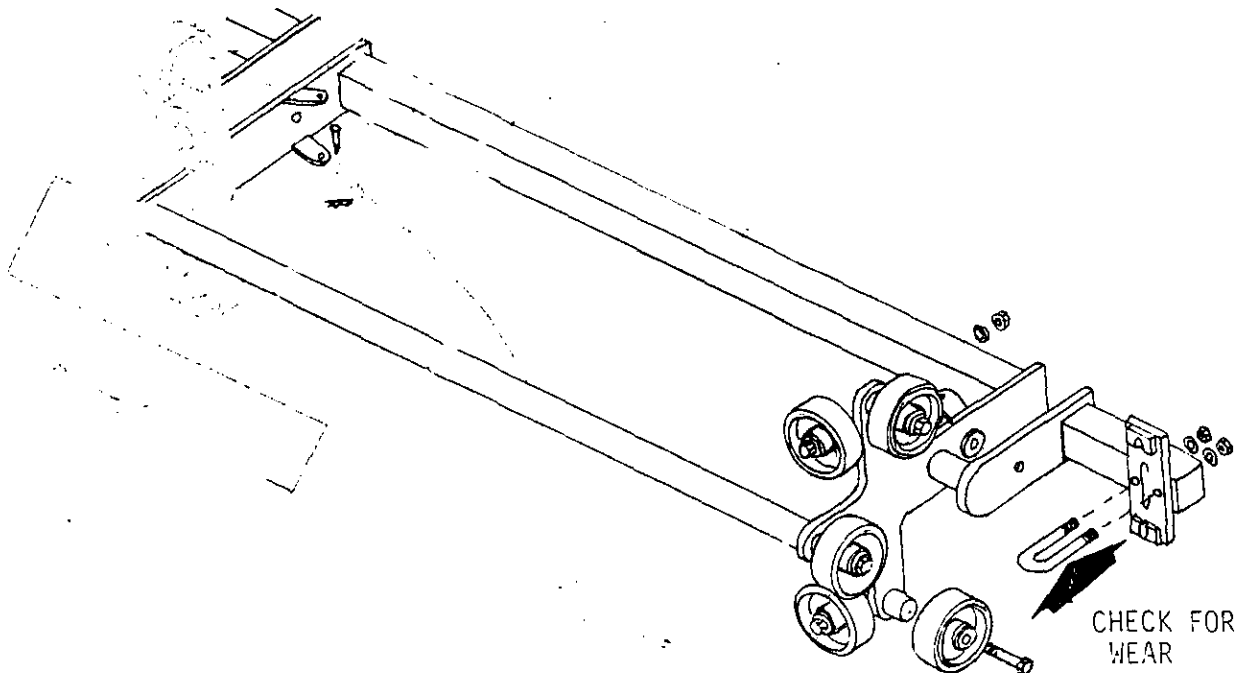
FIGURE A

This condition could result in extensive wear both externally and at the cable clamping surface.

Please inspect all clamps for signs of wear and notify Chance Manufacturing if such a condition exists.

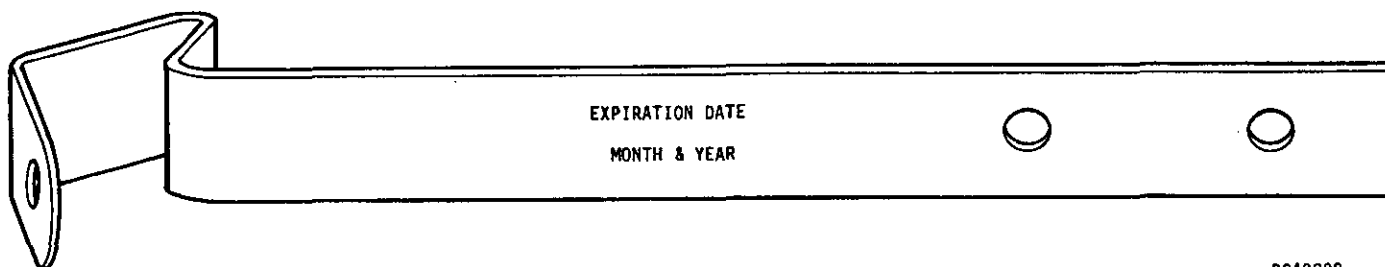
An expiration date is electrically etched into each spring latch in the location shown below.

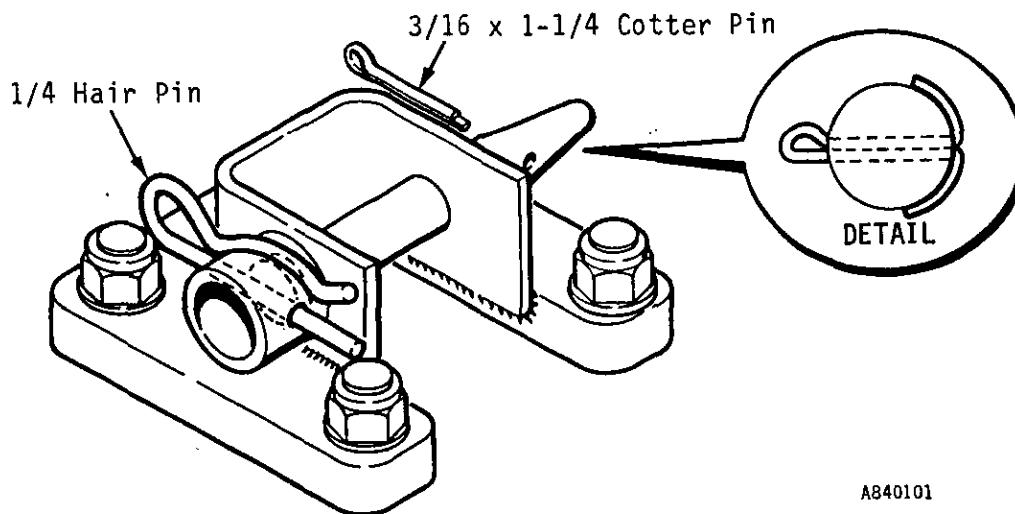
Recent field inspections have found ZIPPER seat hanger pins secured with incorrect parts. The illustration below shows the correct method of securing the tapered pin in the seat hanger.

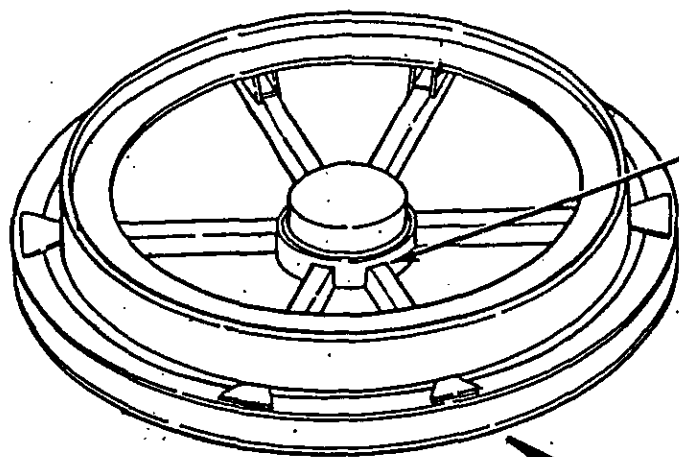
Inspect for cracks in or near welds between spokes and hub

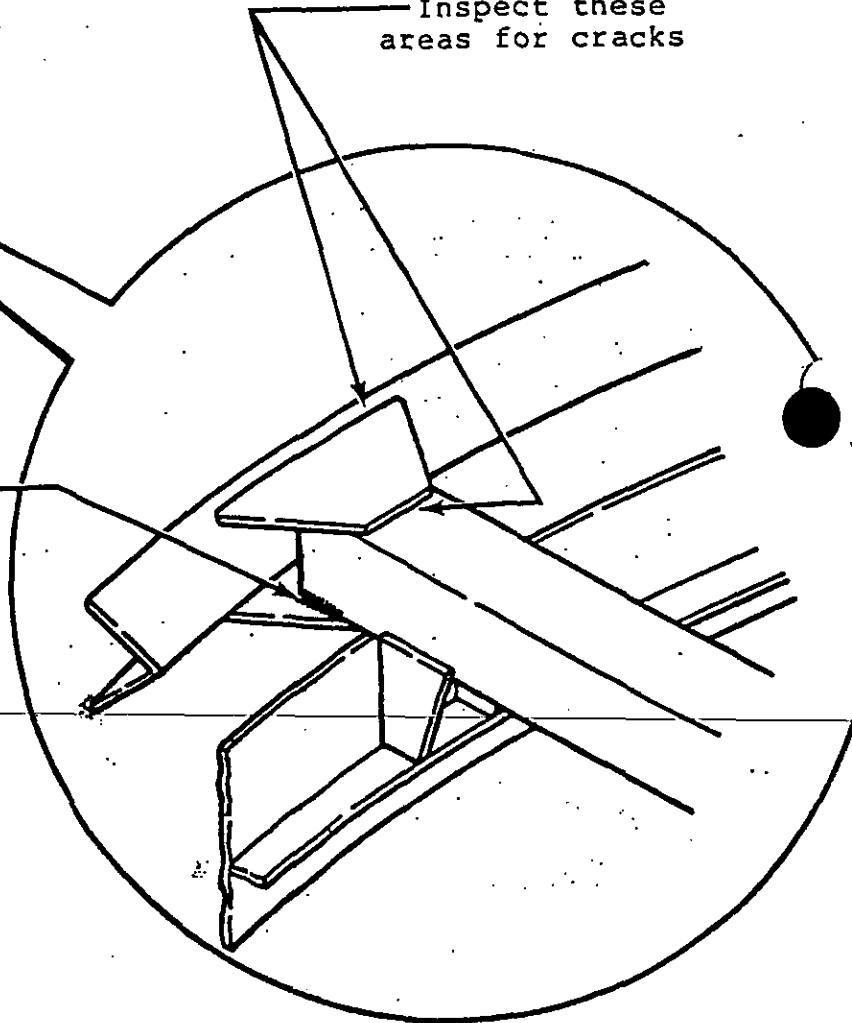
IF THIS AREA IS NOT WELDED, CONTACT THE CHANCE CUSTOMER SERVICE DEPT. IMMEDIATELY

1. Inspect the cable sheave for cracks where the spokes weld to the hub. The weld must go completely around the spoke on all four sides.

3. IF ANY CRACKS ARE FOUND, OR IF ANY WELDS ARE QUESTIONABLE, CONTACT THE CHANCE CUSTOMER SERVICE DEPARTMENT IMMEDIATELY.

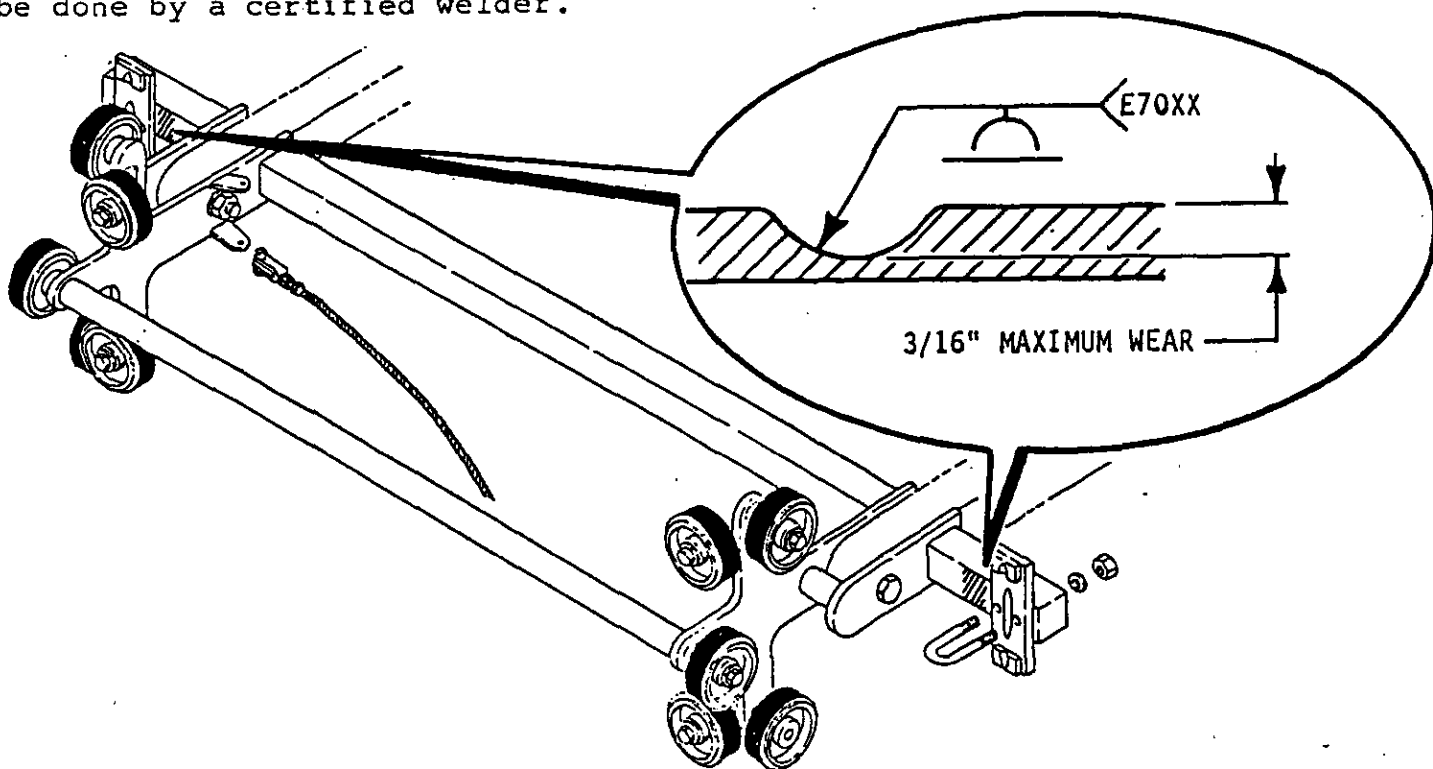
If the wear is no deeper than  $3/16$ ", it can be corrected by welding the worn area and grinding the entire repaired area smooth as shown. All work must be done by competent, qualified mechanics, capable of understanding the function of the parts and their proper installation. All welding must be done by a certified welder.

If this type of wear occurs frequently, or the amount of wear is severe contact the CHANCE CUSTOMER SERVICE DEPARTMENT for further corrective measures.

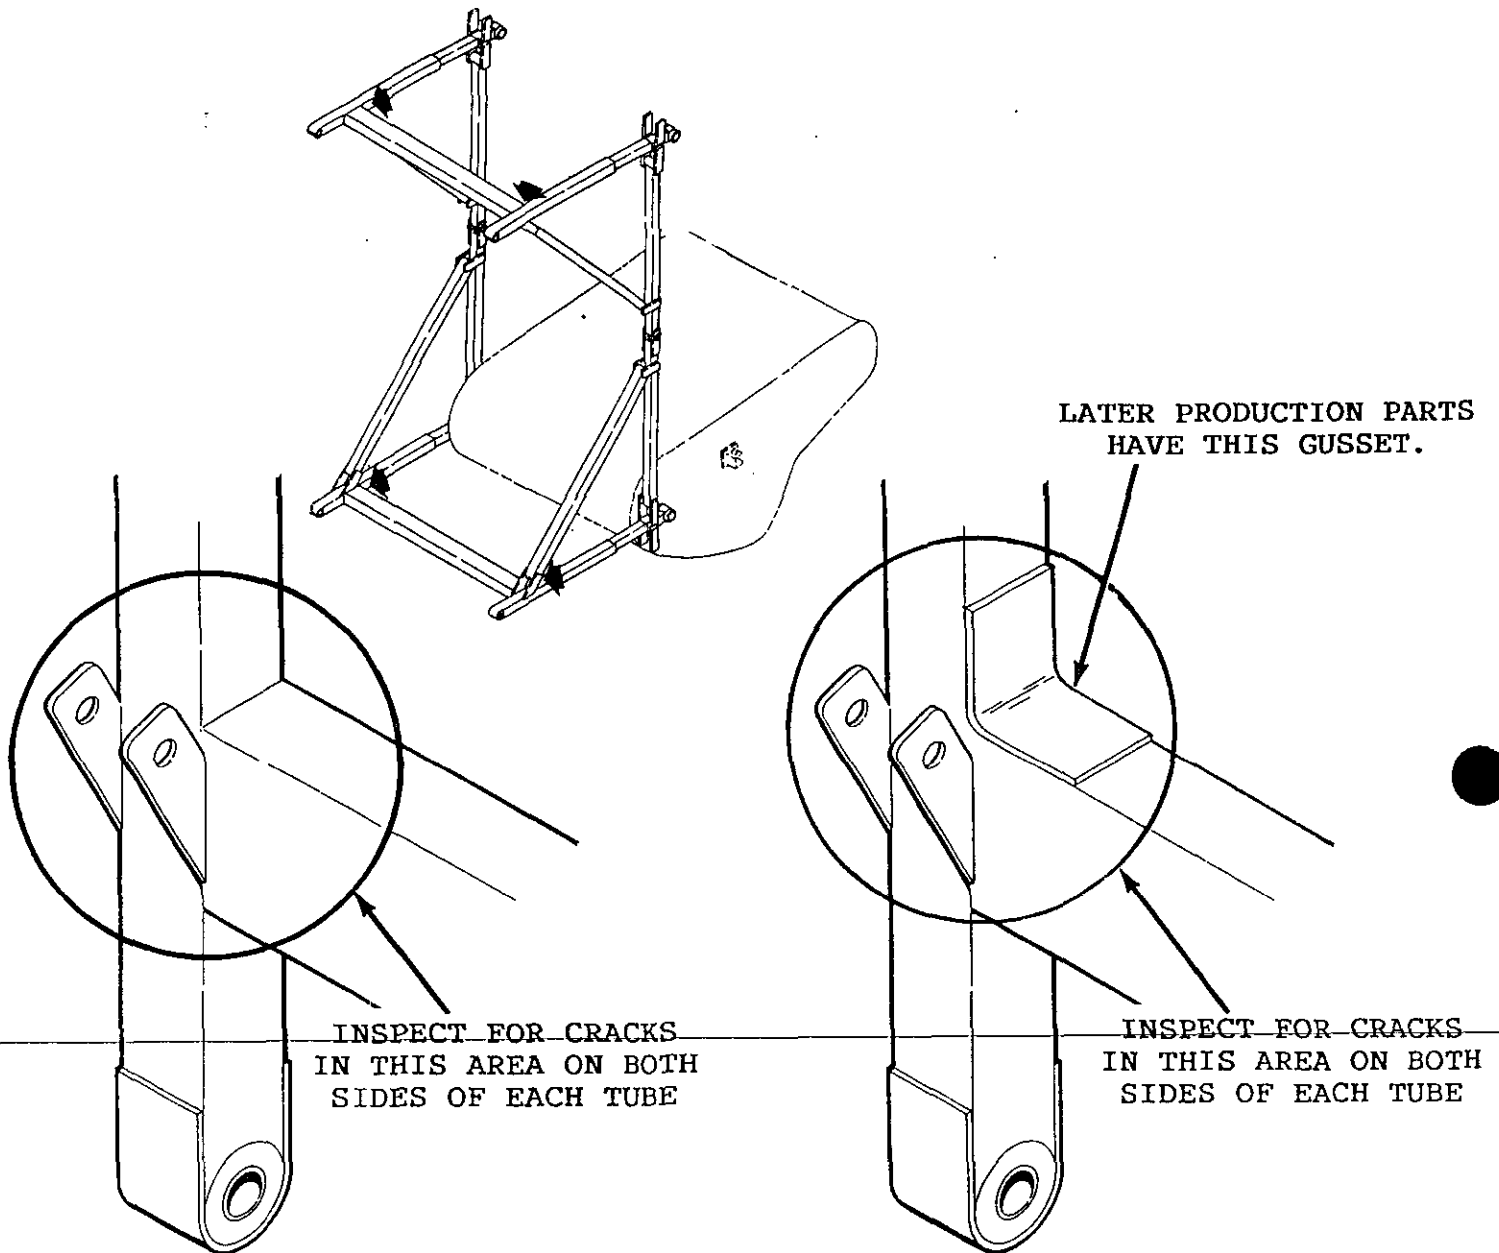
Check each seat support frame (12 per ride) for cracks as shown in the following illustration. Inspect the weld and the tubing near the welded joint.

- If a crack is found in a seat support frame, replace the frame with a new part. Do not attempt to weld or otherwise repair a cracked seat support frame. DO NOT OPERATE THE RIDE.
- If no cracks are present, and the seat support frame does not have the reinforcing gusset, order Kit No. K05-0344-00. Install the kit using the following instructions.

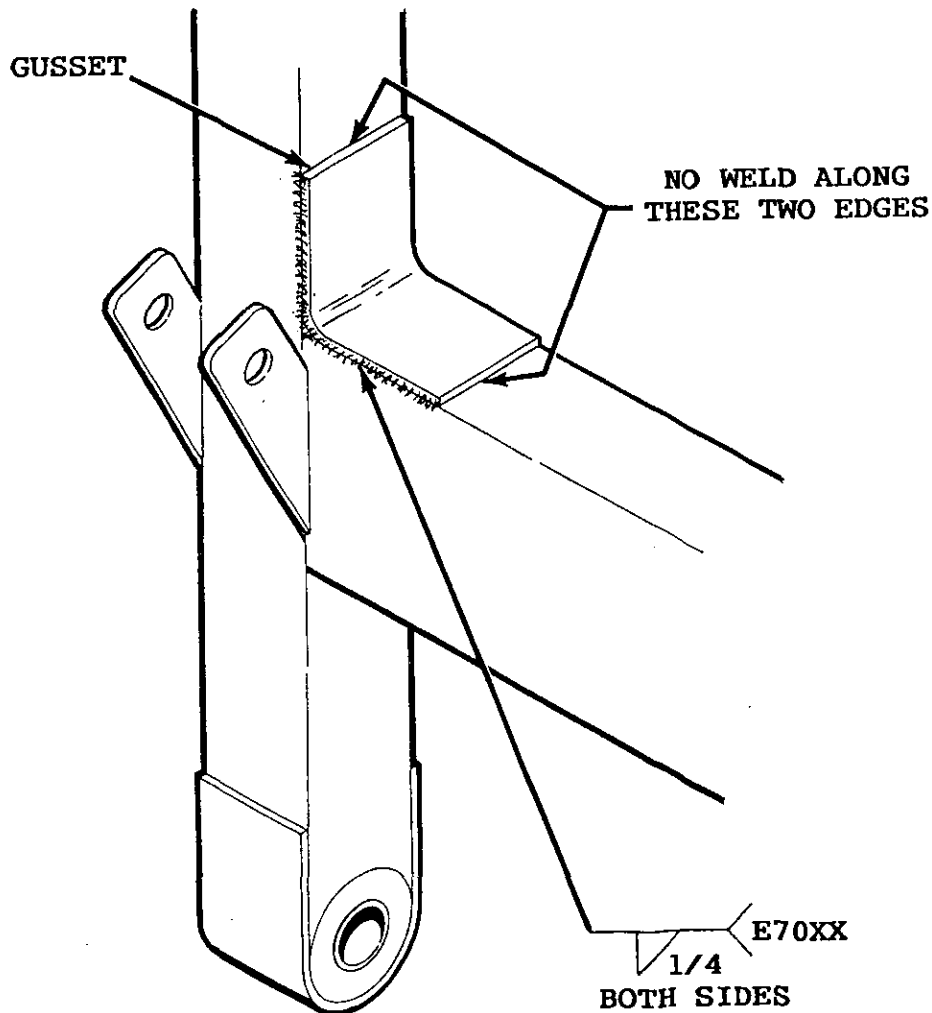
All seat support frames must have the reinforcing gusset like later productions parts. Locate and weld the gusset two places on the seat support frame as shown.

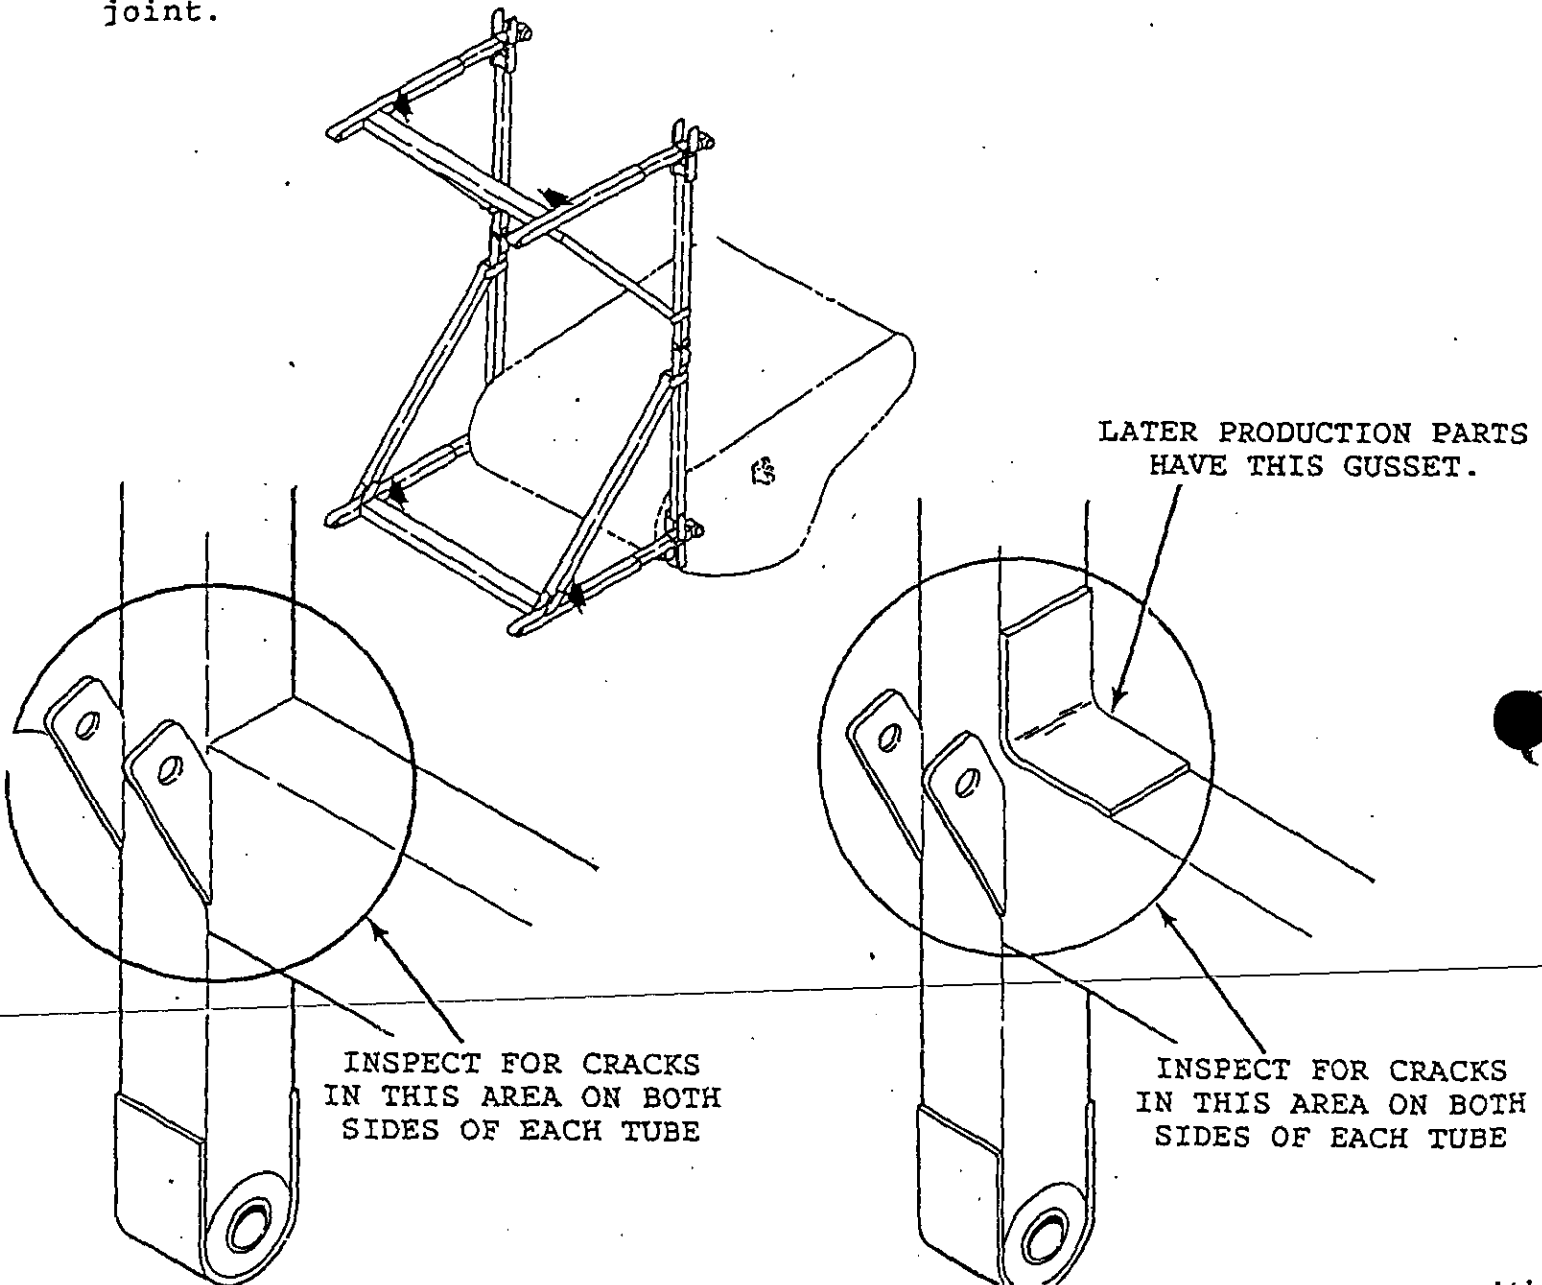
Check each seat support frame (12 per ride) for cracks as shown in the following illustration. Inspect the weld and the tubing near the welded joint.

- If a crack is found in a seat support frame, replace the frame with a new part. Do not attempt to weld or otherwise repair a cracked seat support frame. DO NOT OPERATE THE RIDE.
- If no cracks are present, and the seat support frame does not have the reinforcing gusset, order Kit No. K05-0344-00. Install the kit using the following instructions.

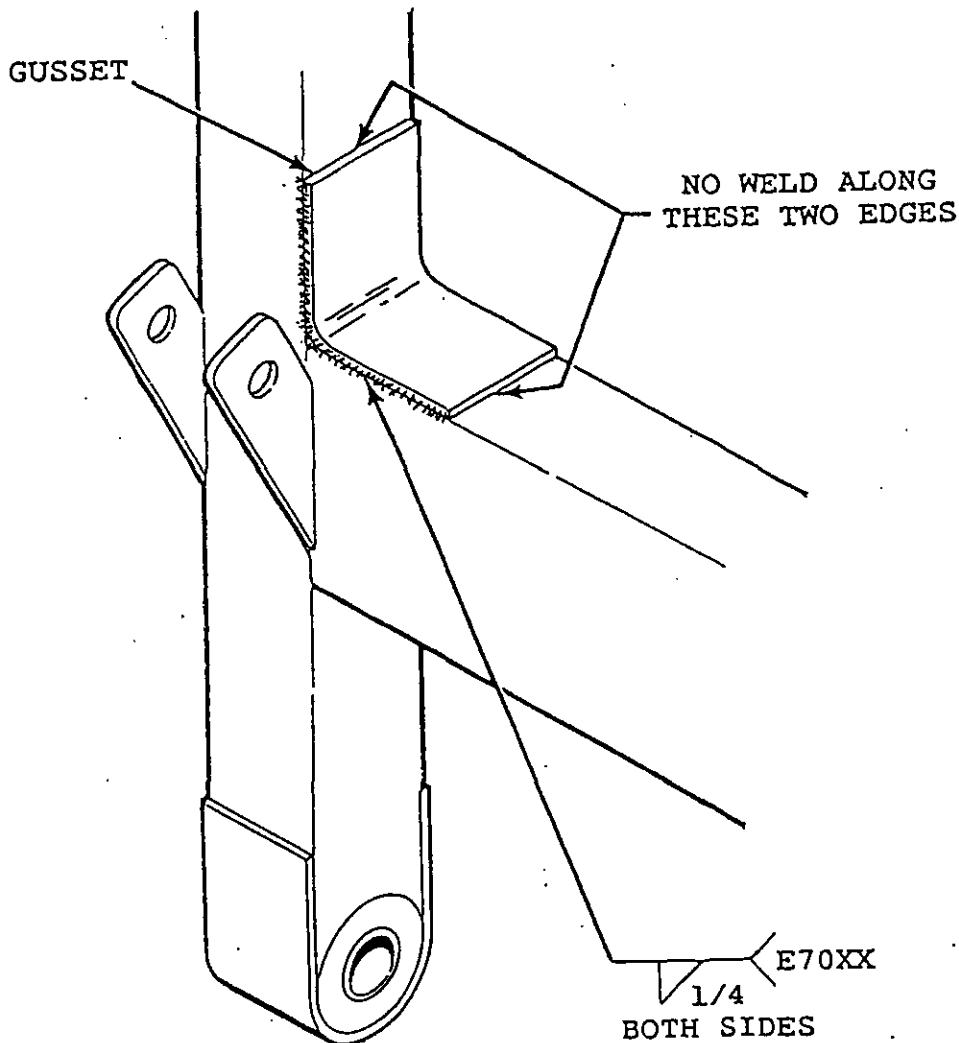
All seat support frames must have the reinforcing gusset like later productions parts. Locate and weld the gusset two places on the seat support frame as shown.

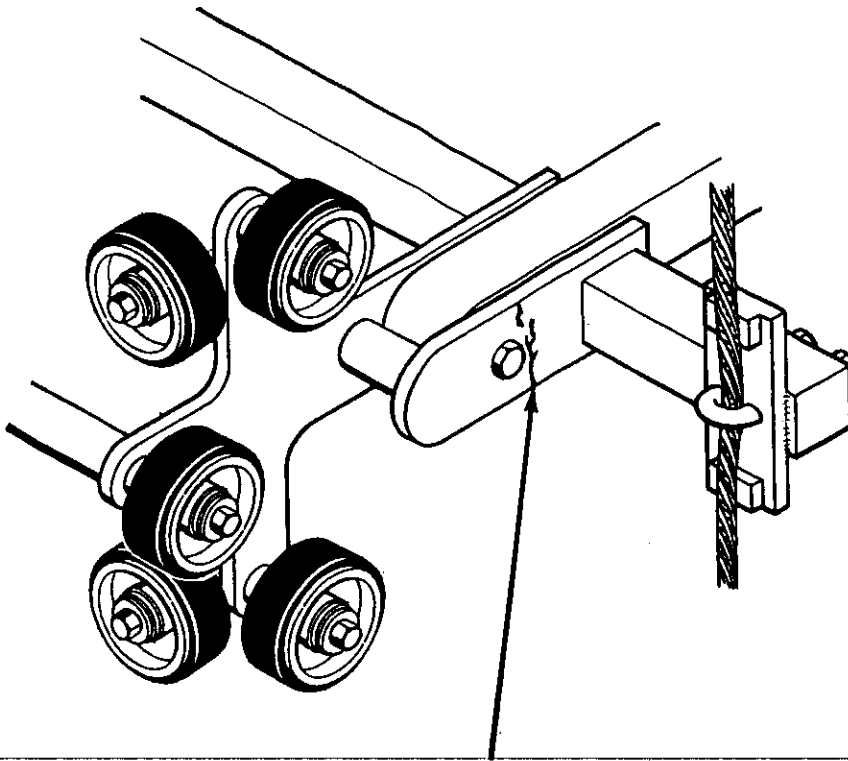
Inspect both ends of each axle frame for cracks as shown in Illustration A.

INSPECT FOR CRACKS  
IN THIS AREA

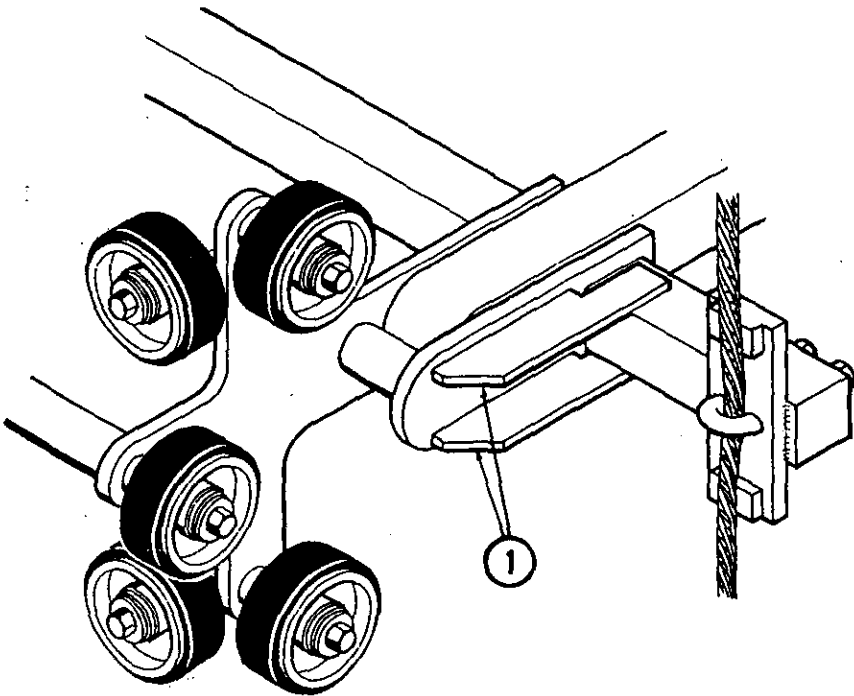
ILLUSTRATION B

Install kit no. K05-0350-00 as shown in Illustrations B and C. Two plates must be added to each end of every axle frame.

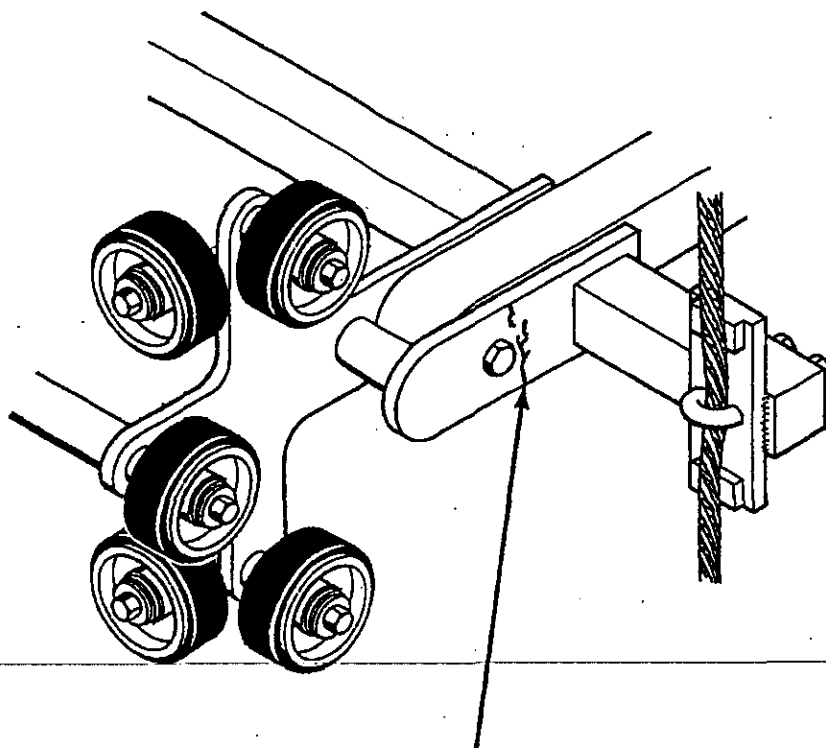
Inspect both ends of each axle frame for cracks as shown in Illustration A.

INSPECT FOR CRACKS  
IN THIS AREA

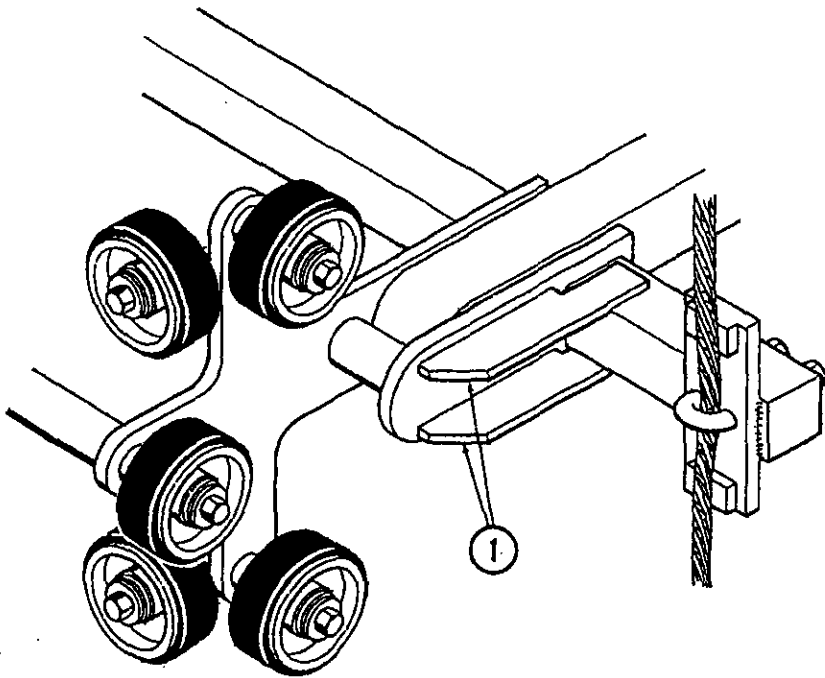
ILLUSTRATION B

Install kit no. K05-0350-00 as shown in Illustrations B and C. Two plates must be added to each end of every axle frame.

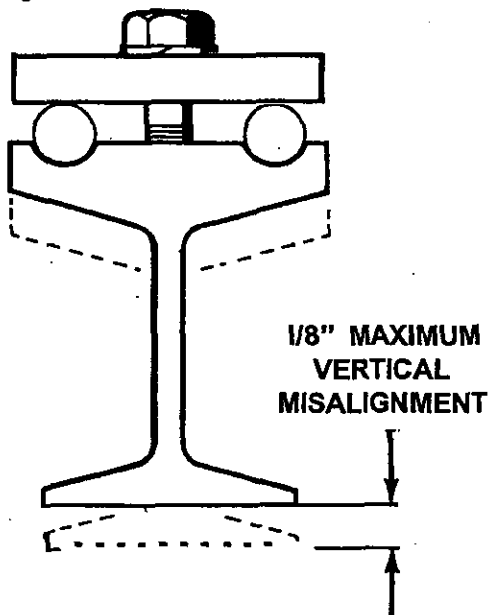
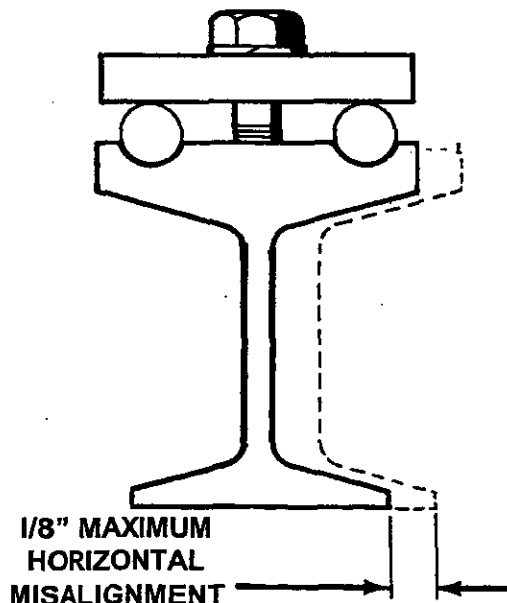
Chance Rides, Inc. has become aware of at least one ZIPPER amusement ride on which the straight track and the curved tracks became misaligned. If this occurs, damage to both the wheels and the bolts holding the wheels may occur. Chance Rides, Inc. requires all ZIPPER owner/operators to check the alignment of the track at each set up or monthly, whichever occurs first.

The maximum misalignment of the track sections, in either an up and down or side to side direction is 1/8".

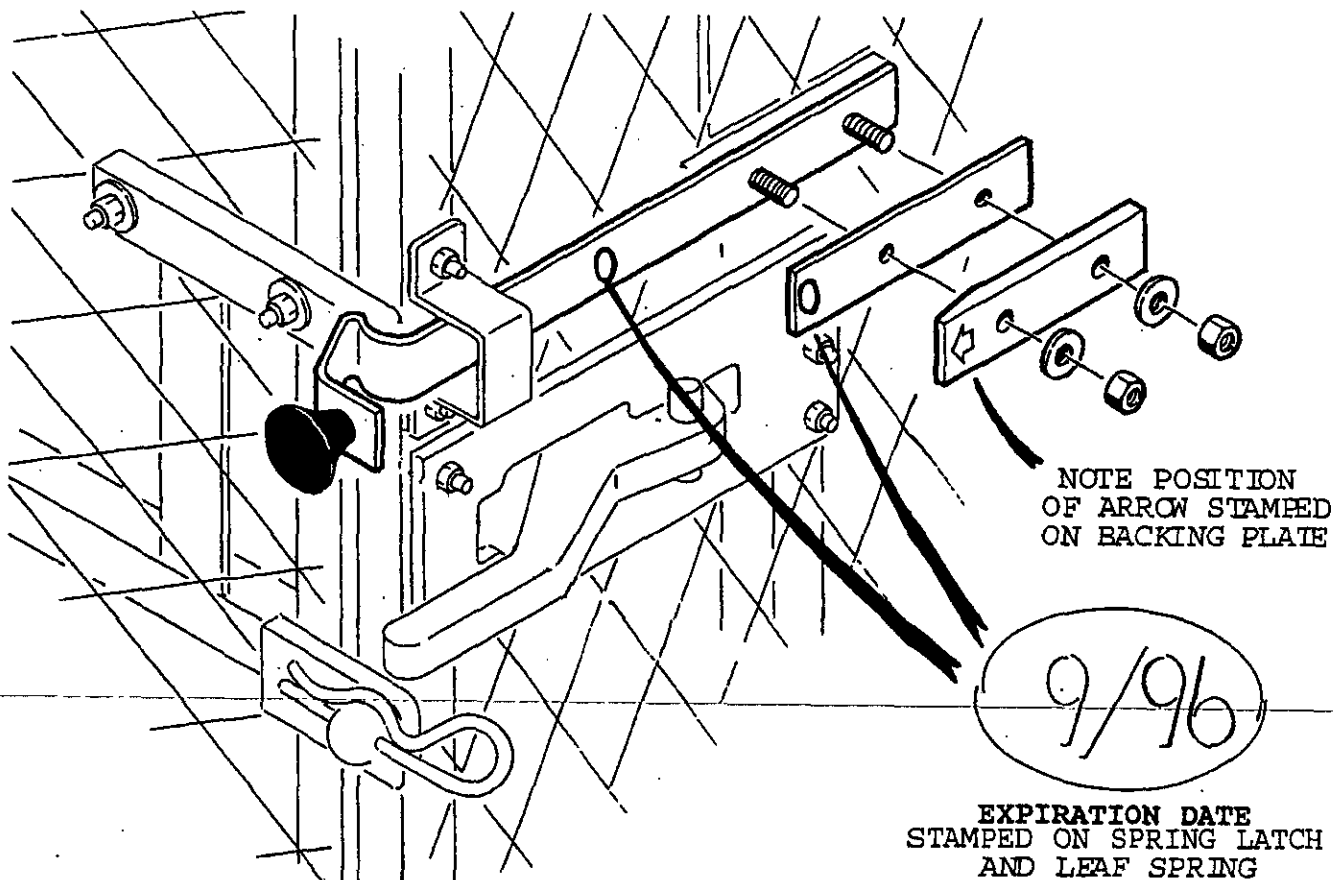
IMPORTANT: The spring latches, leaf springs and backing plates must be installed exactly as shown in this bulletin.
