SERVICE LETTER BR-01
ISSUED BY HUSS MASCHINENFABRIK
DECEMBER 1986

RE: Revolutions per minute for the Breakdance

BREAKDANCE

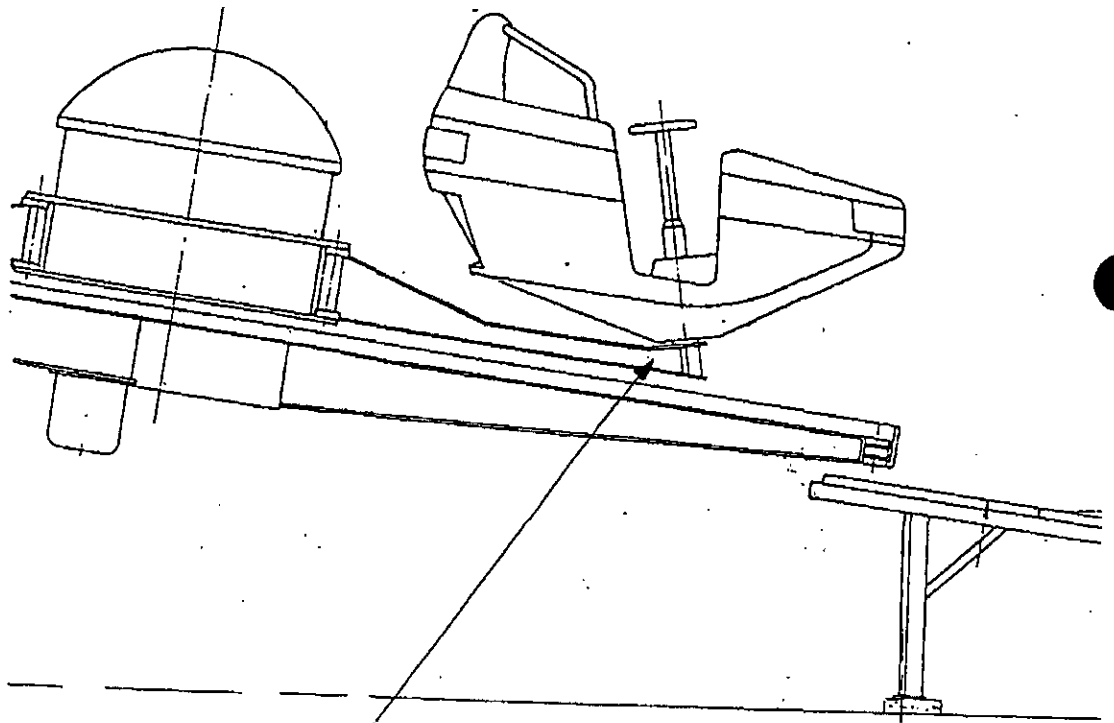
Nr. 4-22378

Even a small increase of the RPM can lead to 50% higher stress on certain structure parts, which can cause cracks at the gondola arms near the braking cylinders.

*Gondelkreuz
gondola cross*

*Diesen Bereich besonders auf Rißbildung kontrollieren
this area is to be controlled for possible cracks*

In any event, the gondola arms have to be checked on a regular basis.

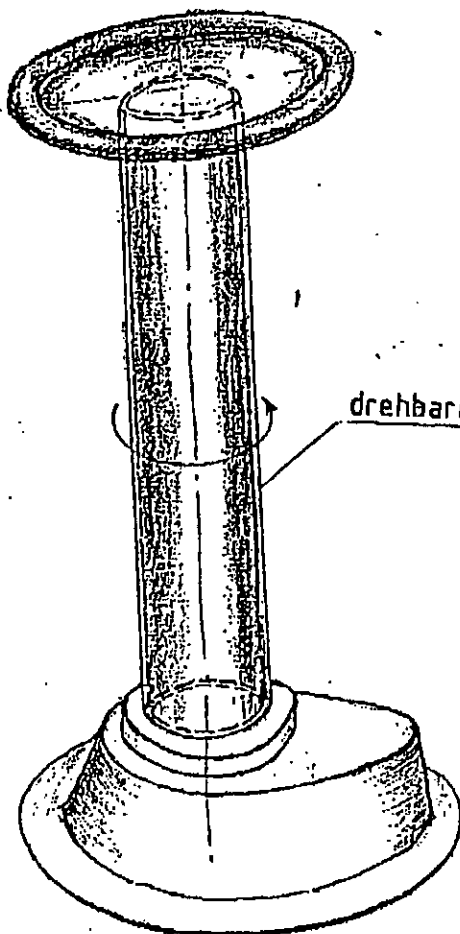
Nr. 4-22843

As reported, there is the danger that loose clothing could be wrapped around the wheel support.

Drehbare Hülse um Gondel-Handradsäule

drehbare Hülse

To avoid accidents, we offer you a conversion kit, where the free-standing tube around the support eliminates this problem.

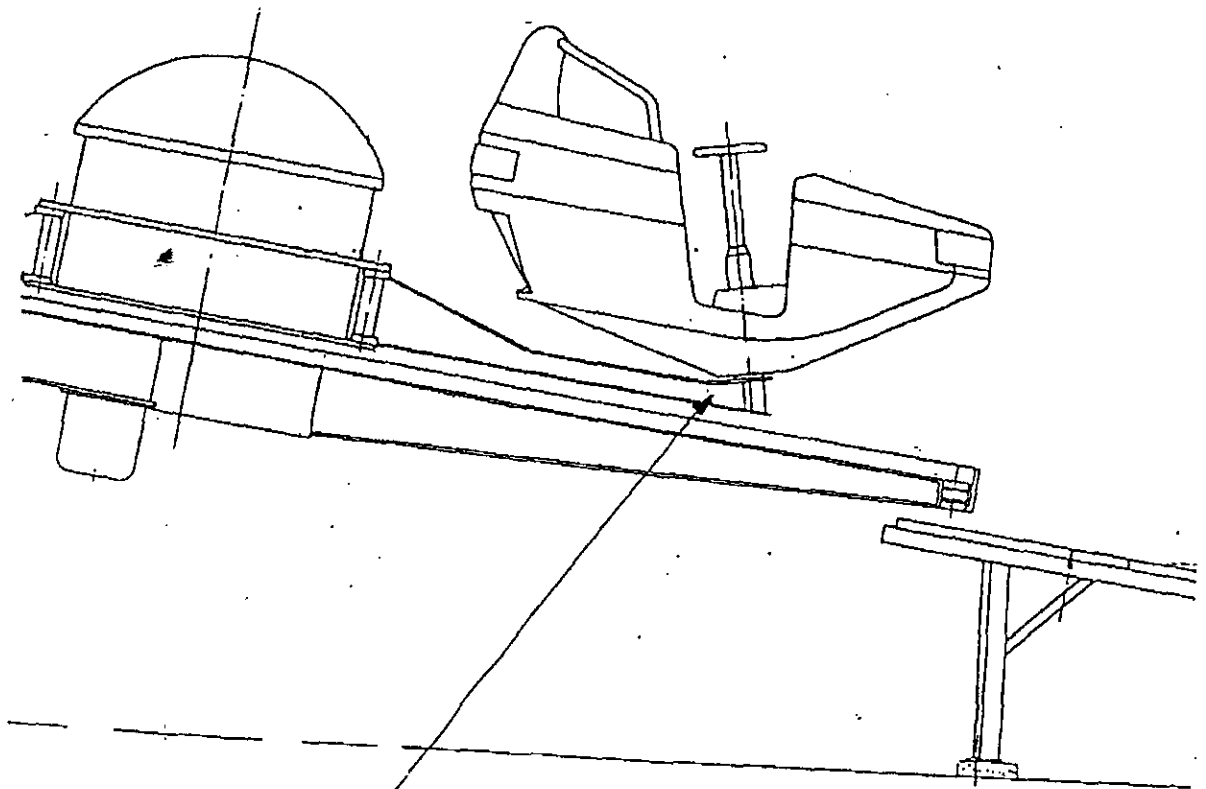
In our Service Letter BR-01 we pointed out that the revolving gondola cross booms, i.e. 4 booms per gondola cross, a total of 16 pieces, must be constantly checked for cracks.

*Gondelkreuz
gondola cross*

*Diesen Bereich besonders auf Rißbildung kontrollieren
this area is to be controlled for possible cracks.*

Today we would like to direct your attention to this matter once again. After 4 - 5 years of operation it may happen that there is cracking. Therefore, we urgently recommend that you think about a complete replacement of the gondola crosses.

Since the bearings are also subject to a certain wear, it may be advisable to replace them at the same time.

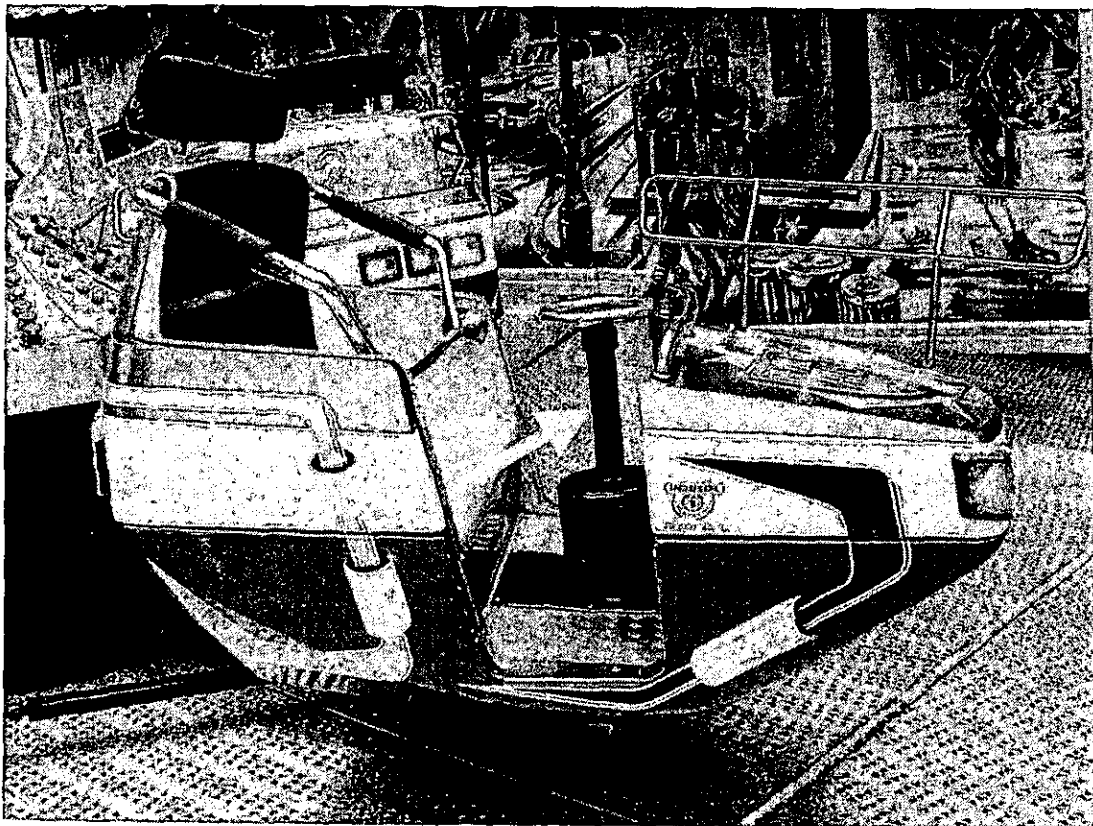
Various models of Break Dance rides have been distributed with a rotational post located in the center of each gondola as shown in the photograph below. These posts require regular inspection - if installed - to ensure that they are securely fastened to the gondola frame.

Recently an incident occurred where a rotational post was ejected from a moving gondola and injured a by-stander. Further investigation identified that the post fasteners had not been regularly checked for security.

Inspect and document rotational post fasteners on a regular basis (i.e. daily) to ensure that they are securely fastened and in good condition.
