CARES Notification

Subject: Main Mast Cracking

Ride(s) affected: Mondial Top Scan

Date: January 12, 2012

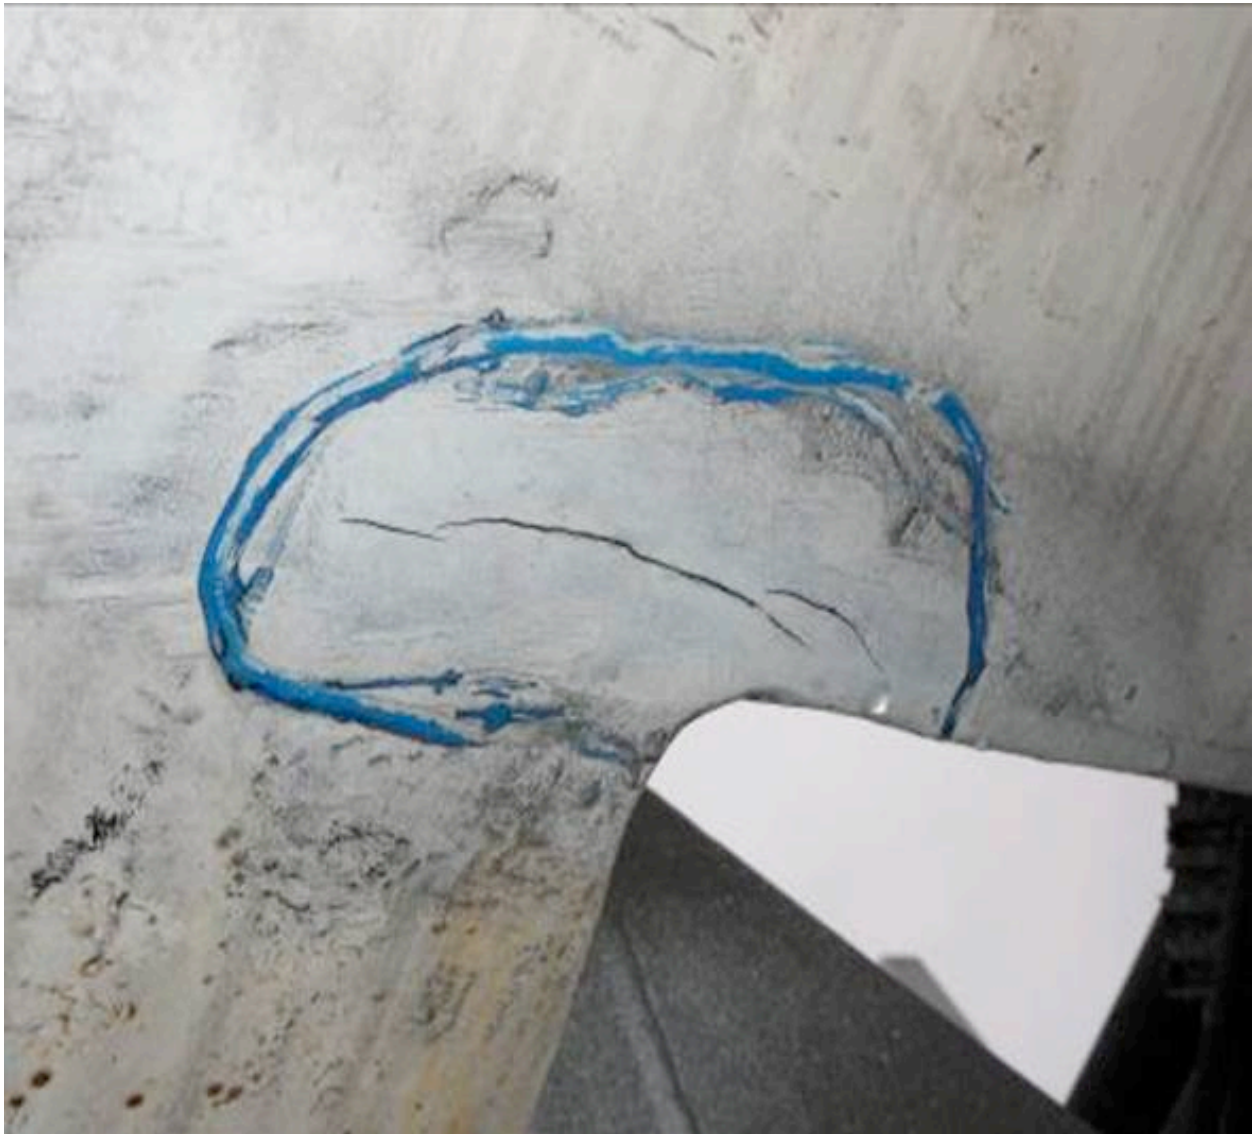
An inspector in the UK has provided the following information regarding a crack found on an “older” Mondial Top Scan:

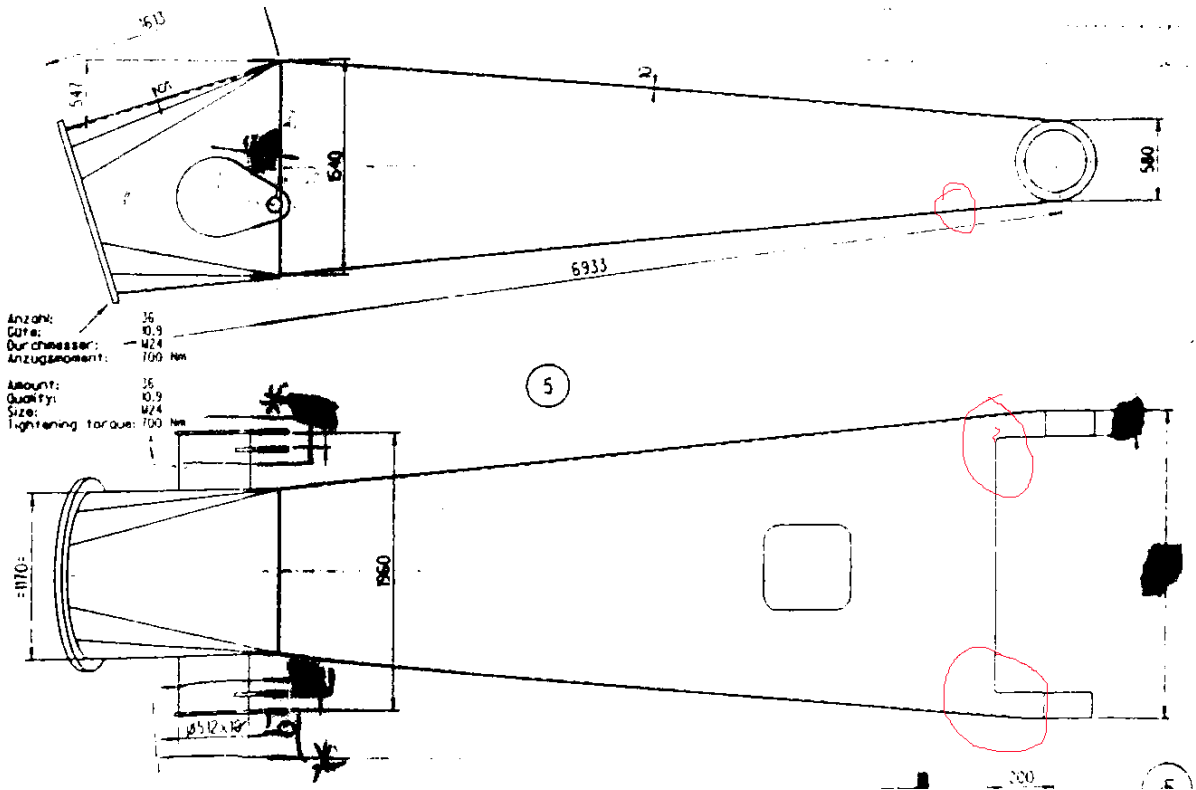
The cracking is on the main mast just above the pivot section where it attaches onto the trailer, as indicated on the following drawing. There may have been a previous weld repairing repair in this region but at this stage that cannot be confirmed. The surface opening width apparently was big enough to be able to push a thumbnail into it, the overall length of the crack being approximately 130 to 150 mm.
