NAFLIC

TECHNICAL BULLETIN — June 2016

415. Sartori Runaway Train/Big Apple roller coaster braking system defects

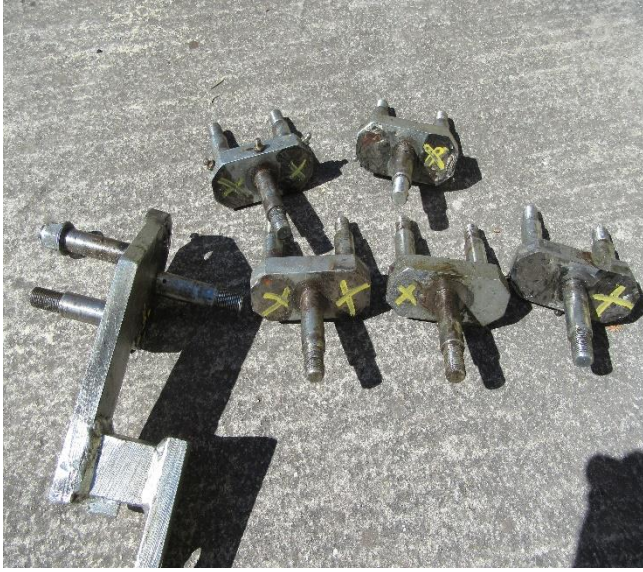
Figure 1

The station brake is a simple ‘pinch’ brake attached to the station track section with a pivot block consisting of a central pin and two outer pins to hold the brake shoes parallel (See Fig 1).

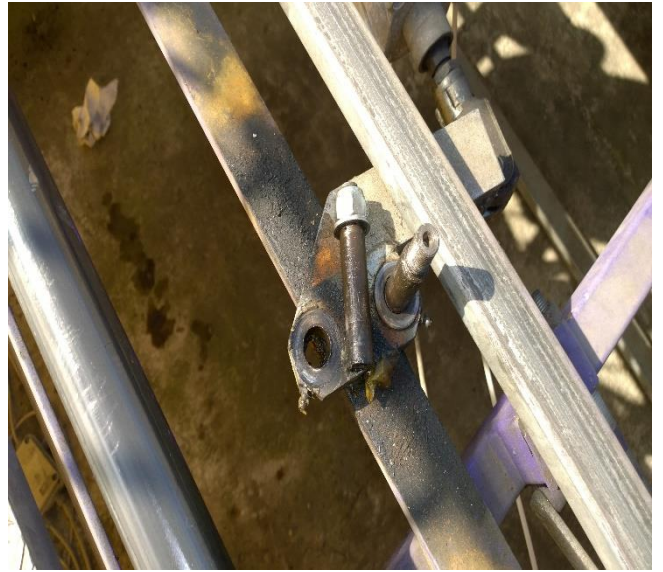
Figure 2

The pins appear to be an interference fit in the pivot block and are welded circumferentially to the lower side of the block (See Fig 2). By removing the accumulated grease and observing the pivot block from the underside, defects (cracking) to the weldments can be easily found (See Figs 3 and 4).

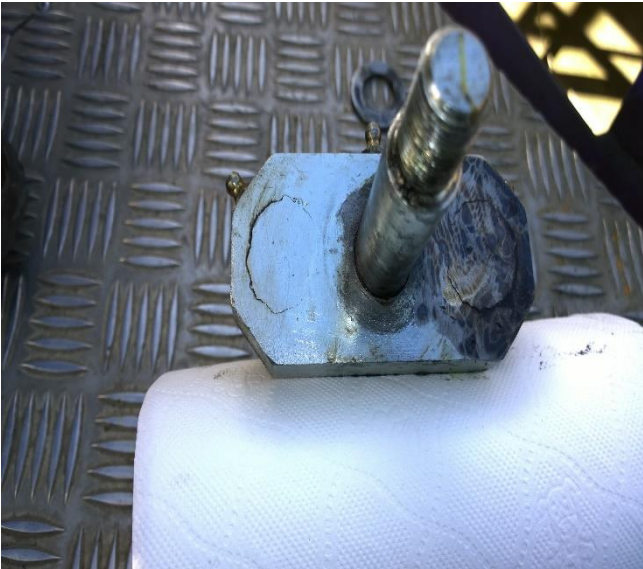
Figure 3

In extreme cases the grease will escape from the ‘crack’ due to wear between the pin and the block.
